# Charlottesville DOWNTOWN MALL TREE MANAGEMENT PLAN

CITY COUNCIL KICK-OFF MEETING

JANUARY 16, 2024

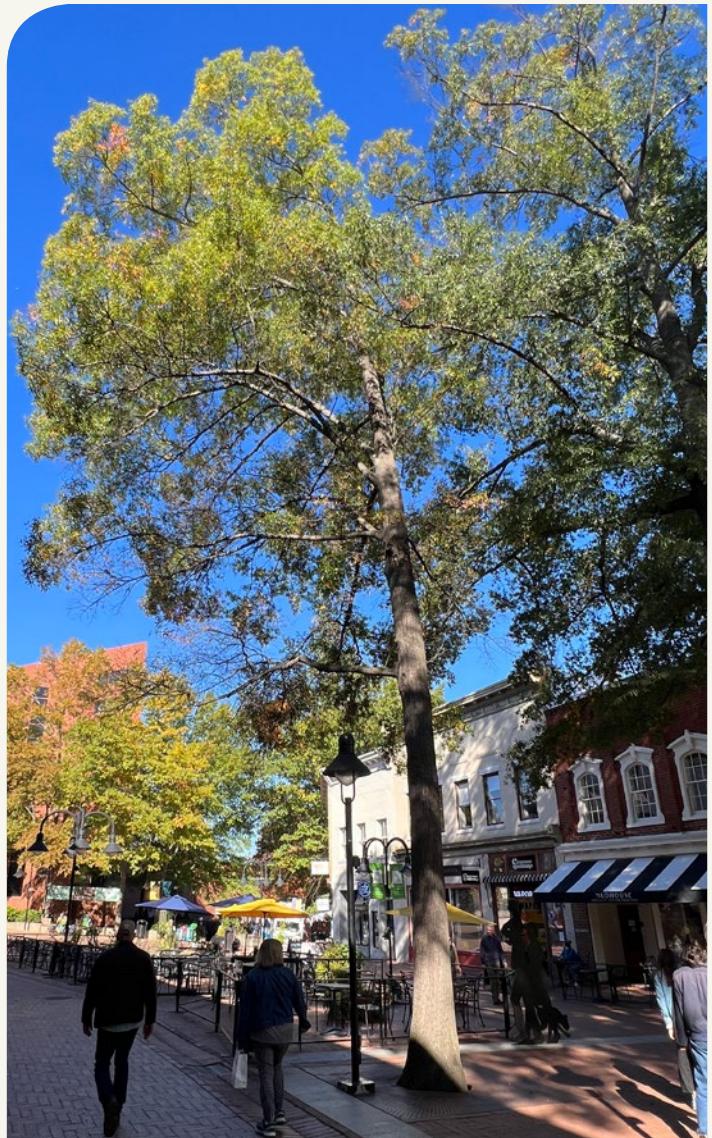
**Willow oak #73**

Major deadwood, thin canopy, phototropic lean with banana crack

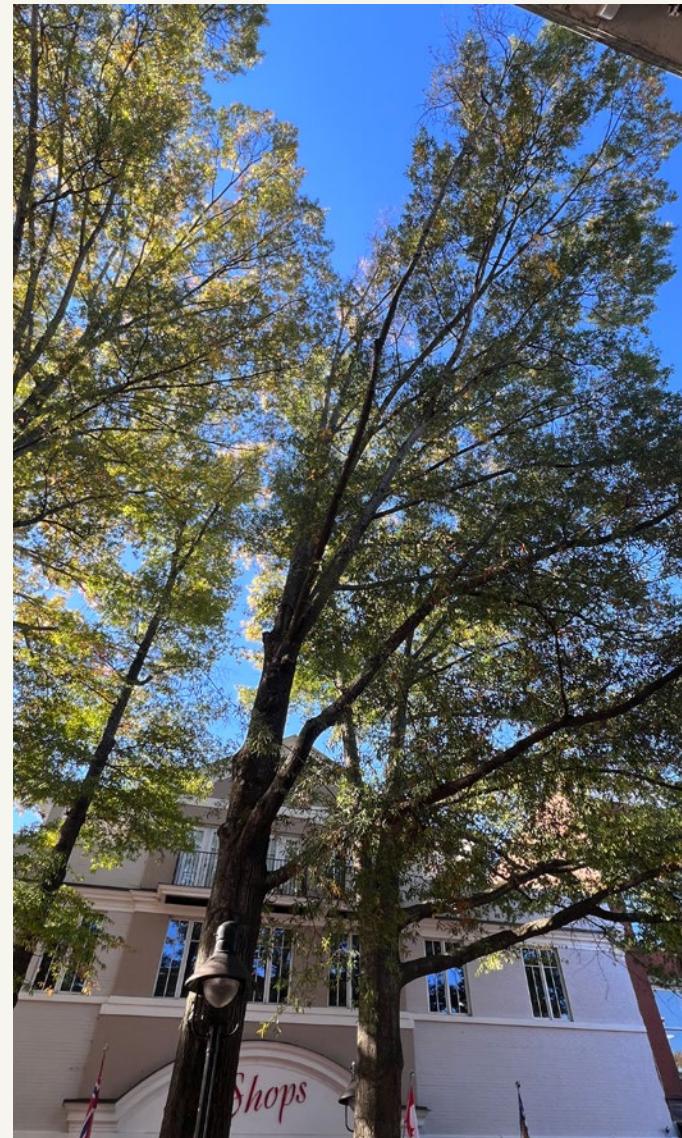
**Willow oak #67**

Poor overall structure, topped central leader, top dieback

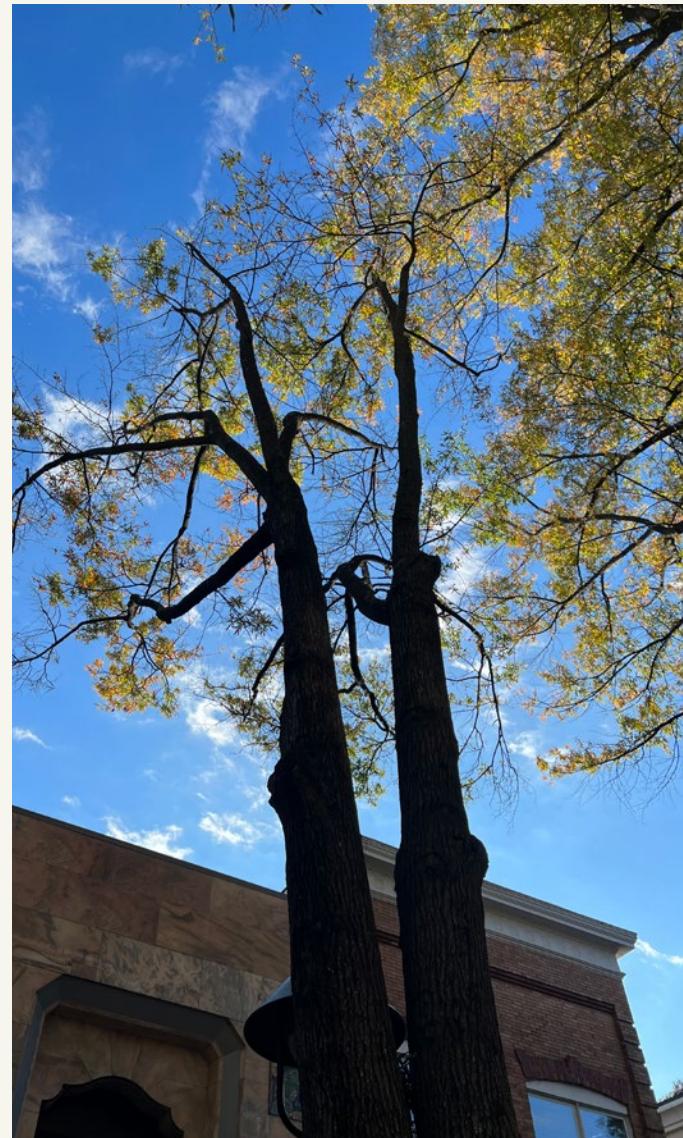
**Willow oak #59**

Co-dominant leader, included bark

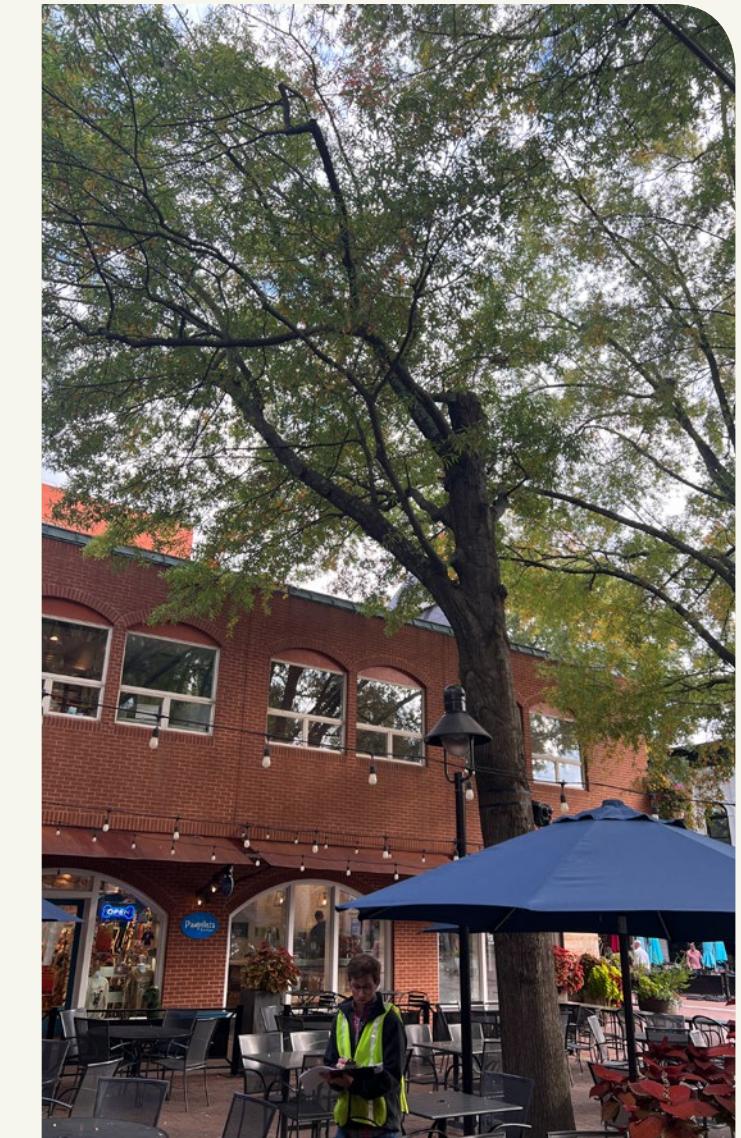
**Willow oak #41**

Topped central leader, internal decay

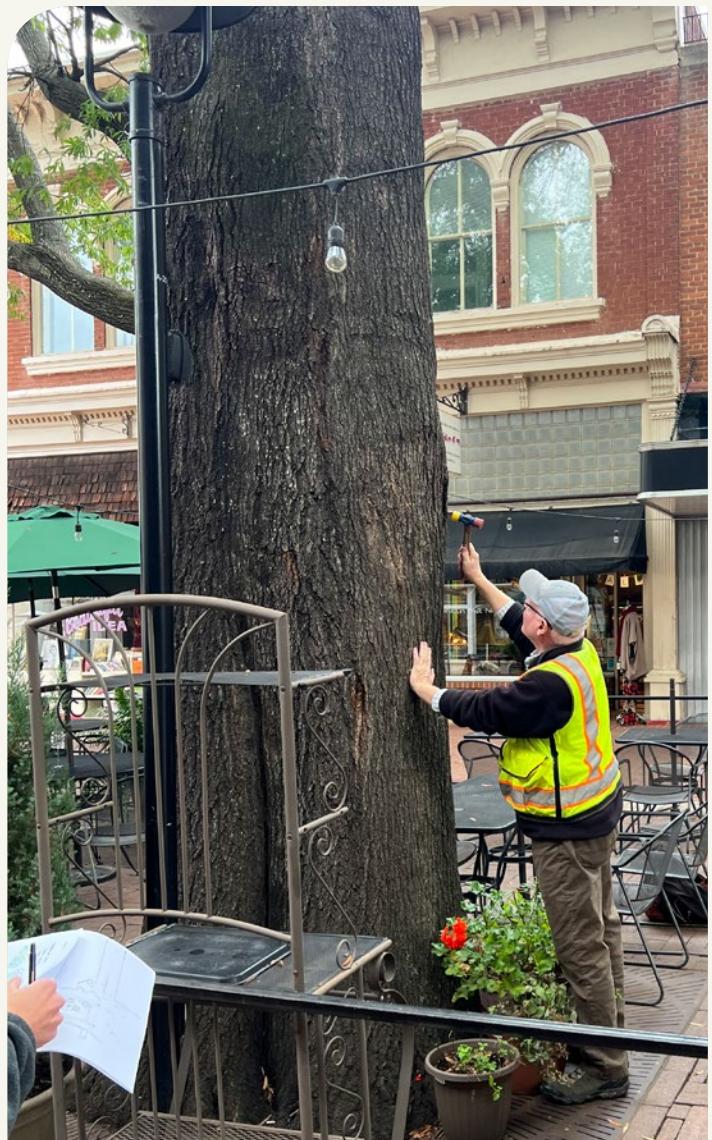
### Willow oak #24

Ambrosia beetle, heater wound, co-dominant leader, included bark, callus wood, internal decay

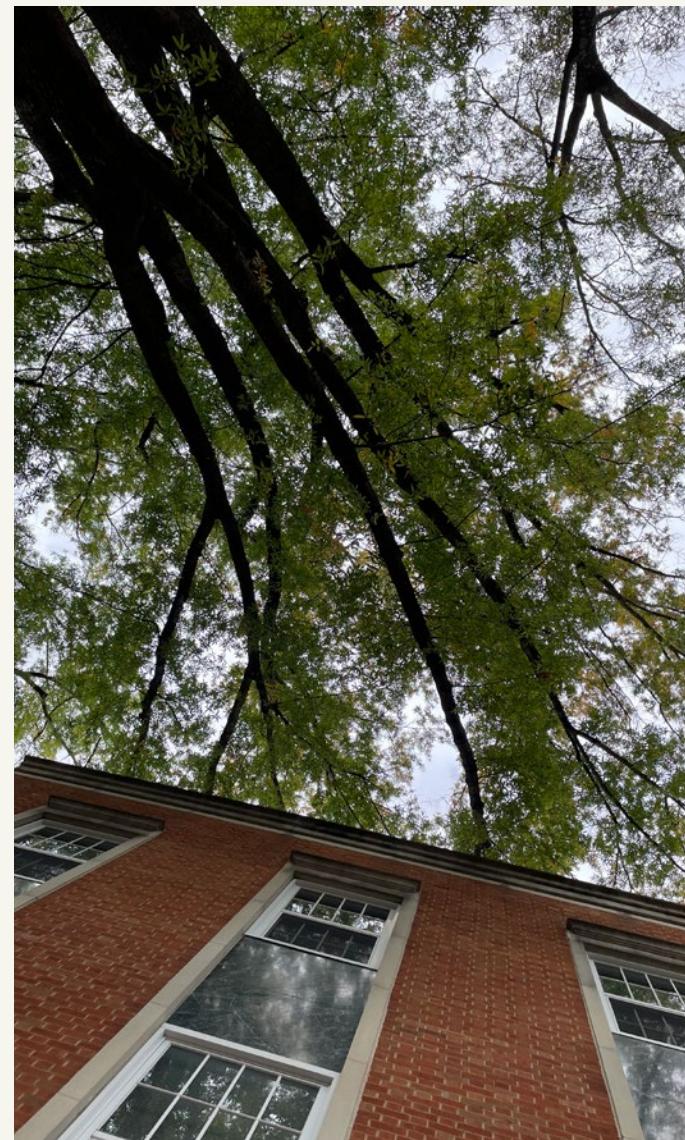
### Willow oak #20

Canker at trunk flare, possible insect damage, pruning clearance from building needed

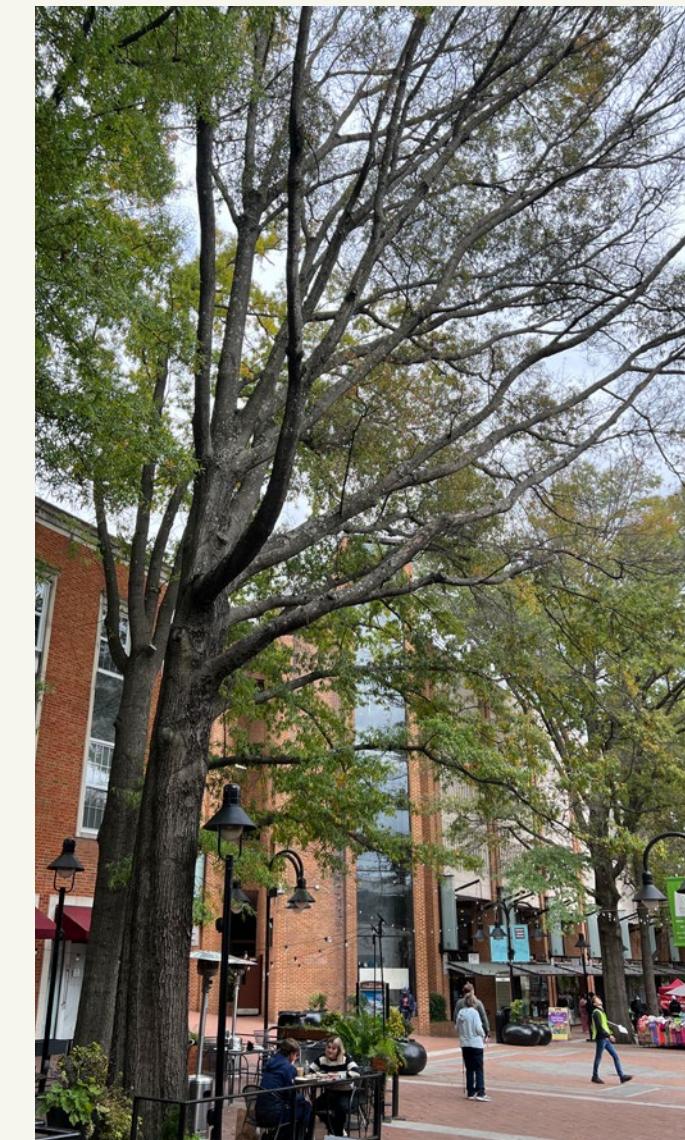
### Willow oak #19

Major deadwood and crown dieback, Hypoxylon canker, trunk flare growing into grate, heavy pruning/ removal needed

**High risk willow oak #19 removed (1/8/24)**

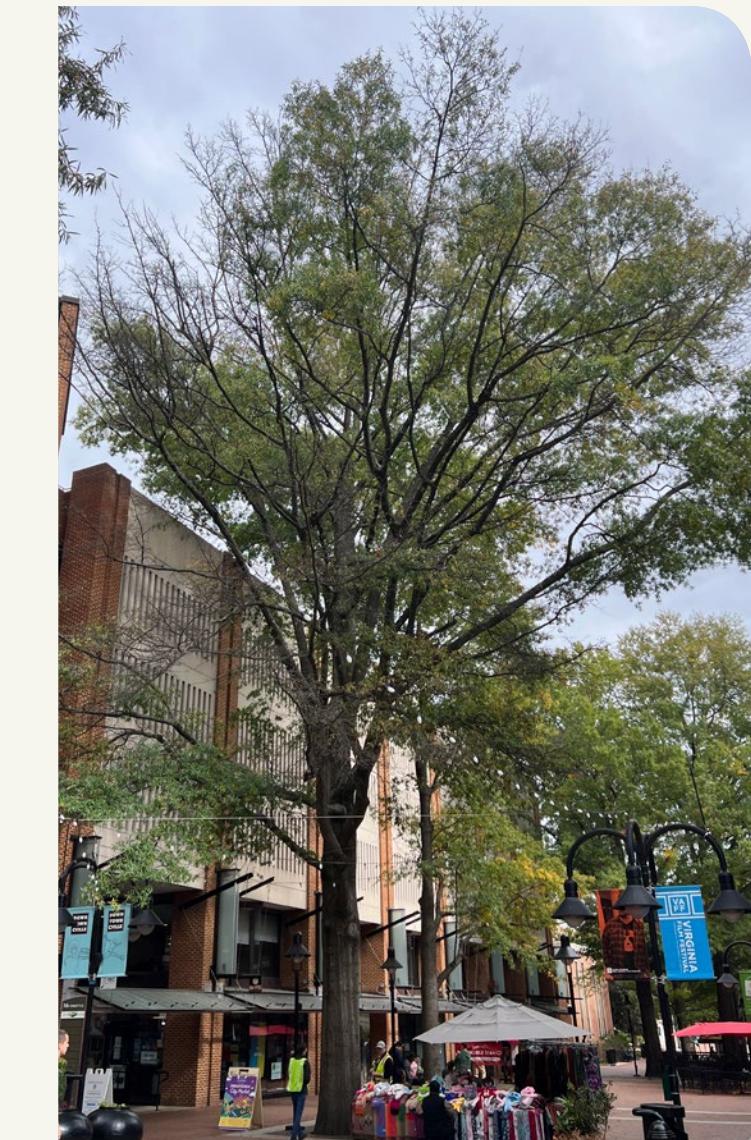
### Willow oak #17

Trunk flare growing into grate, flush pruning cuts, quick internal growth bark ridge, internal decay, crown dieback

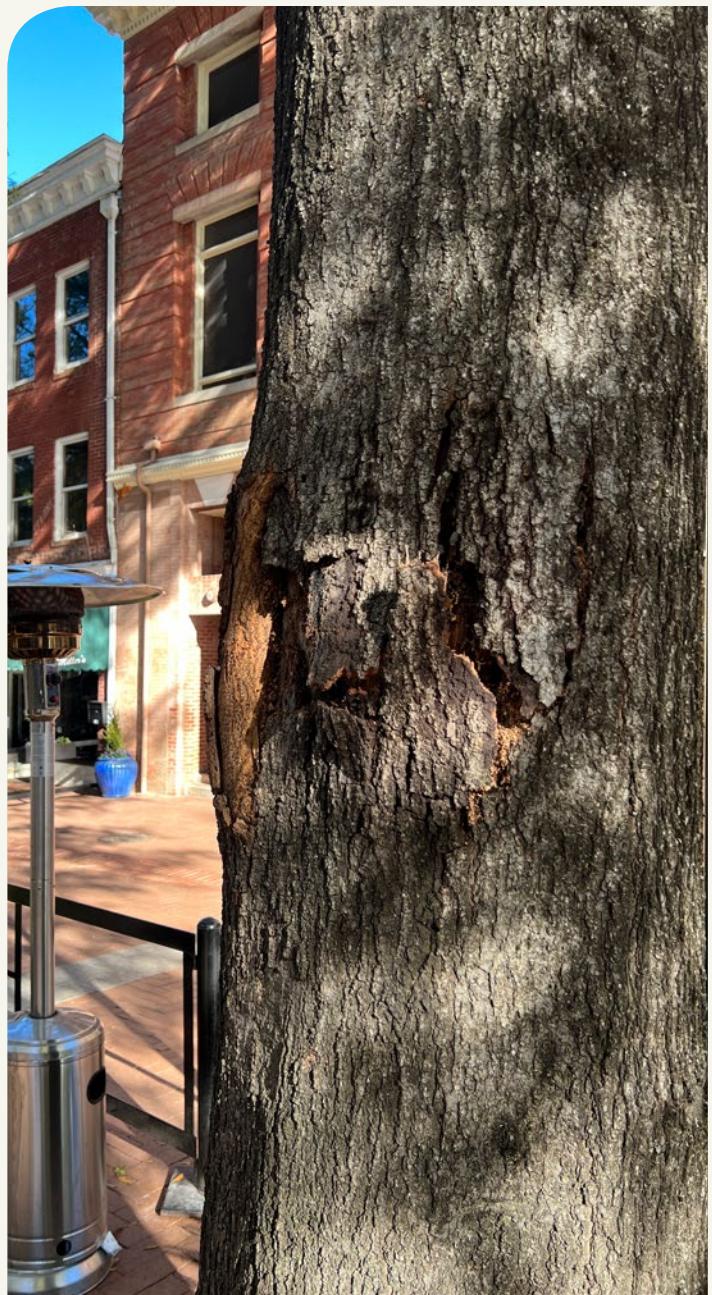
Willow oak #62

- 9 of 55 original willow oaks were impacted by heater use too close to the trees  
*(preventable, human-caused damage)*
- 2 of these 9 trees required removal in 2022
- 5 of the 6 cafe enclosures that use heaters near trees have caused the damage

- Minimum 10' clearance from trees
- All heater locations to be approved with NDS
- Penalties include loss of heater usage and possible revocation of cafe space

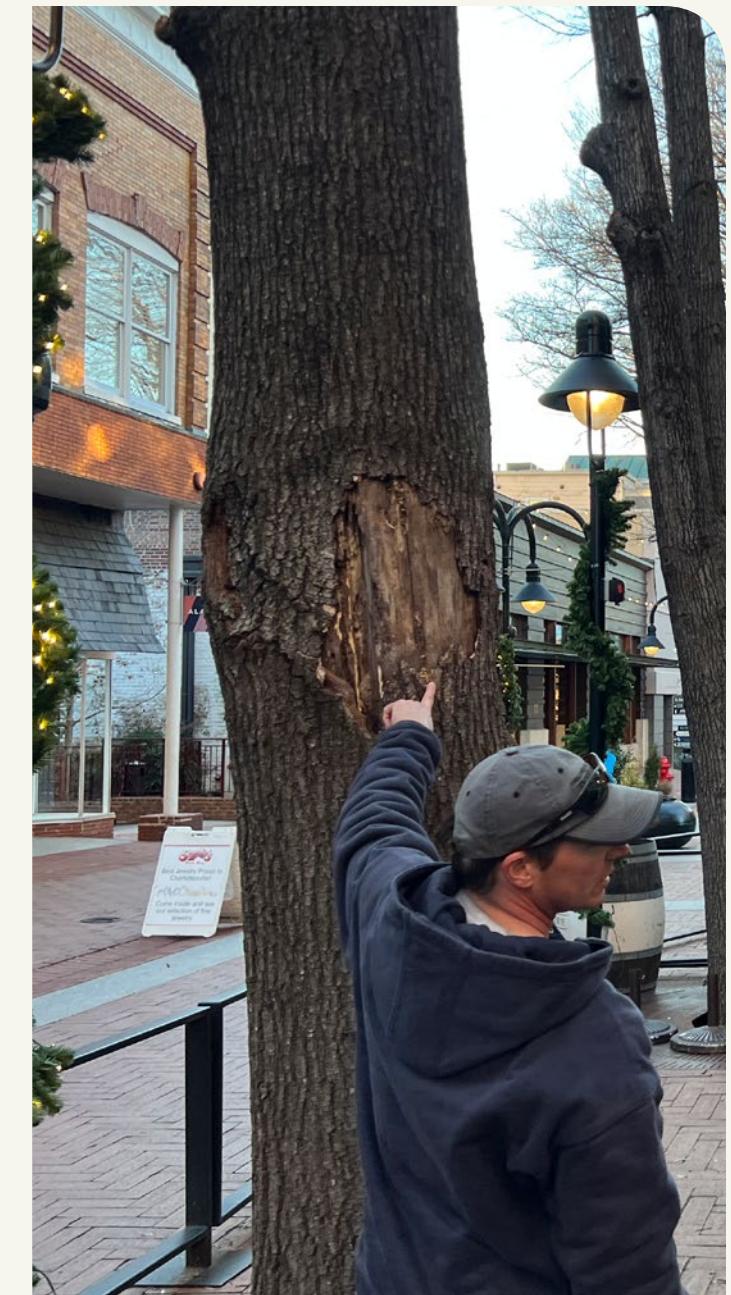
Willow oak #57  
photo taken prior to removal

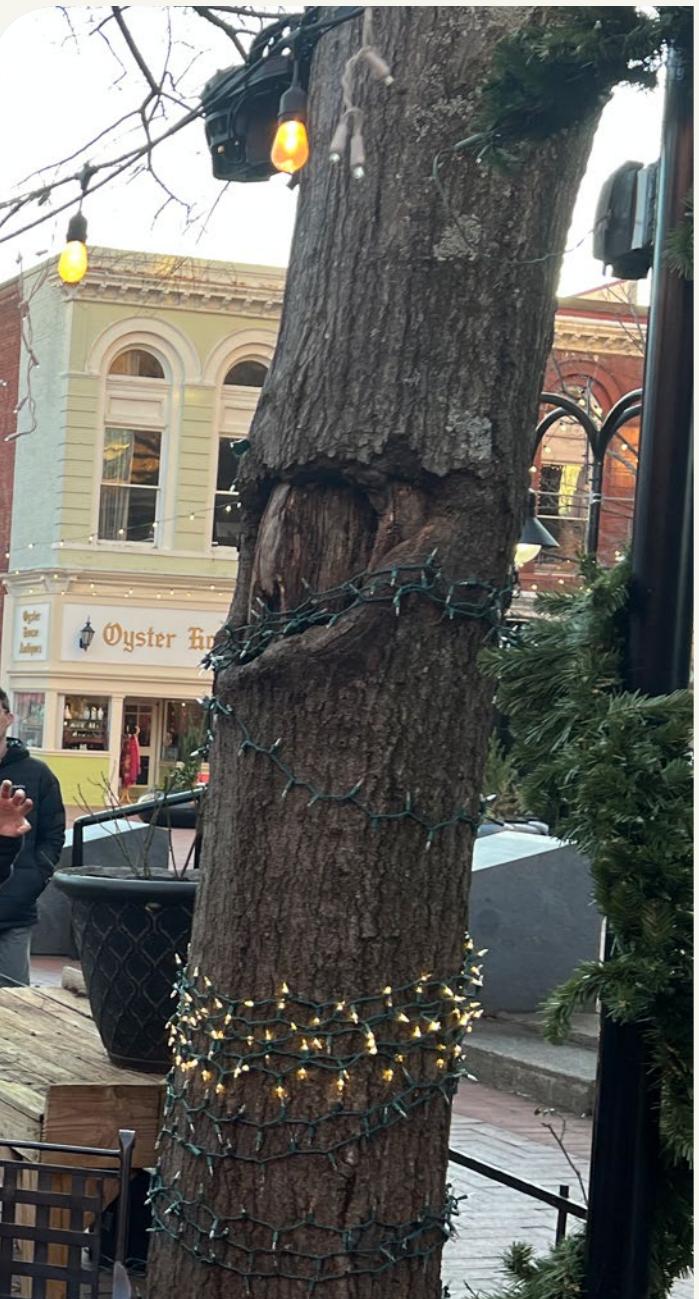
**Willow oak #45**

photo taken prior to removal
