# Earlysville Road Traffic Analysis

Gerald Gatobu, AICP, LEED AP  
Principal Planner-Transportation  
County of Albemarle Department of Community  
Development  
401 McIntire Road, Charlottesville, VA  
22902-4596

EPR, P.C.  
Bill Wuensch, P.E., PTOE  
637 Berkmar Cr, Charlottesville, VA, 22901

July 7th, 2015  
Revised July 30, 2015 and December 29, 2015

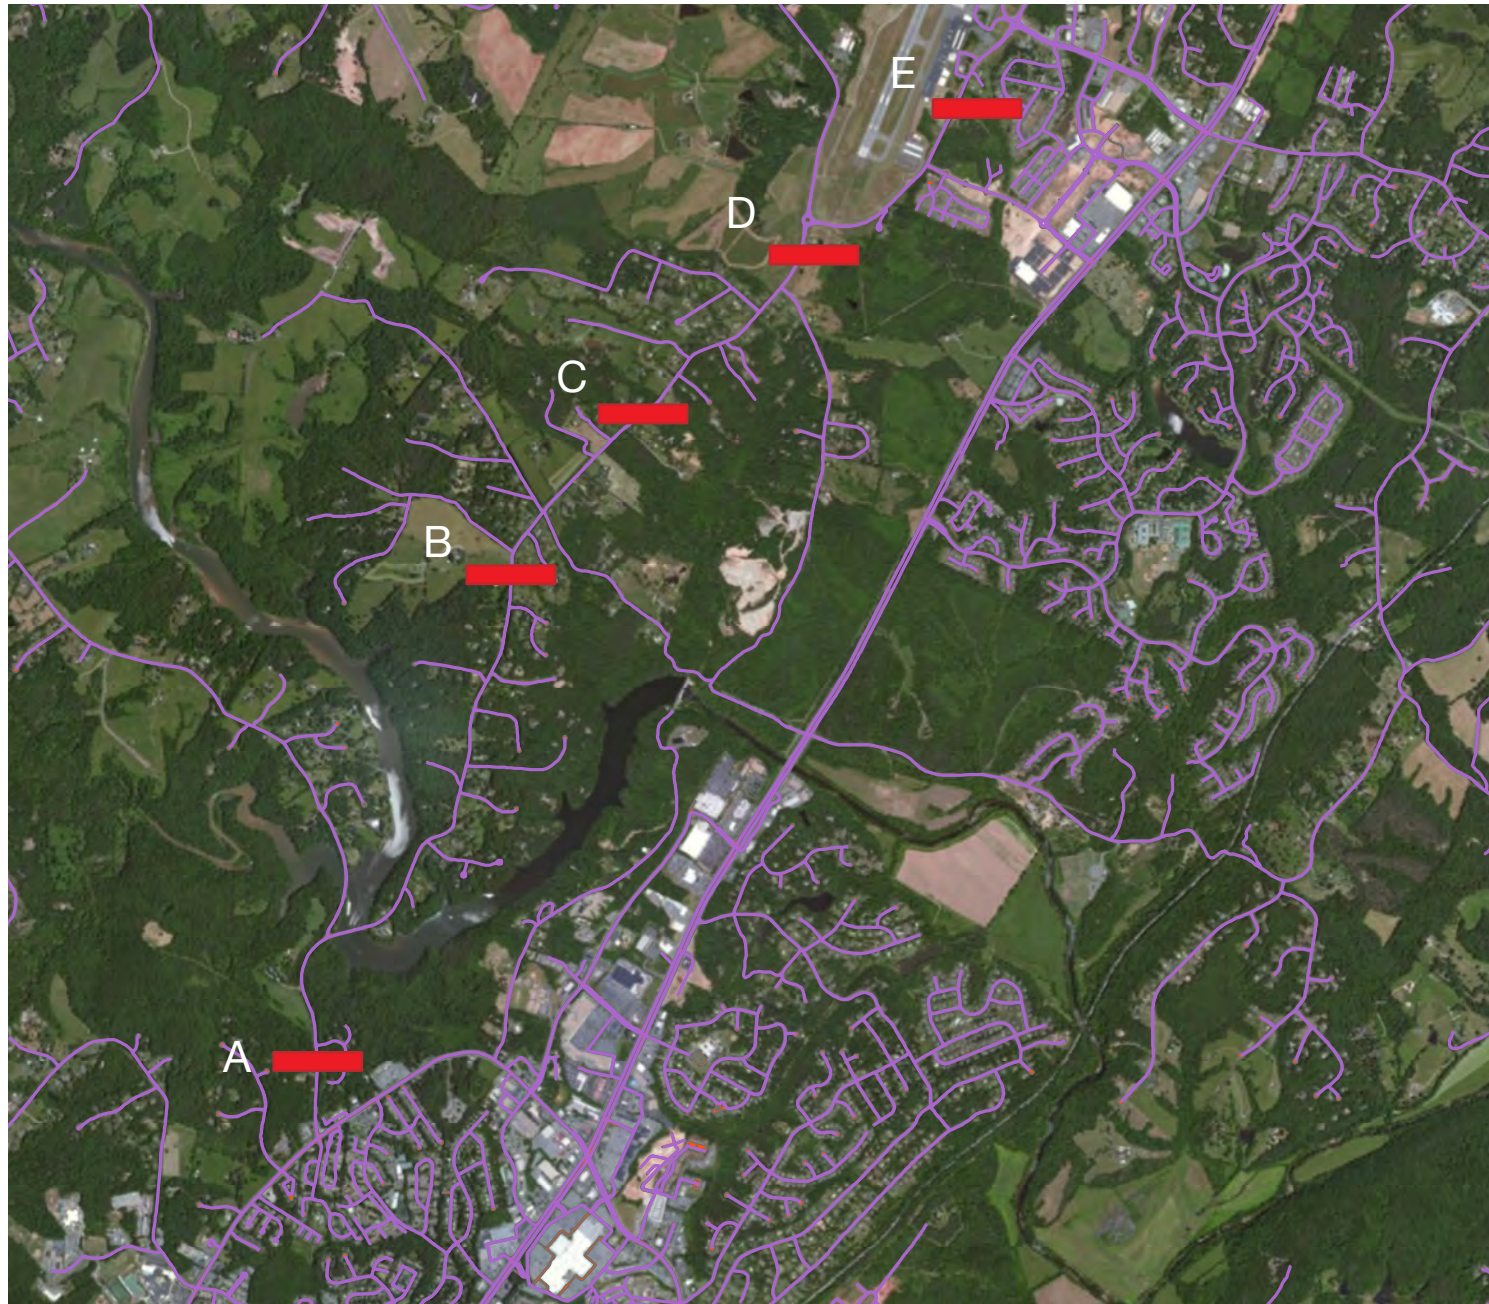
**Figure 1 - Project Location Map and Count Locations**

Bi-directional hourly traffic volumes were collected along Earlysville Road and Dickerson Road in five locations. (See attached Map – **Figure 1**). Four pneumatic tube counters were placed on Earlysville Roads and the northern most counter was located on Dickerson Road. Data was collected from 3 PM Friday, May 15th through 2 PM Friday, May 22nd.

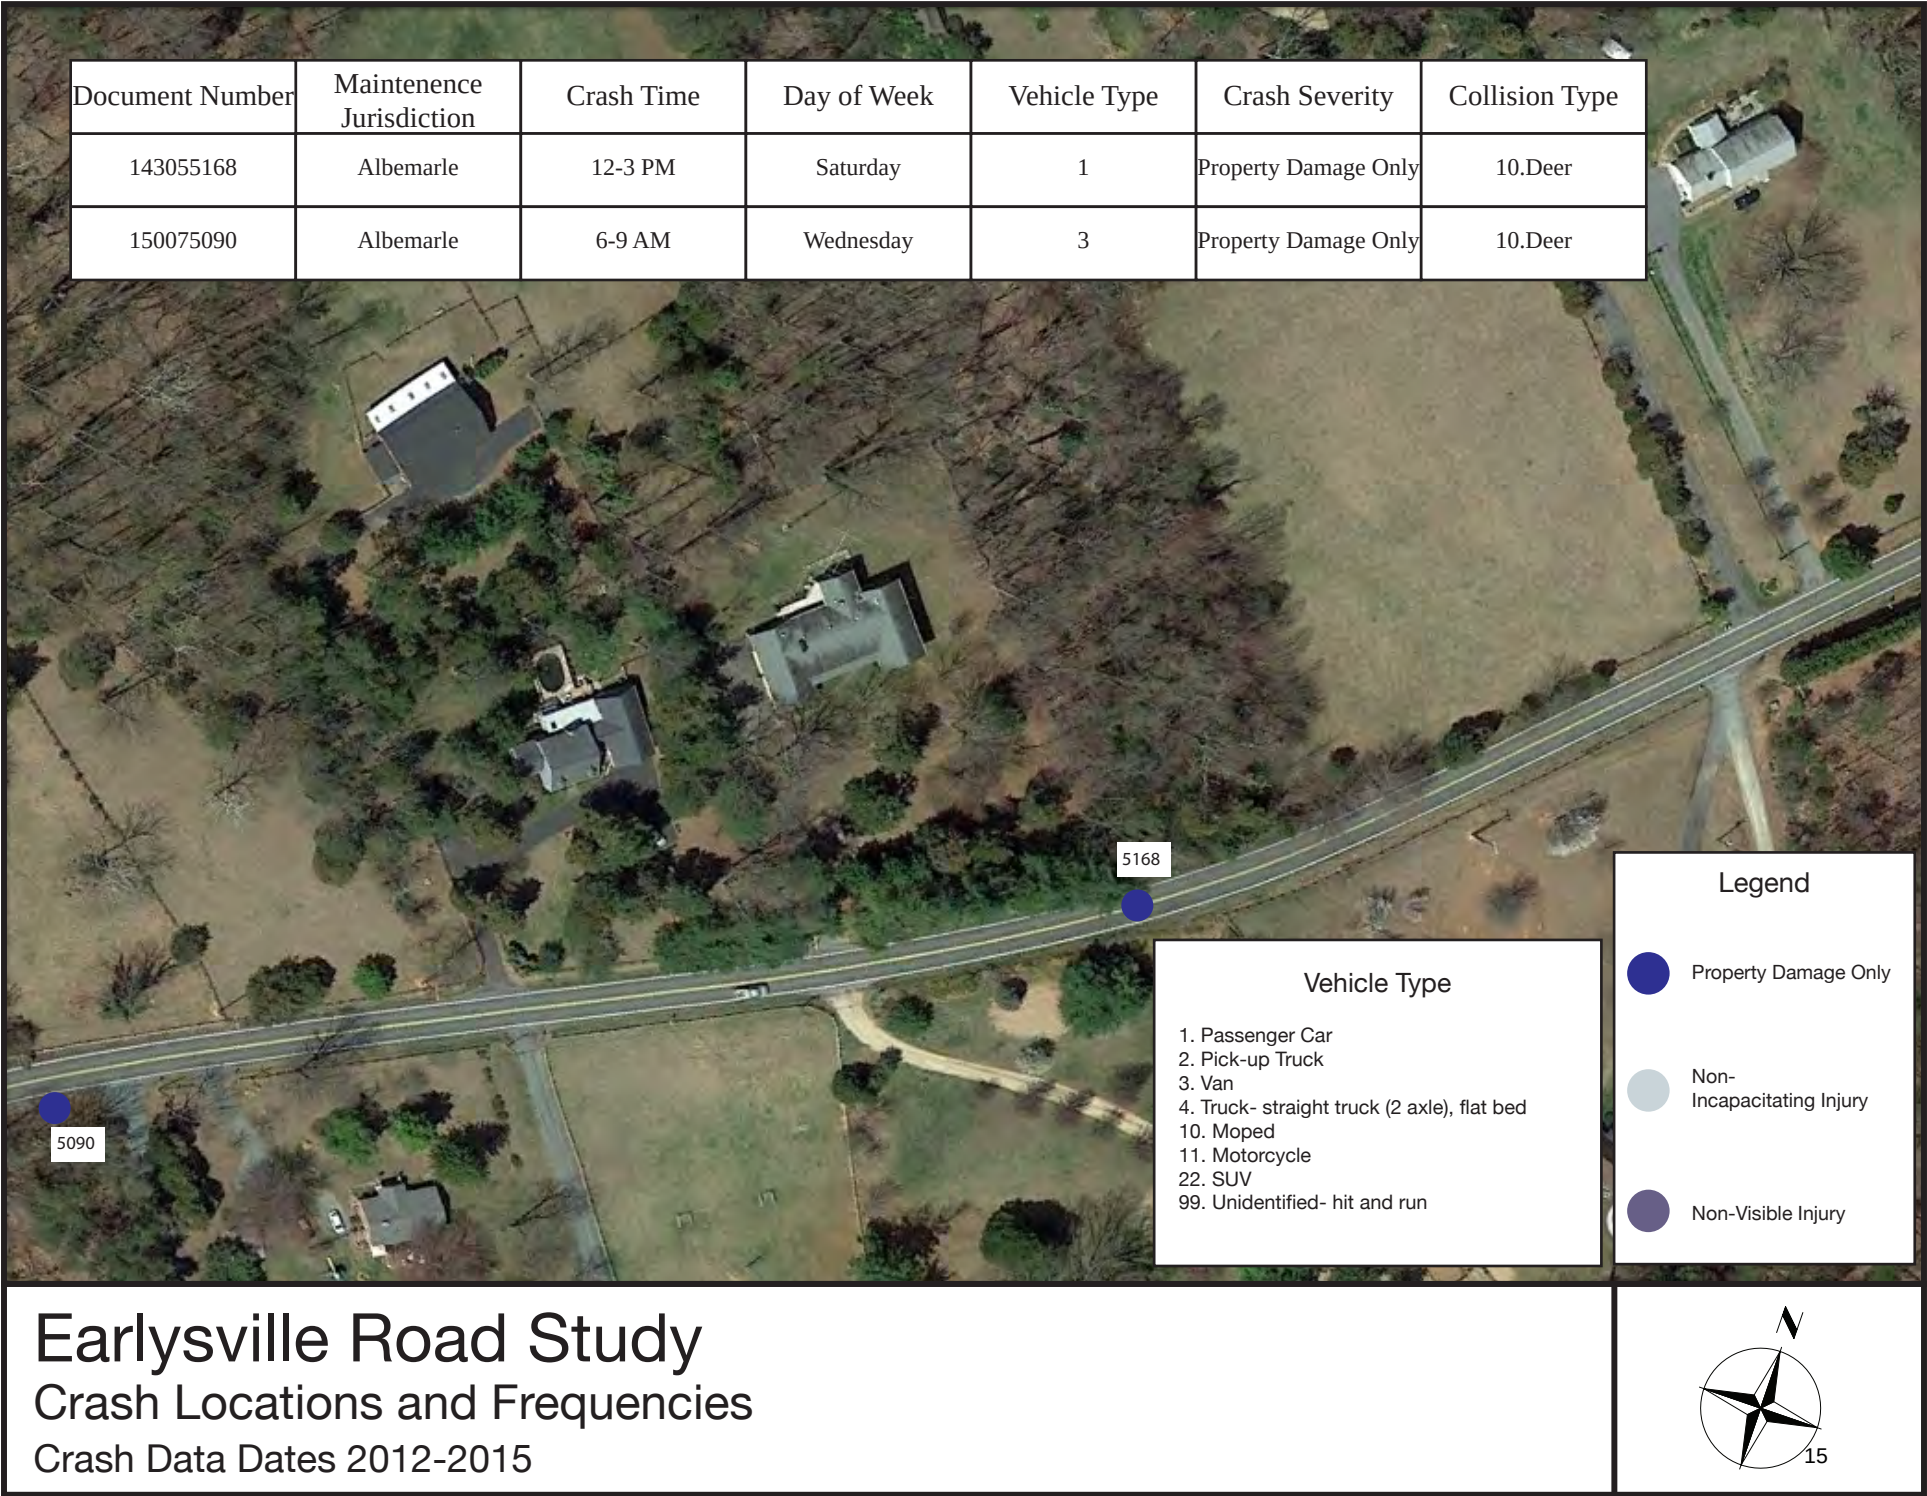
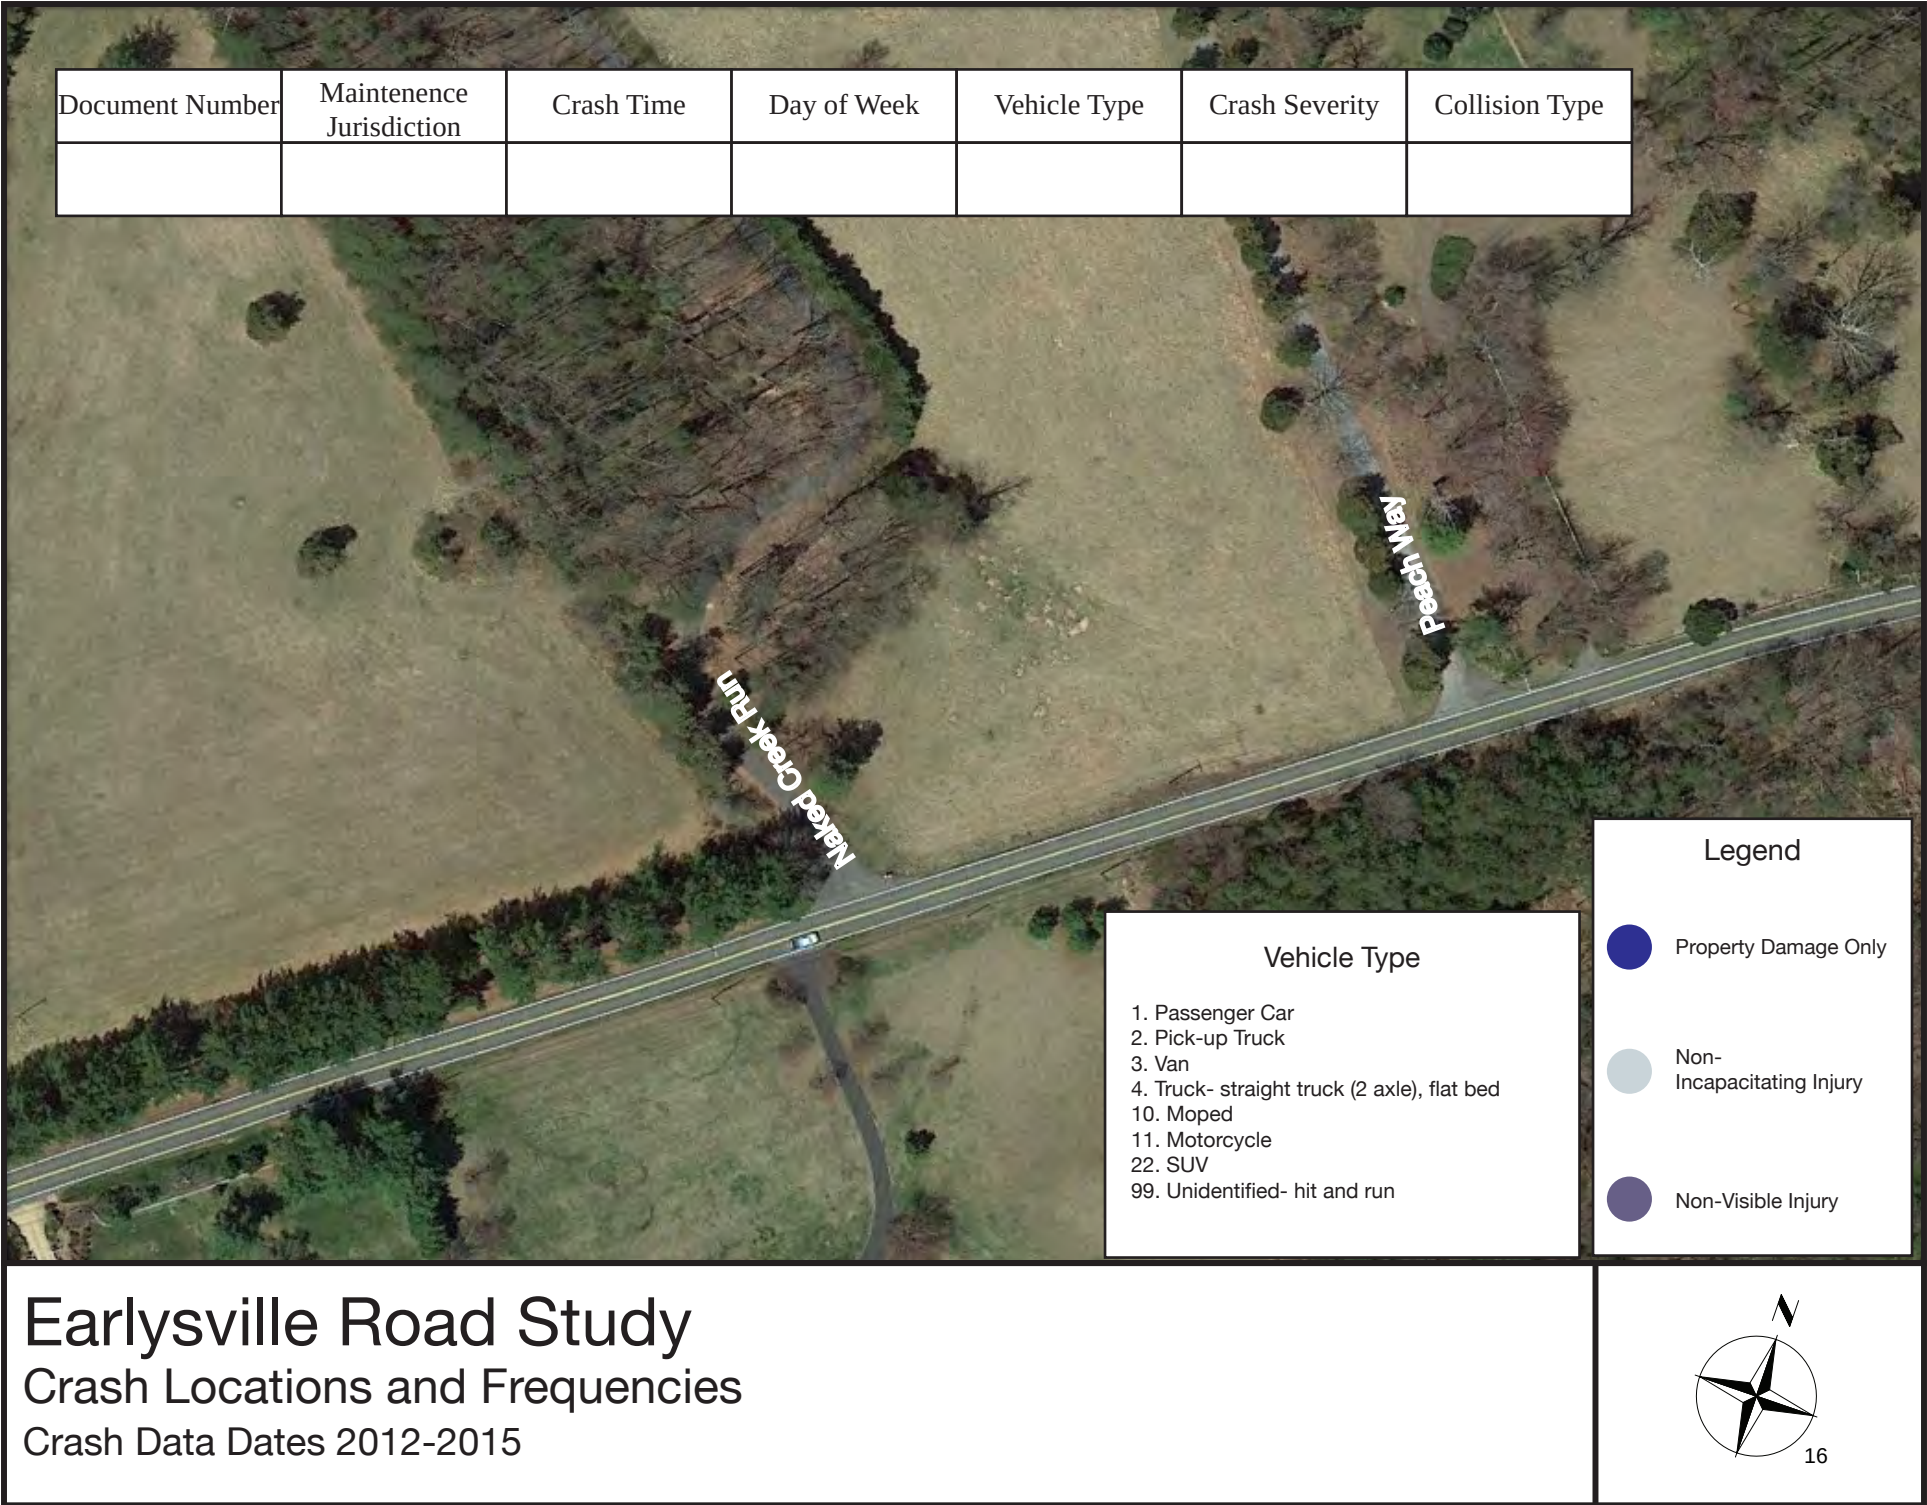
Crash history was recorded and visualized via aerial imagery as shown in **Figures 7 through 23**. The data for these maps was obtained from a VDOT database for the previous three years (2012-2015). This data includes location of the crash, the date of the accident, the time period it occurred, type of crash, and the type of vehicles involved in the crash.

Per the database, 60 crashes were recorded within the study area for the years 2012-2015. Of those crashes, 25 crashes were rear ends, accounting for 42% of all crashes. Only one truck was involved in any of the 60 crashes. This crash was a rear end incident involving the two-axle truck and two other cars. The vast majority of crashes occur traveling northbound, with just nine crashes occurring southbound.

Crashes appear to be correlated to locations of entrances and sharper curves, and there is no apparent correlation with truck traffic. Particularly notable was the high concentration of crashes that occurred northbound at the Ivy Creek Natural Area. While a detailed analysis was not conducted, there could be a need to provide a destination sign in advance of the turn to warn motorists to slow and use their turn signal earlier in their approach. The theory being that many of the users of the facility are tourists or first time customers and the entrance can not be seen until the approaching vehicle is very close to the entrance. This could cause a quick breaking reaction resulting in rear end crashes. However, before any action is taken discussions with the law enforcement personnel who have responded to these crashes should be consulted to have benefit of their experience and perspectives.

Also, per inspection of the data there were numerous run-off the road crashes along the corridor. These could be the result of either a lack of shoulders, or they could be associated with avoidance maneuvers to avoid hitting another vehicle (rear end, side-swipe, and head-on). Additional study could be provided to include discussions with law enforcement officers who are responding to these incidents.
