# Community Inventory PILOT PROJECT

PHASE I

2018

## EXECUTIVE SUMMARY

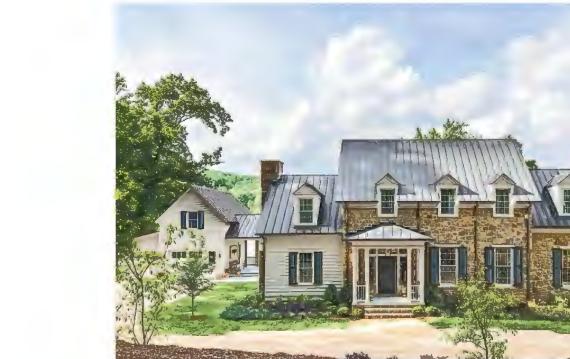
**Sound**

These are buildings with no visible deficiencies. Most new construction falls under this category, but older structures can as well. These buildings may have some cosmetic flaws, but nothing that diminishes the condition of the home.

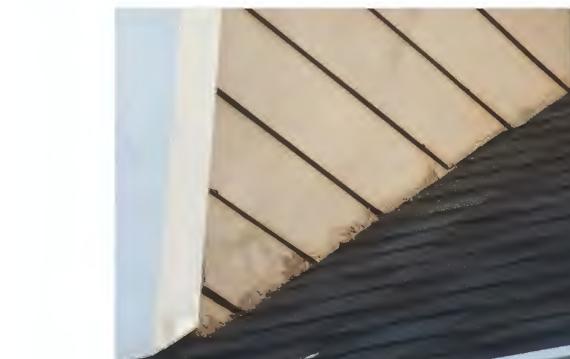
**Sound with Minor Repairs**

These are buildings that are sound but have minor deficiencies. This can include chipping or peeling paint, a handful of loose singles, minor rot around windows or similar issues. These are generally problems that a homeowner can fix themselves or that can be repaired with limited resources from a professional.

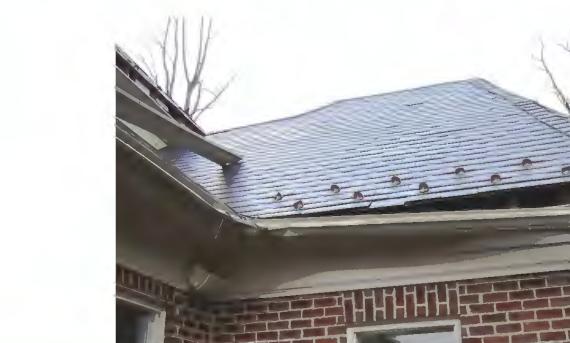
**Minor to Moderate Repairs**

These structures have repairs that require more immediate action and may be beyond the skills of the average person. This may include visible cracks in the walls or siding. The fascia may be rotten or falling off the roof. Multiple shingles may be missing. These buildings are presently sound but identified deficiencies will lead to structural issues if left unresolved.

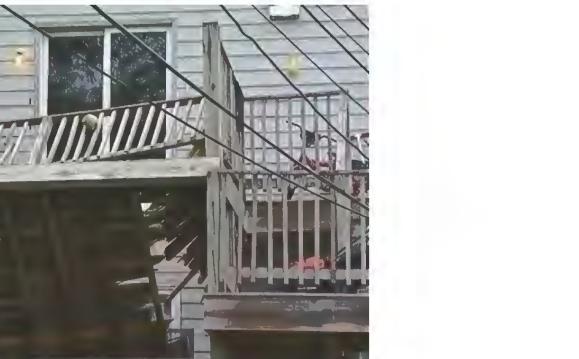
### **Moderate to Major Repairs**

These buildings appear to have structural weaknesses. This includes interior walls that are exposed to the elements, roofs that need replacing, leaning chimneys or sagging window frames. Only a specialized professional can make these repairs and the work would be costly. Unlike the previous categories, these structures are not sound or will soon be unsafe.

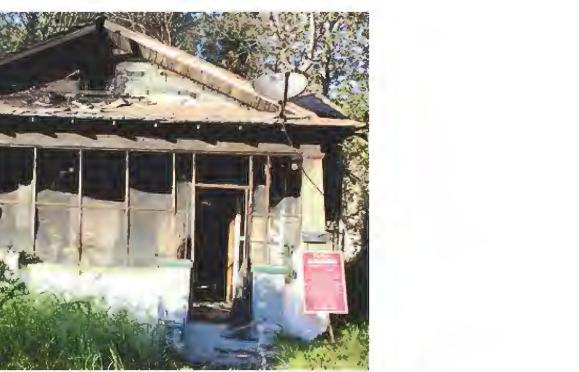
### **Dilapidated**

With major structural degradation, these structures are unsafe and unfit as a housing option for residents. These buildings are likely beyond repair, where demolition is the most cost-effective response. This may also include structures that had a severe fire, where repairs have yet to start.

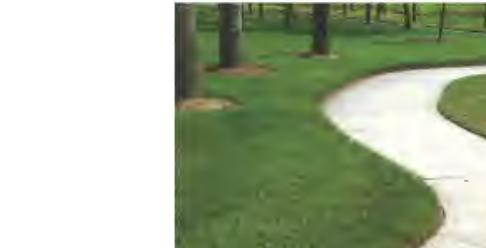
## Excellent

Facilities in this category have no discernible problems or impediments. Furthermore, there is no general wear and tear. Moving forward, the facilities in this category will likely not have to be monitored for potential maintenance issues.

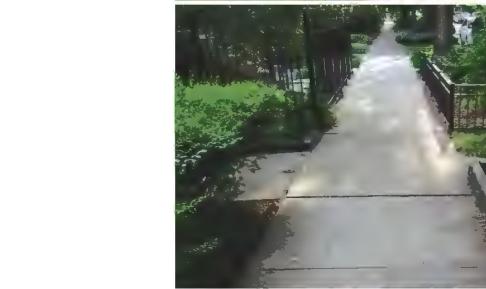
## Good

Facilities in this category will have few, if any, problems or impediments. What sets this category apart from the 'Excellent' category is the wear and tear these facilities have endured. While this is usually minor, it does mean that these facilities should be monitored for potential maintenance issues in the future.

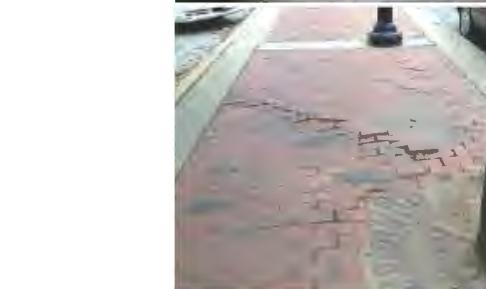
## Fair

Facilities in this category, while generally traversable, will have some sections that have impediments. The wear and tear of this category is high. In this category, the facilities are still usable; however, maintenance on these segments should begin to be discussed before the facilities degrade any more.

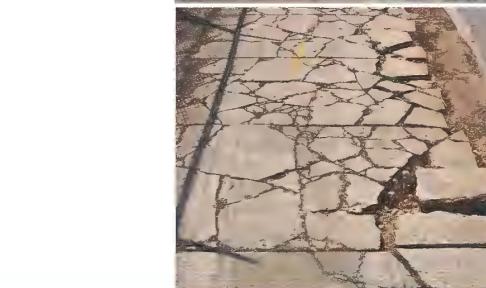
## Poor

Facilities in this category are in serious need of repair. Large parts of these segments will be significantly cracked or missing. These segments should be high in priority for repair and maintenance.

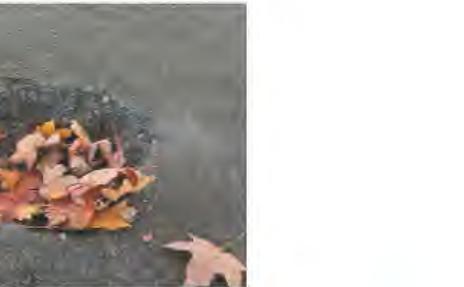
### **Pothole**

This maintenance issue is a large hole in the facility that severely impedes movement at a single spot in the segment.

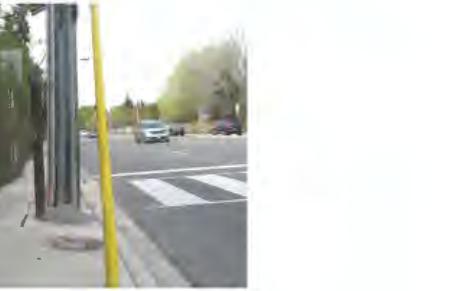
### **Obstruction**

When an object, like a mailbox or powerline, is in a path of movement for the facility.

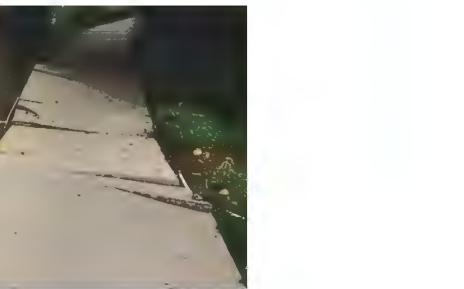
### **Displacement**

This impediment occurs when the facility, usually a sidewalk, is displaced by some outside force, like tree roots.

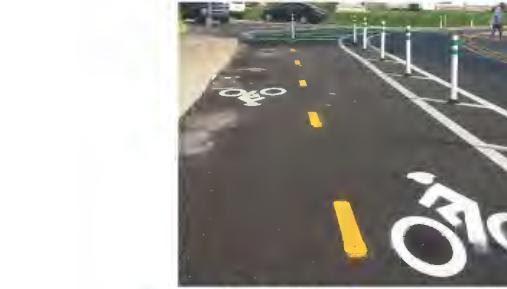
### **Excellent**

Facilities in this category have no discernible problems or impediments. Furthermore, there is no general wear and tear. Moving forward, the facilities in this category will likely not have to be monitored for potential maintenance issues.

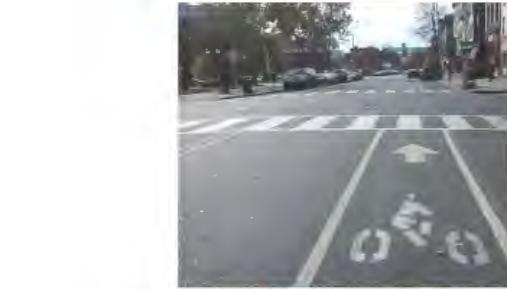
### **Good**

Facilities in this category will have few, if any, problems or impediments. What sets this category apart from the 'Excellent' category is the wear and tear these facilities have endured. While this is usually minor, it does mean that these facilities should be monitored for potential maintenance issues in the future.

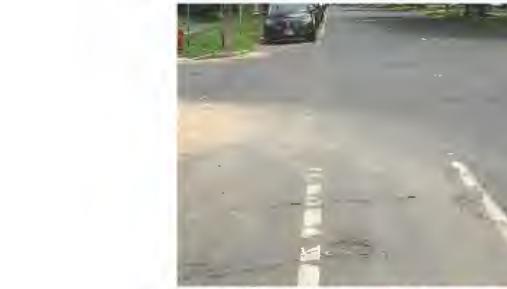
### **Fair**

Facilities in this category, while generally traversable, will have some sections that have impediments. The wear and tear of this category is high, usually as it relates to the visibility of the facility. In this category, the facilities are still usable; however, maintenance on these segments should begin to be discussed before the facilities degrade any more.

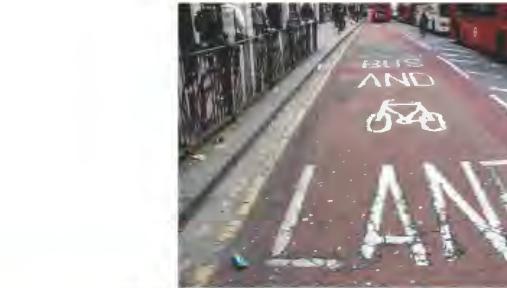
### **Poor**

Facilities in this category are in serious need of repair. Large parts of these segments will be significantly cracked or missing. These segments should be high in priority for repair and maintenance.

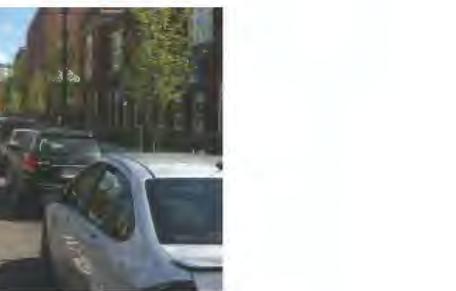
### Shared Lane

Is a roadway with shared lane bike markings? These can either be signs or bike specific pavement markings.

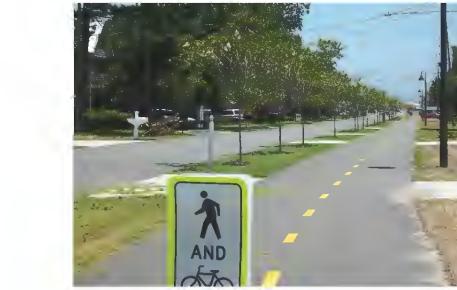
### Shared-Use Path

A shared use path is an improved surface facility designed for use by bikes and pedestrians. These facilities can be located adjacent to roadways or in parks and other recreational facilities.

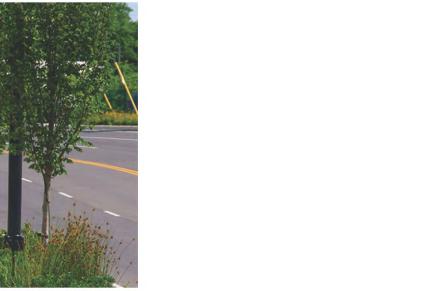
### Street Trees

This data documented the location of trees located in the public right-of-way. In addition to the tree's location, staff also collected the circumference of the tree at chest height and if it is deciduous or evergreen.
