Limited Phase II Investigation Report

Scott's Ivy Exxon Site – 4260 Ivy Road
Charlottesville, Virginia

Date: April 12, 2013

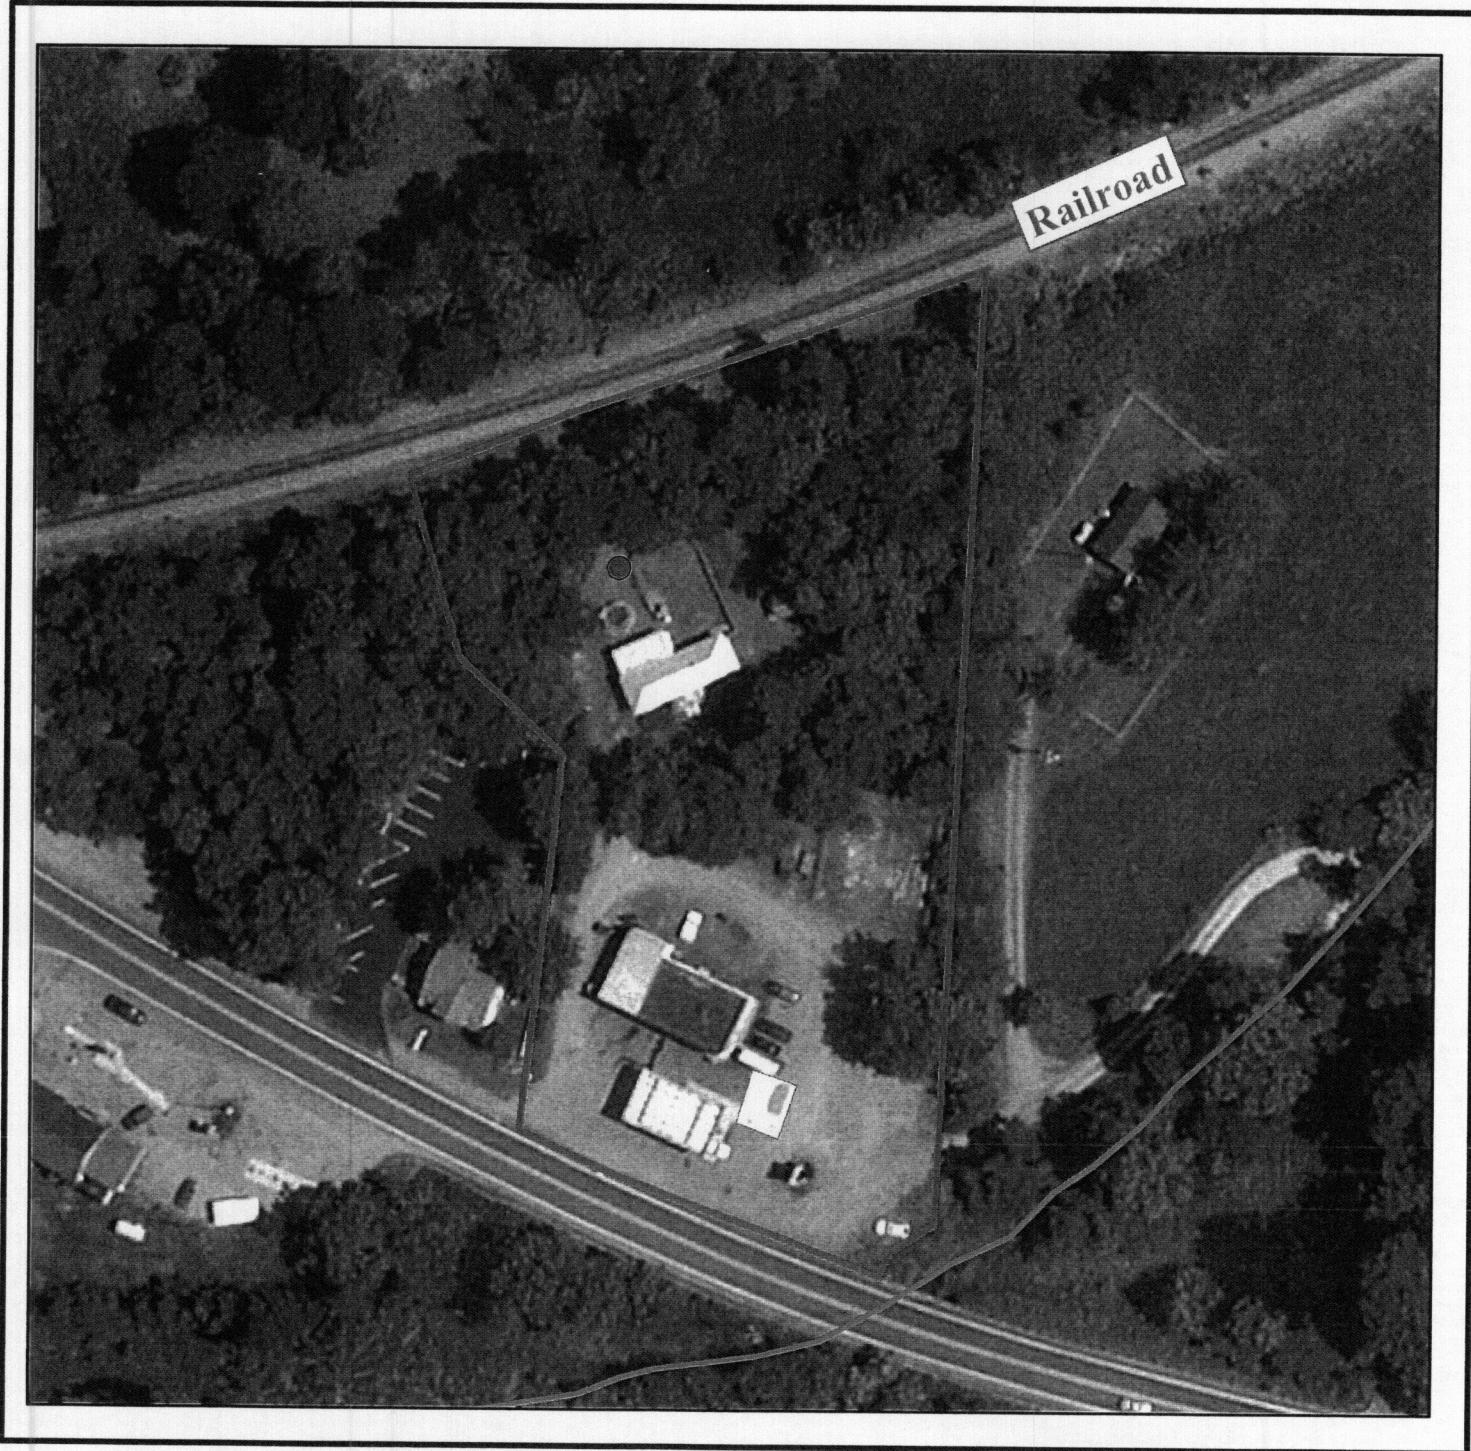
FIGURE 2a: SITE LAYOUT MAP

The Scott's Ivy Exxon site is currently being operated as a gasoline and diesel fueling station and as an automotive repair shop. Two buildings are present at the site; the southern building is used as an automotive repair shop (service building) and the northern building is residential (residential building). Gasoline and diesel fueling dispensers are present to the south of the service building. The gasoline fueling island is supplied by two active underground storage tanks (USTs). According to the Virginia UST database, these tanks have capacities of 8,000 gallons and 12,000 gallons, and were installed in 1998. The diesel fueling dispenser is supplied by a 500-gallon aboveground storage tank (AST). The residential building is supplied by a heating oil UST of unknown capacity. A railroad runs along the northern boundary of the site.

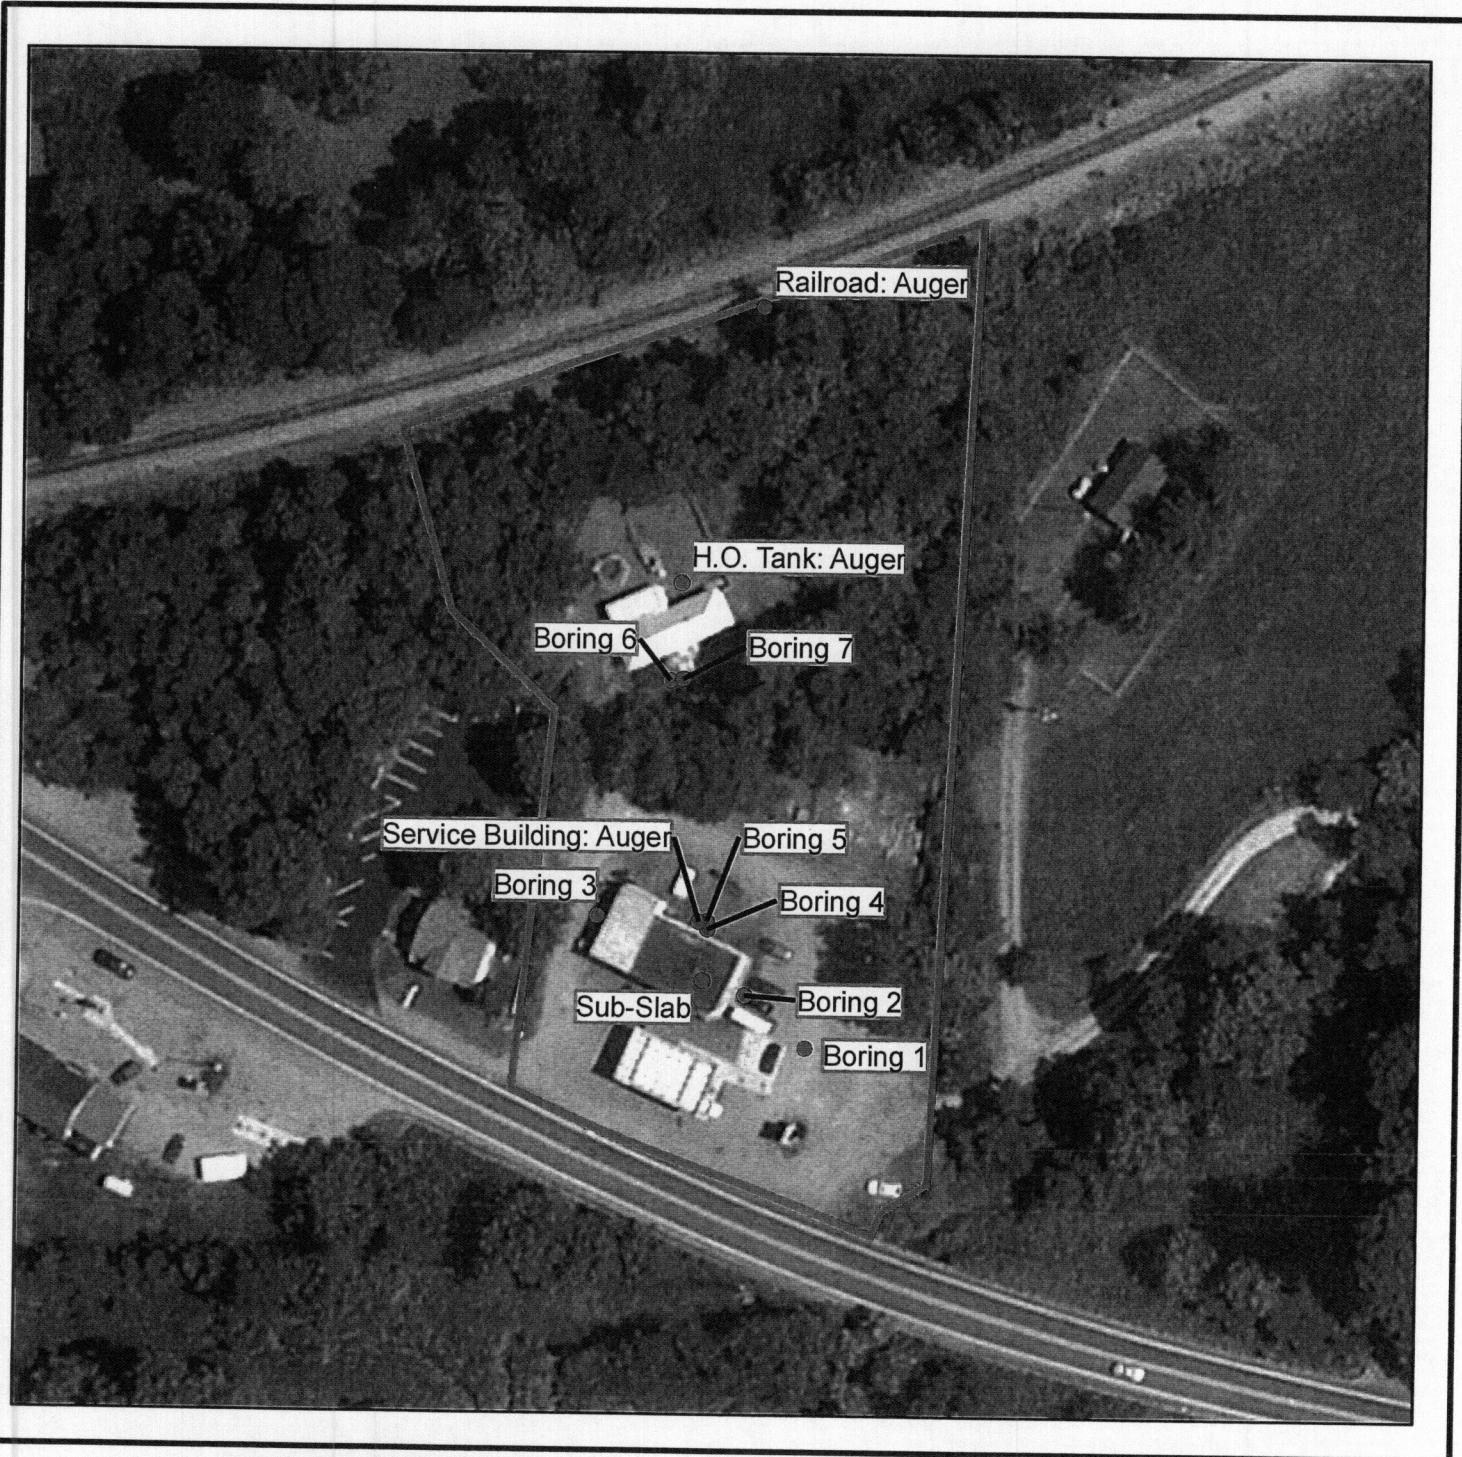
FIGURE 2b: BORING LOCATIONS MAP

Boring 1, 2, 3, 4, and 5 (Figure 2b). Additionally, ASI personnel used a hand-auger to bore to a depth of 5.3 feet bgs near the used oil UST. The hand-augered sample collected near the service building is identified as Service Building: Auger (Figure 2b). A soil sample was also collected in the service building, beneath the concrete building foundation in an oil-changing bay, and is identified as Sub-Slab (Figure 2b).

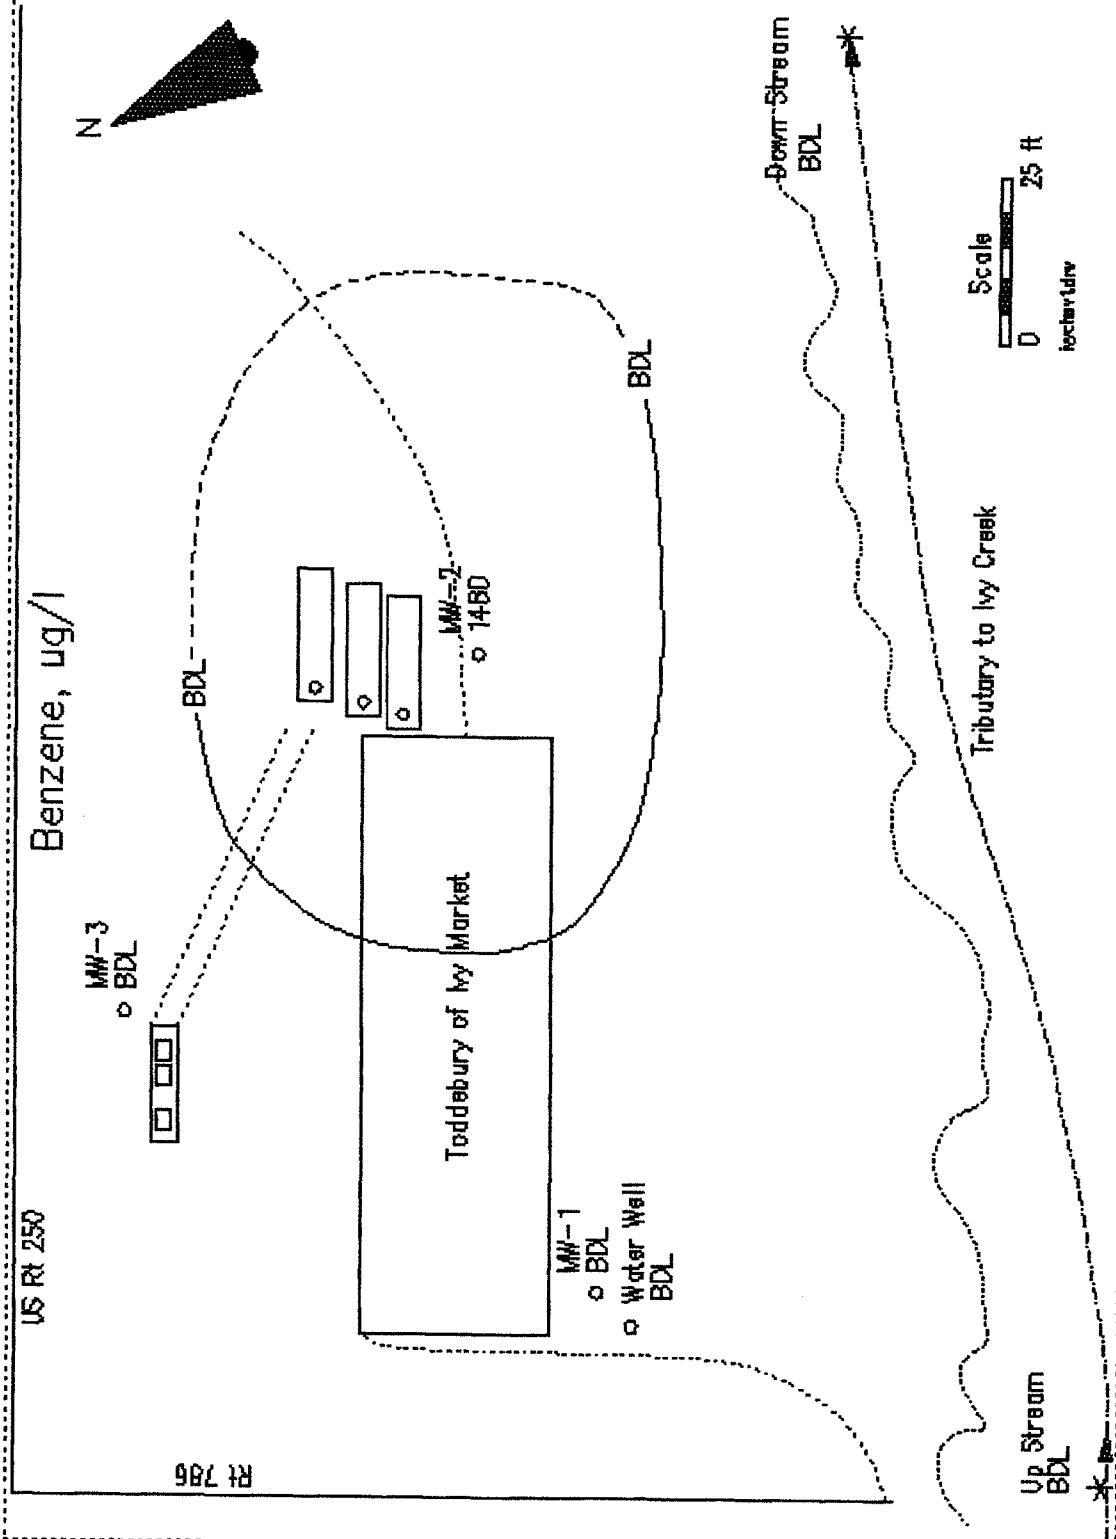
Figure 7 - Dissolved Benzene in
Groundwater, $\mu\text{g/l}$, 11/29/01
Toddsbury of Ivy
Ivy, Virginia

The results of the groundwater analyses are summarized in Table 3 and reported in Appendix B. Figures 7 and 8 show the extent of dissolved benzene and MTBE, respectively. The full laboratory report is presented in Appendix B.

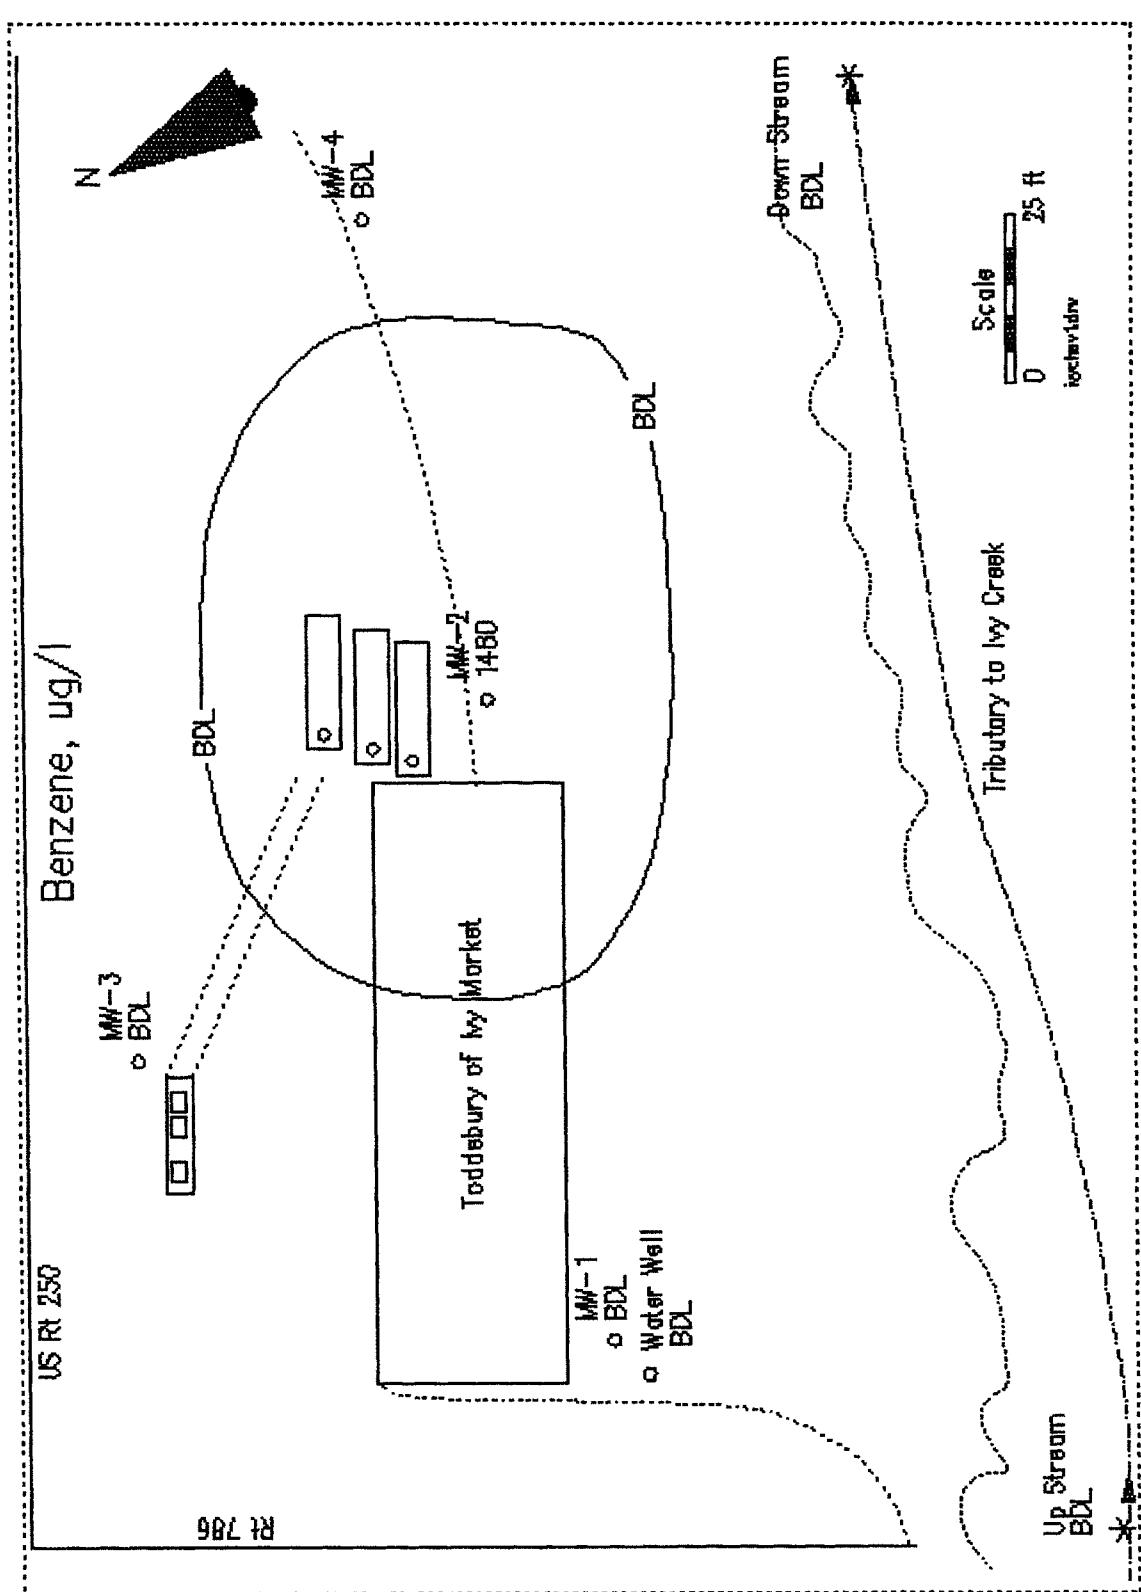
Figure 5 - Benzene in Groundwater, $\mu\text{g/l}$, 11/29/01 & 03/14/02
 Toddsbury of Ivy

The results of the groundwater analyses are summarized in Table 1 and reported in Appendix B. Figures 5 and 6 show the extent of dissolved benzene and MTBE, respectively. The full laboratory report is presented in Appendix B.

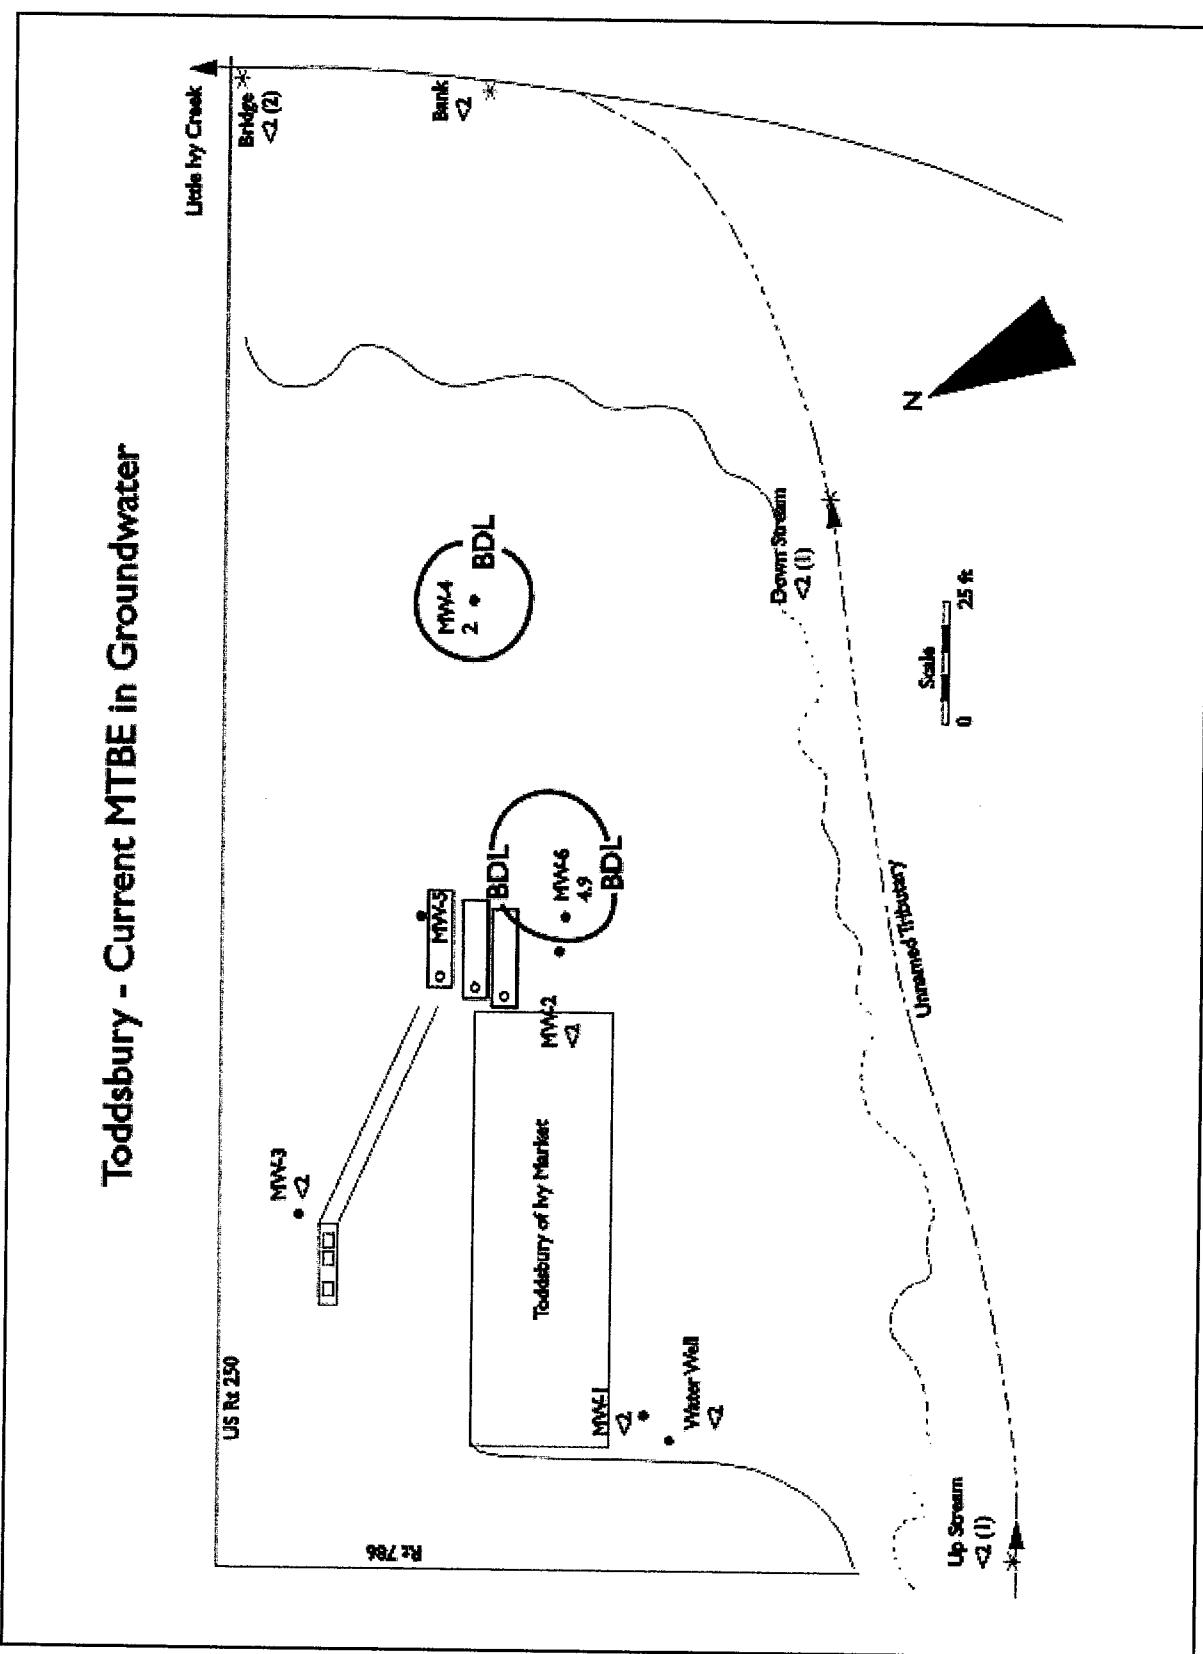
Figure 3. Extent of dissolved MTBE in the groundwater for this event.

Last fall, only the recovery well MW-6 had any MBTEX contamination with BEXM. For this quarter, MW-6 had only MTBE at 4.9 µg/l. For this quarter, MW-4 had 2.0 µg/l MTBE. MW-2 was free of detectable MBTEX. Only a figure for the extent of dissolved MTBE is presented (Figure 3).

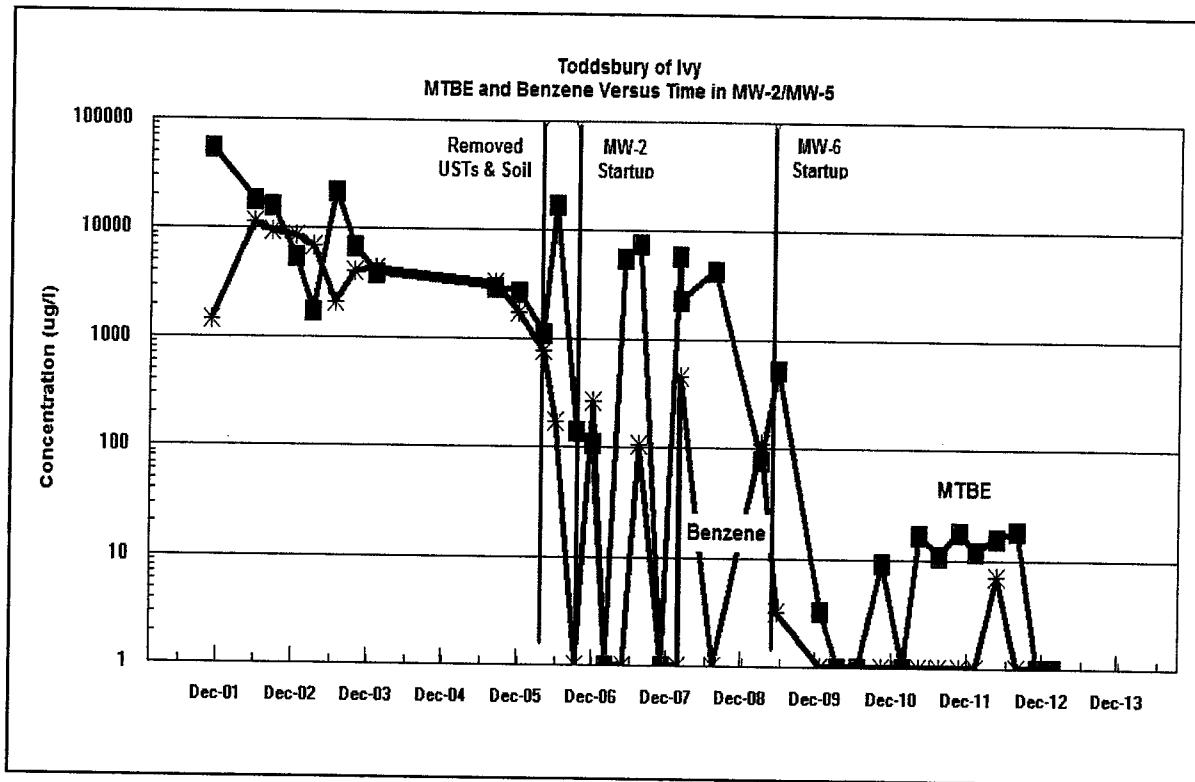
Figure 4. MTBE and benzene concentrations versus time in MW-2/MW-5.

MW-2/MW-5. The shallow groundwater from MW-2 had the highest concentrations historically, with MTBE at 56,400 µg/l and benzene at 11,500 µg/l in 2001 and 2002. Even with the historically high concentrations in MW-2, measurable free product has not been observed, and a sheen was seen only once in 2005. After a period of two years with MTBE at between 10 and 20 µg/l, MTBE has not been detected for the last two quarters.

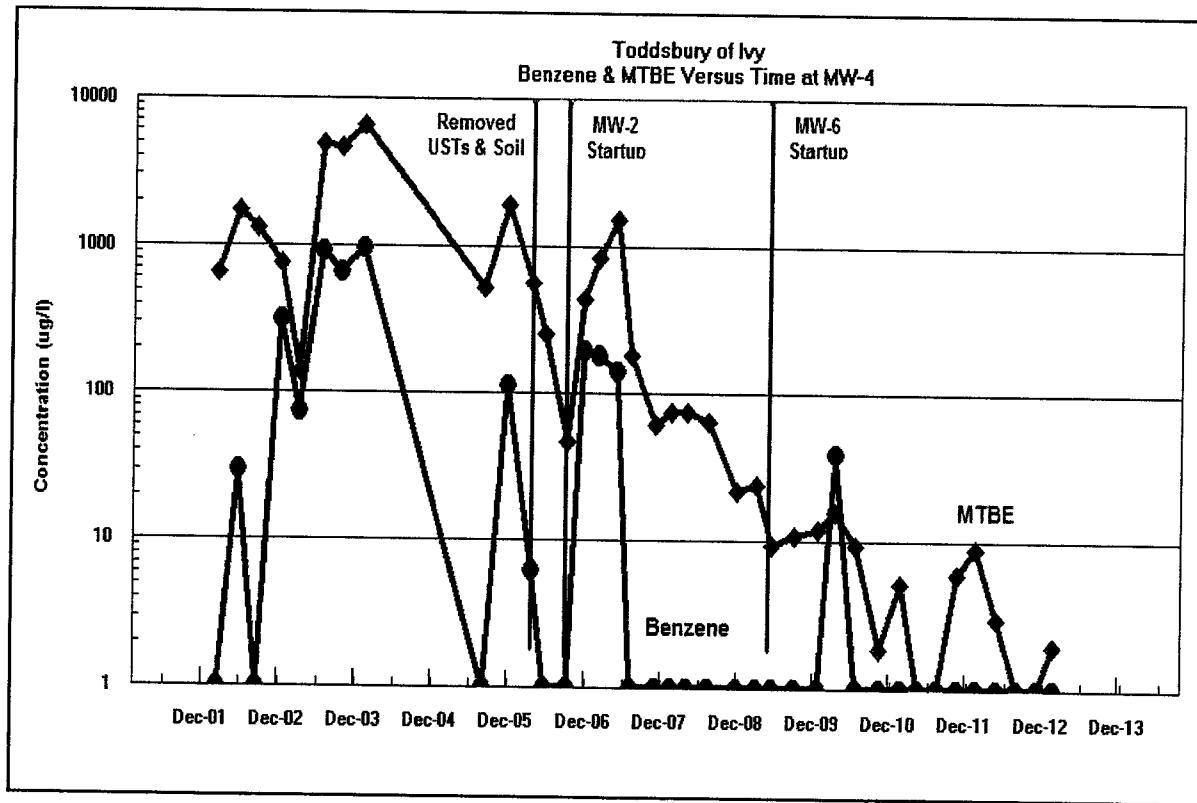
Figure 5. Benzene and MTBE versus time at MW-4.

Down gradient (MW-4). Down gradient of the source area at MW-4, MTBE has been following an overall decreasing trend since 2003, even before remediation began, as shown in the graph in Figure 5. This may be related to groundwater migrating eastward through MW-4. However, since MW-6 began pumping, MTBE in MW-4 increased for a short period, then began a steep downward trend. MTBE was not detected for the summer and fall events, but was 2.0 $\mu\text{g/l}$ for this event. The BTEX compounds have been virtually absent from MW-4 since early 2010.

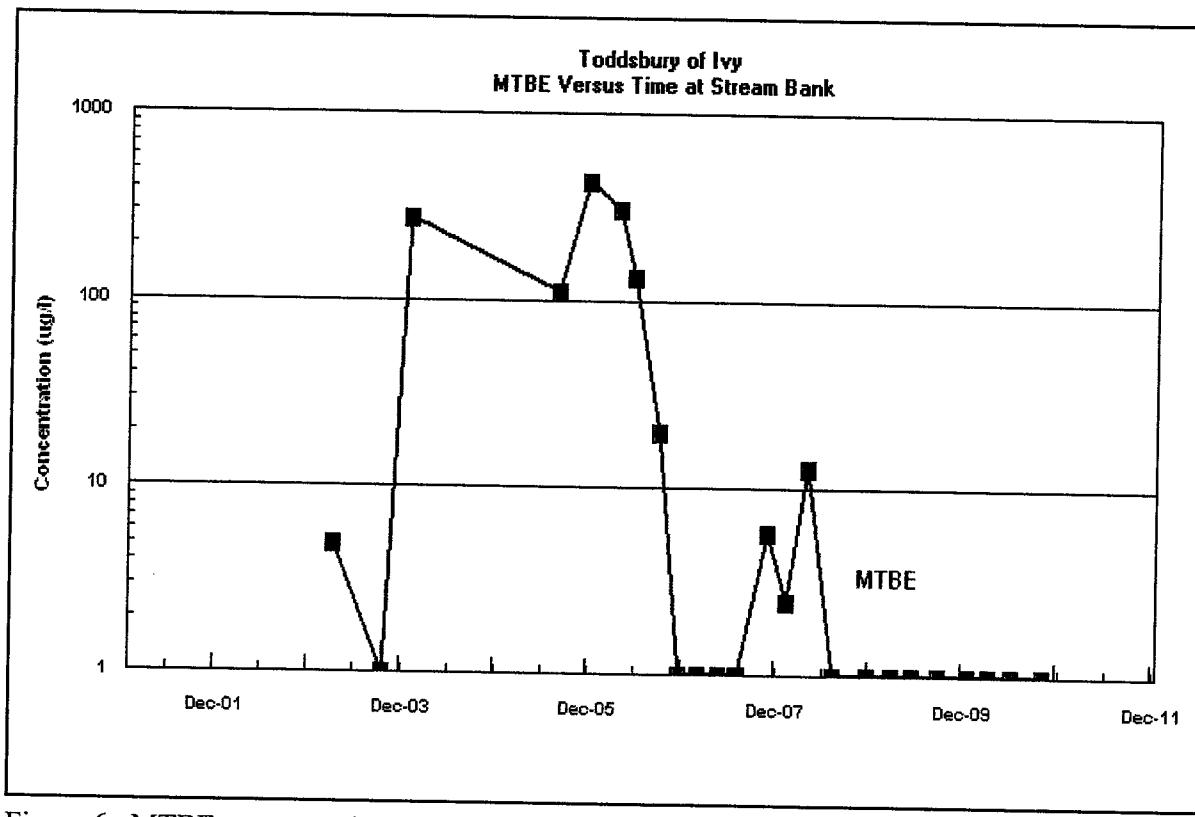
Figure 6. MTBE concentration versus time at the Stream Bank.

Stream Bank. The groundwater quality at the stream bank was below detection from August 2008 through November of 2010 (the last sample analyzed). Figure 6 shows the change in MTBE concentration in the stream bank sample over time. The stream bank groundwater, and, by association, the stream, are no longer at risk from contaminated groundwater.

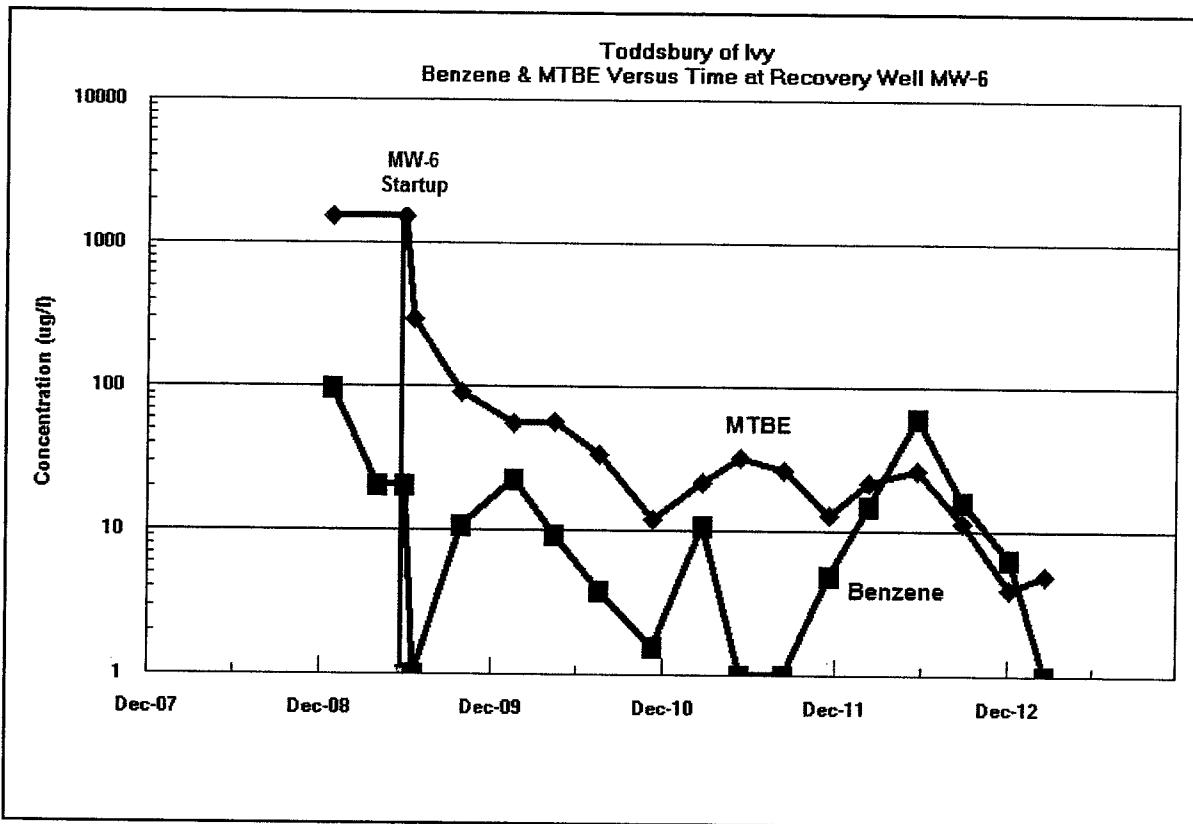
Figure 7. Benzene and MTBE versus time at MW-6.

MW-6. The trends for MTBE and benzene in the recovery well, MW-6, are shown in Figure 7. MTBE showed a relatively consistent decrease over time from the startup of MW-6.

MTBE and benzene have had three peaks since startup of MW-6 pumping. All three peaks have occurred in the January 2010, February 2011, and May 2012 for benzene, while the peaks for MTBE have been in April 2010, and May of 2011 and 2012. These peaks coincide with the normal groundwater recharge season. Since one of the gasoline USTs was left in the ground, because it was under the building, the annual recharge events may be causing residual gasoline from in and around that remaining gasoline UST to be flushed into the groundwater.

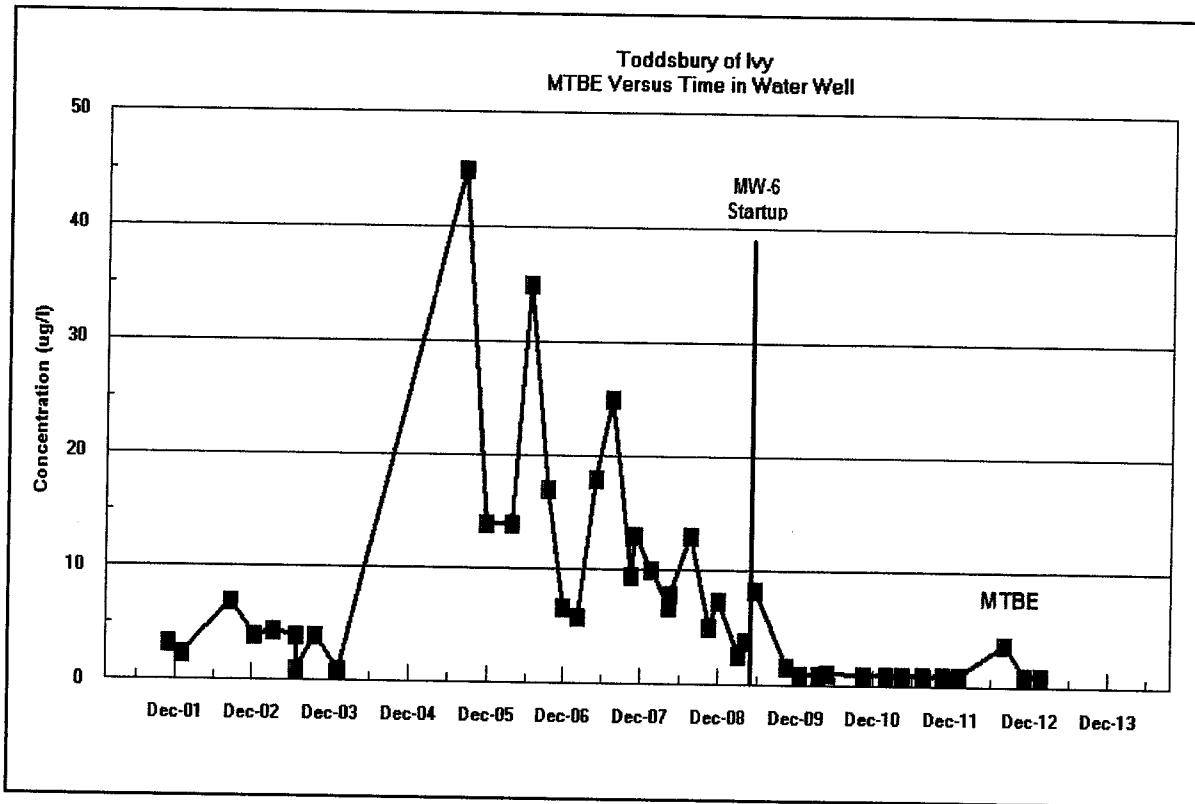
Onsite Water Well. The well water samples had been less than 2.0 $\mu\text{g/l}$ from November of 2009, and less than 1.0 $\mu\text{g/l}$ for eight out of the nine quarters and the last six straight leading to May of 2012. As with the spikes in MTBE witnessed in MW-2, 4 and 6, the well water had a small spike in August of 3.7 $\mu\text{g/l}$. MTBE was not detected in the water well for the last two events.

Figure 8. MTBE versus time in the onsite water well. MTBE cleanup is predicted to be much quicker after MW-6 startup than before.

CAPI Performance. The well water was virtually clean from January of 2010 through February of 2012. Now that the spike of 2012 appears to have passed through, the well water is expected to remain clean. .

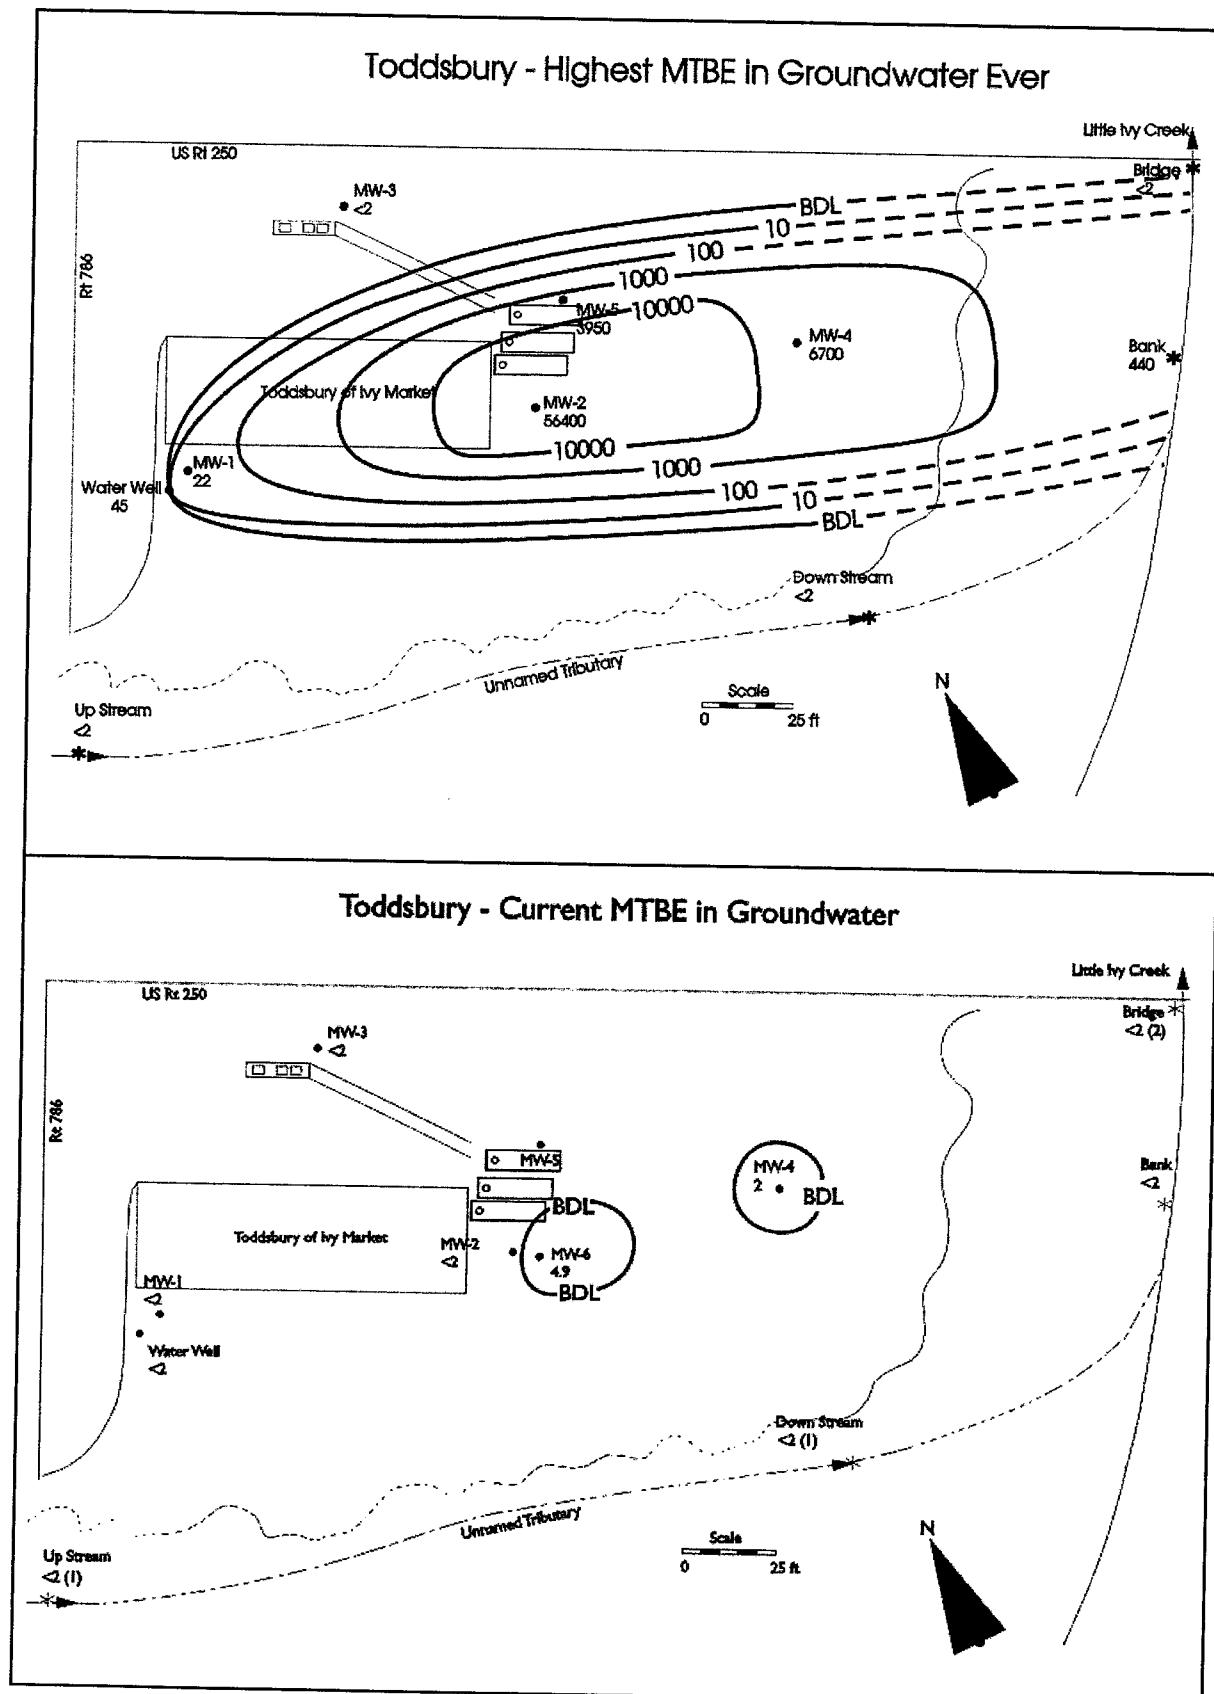
Figure 9. Comparison of the MTBE plume based on the highest concentrations ever observed (top) to the current MTBE plume (bottom).
