VDOT CRASH DATA

SE202000019 CHRISTIAN AID MISSION

CRITICAL SLOPES DISTURBANCE REQUEST

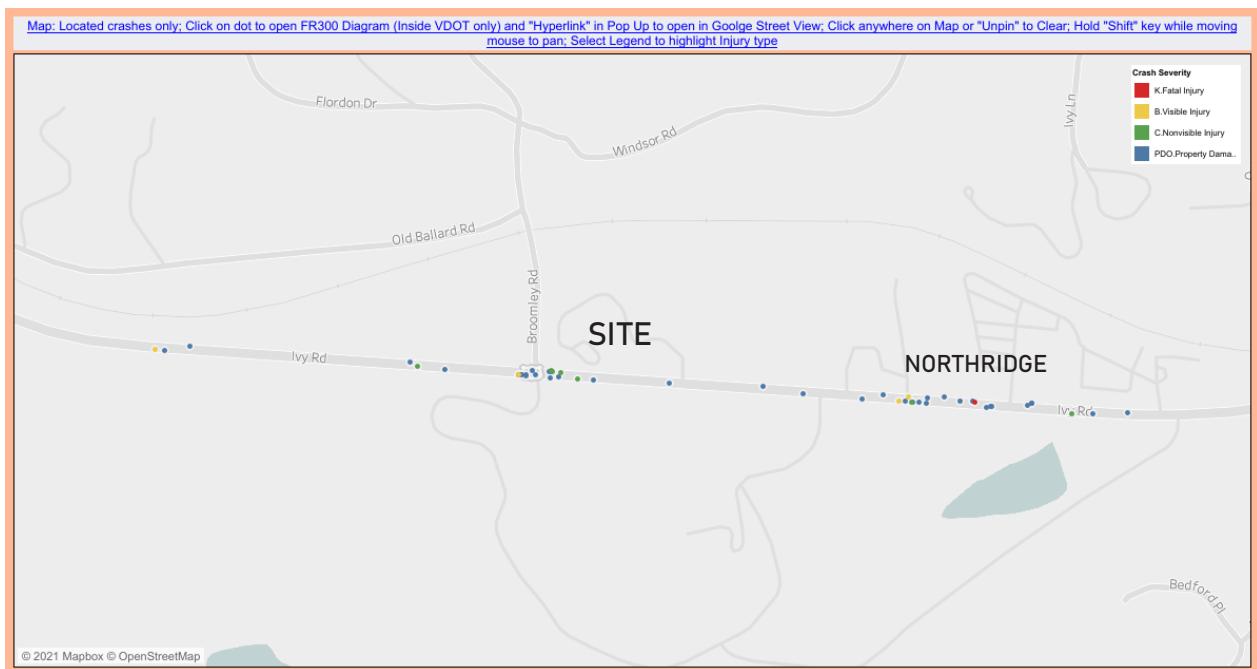
Collision Map (Figure 1):

Collision Data Location: Route 250, MP 90.7 to MP 91.6; generally, this is from .25 miles west of the intersection of Broomley Road and Route 250 to .6 miles east of the Broomley Road and Route 250 intersection. The existing entrance to tax parcel 59-23G1 from Route 250 is approximately 600' east of the intersection of Broomley Road and Route 250.

The data provided below corresponds to the data plotted in Figure 1

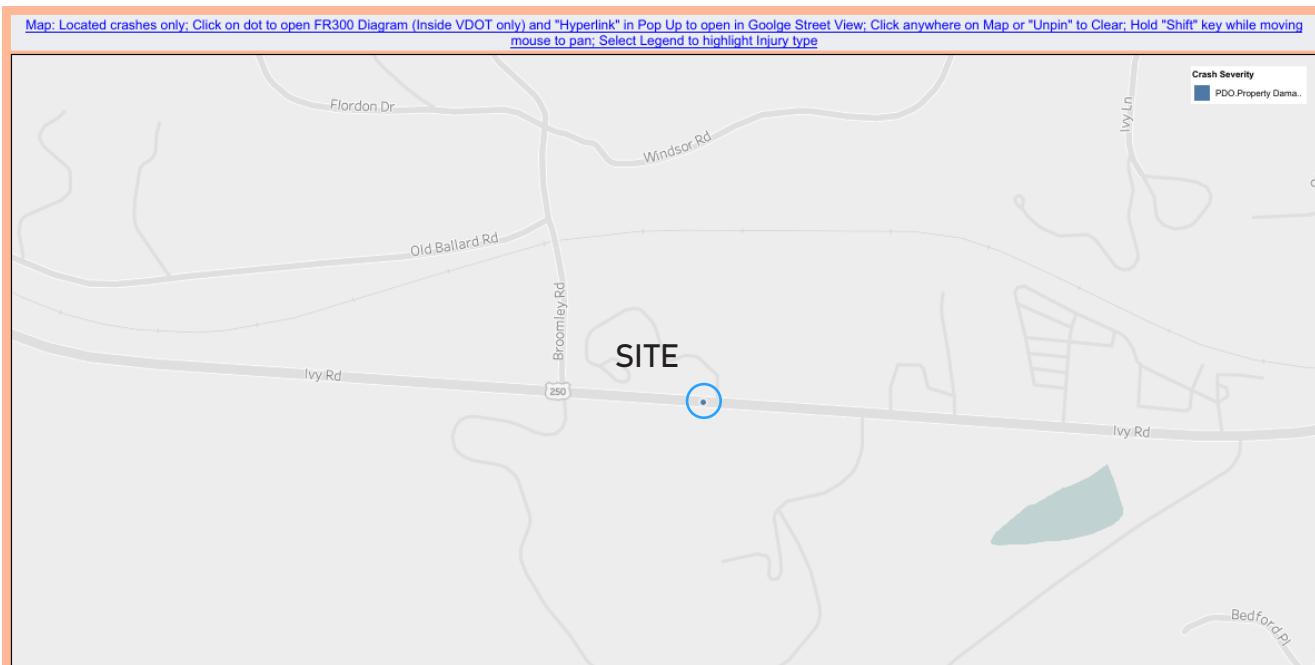
Collision Data near Existing Property Entrance (Figure 3):

There was one collision in very close proximity to the existing property entrance since late 2014. This was a rear end collision that was caused by a vehicle following too closely.

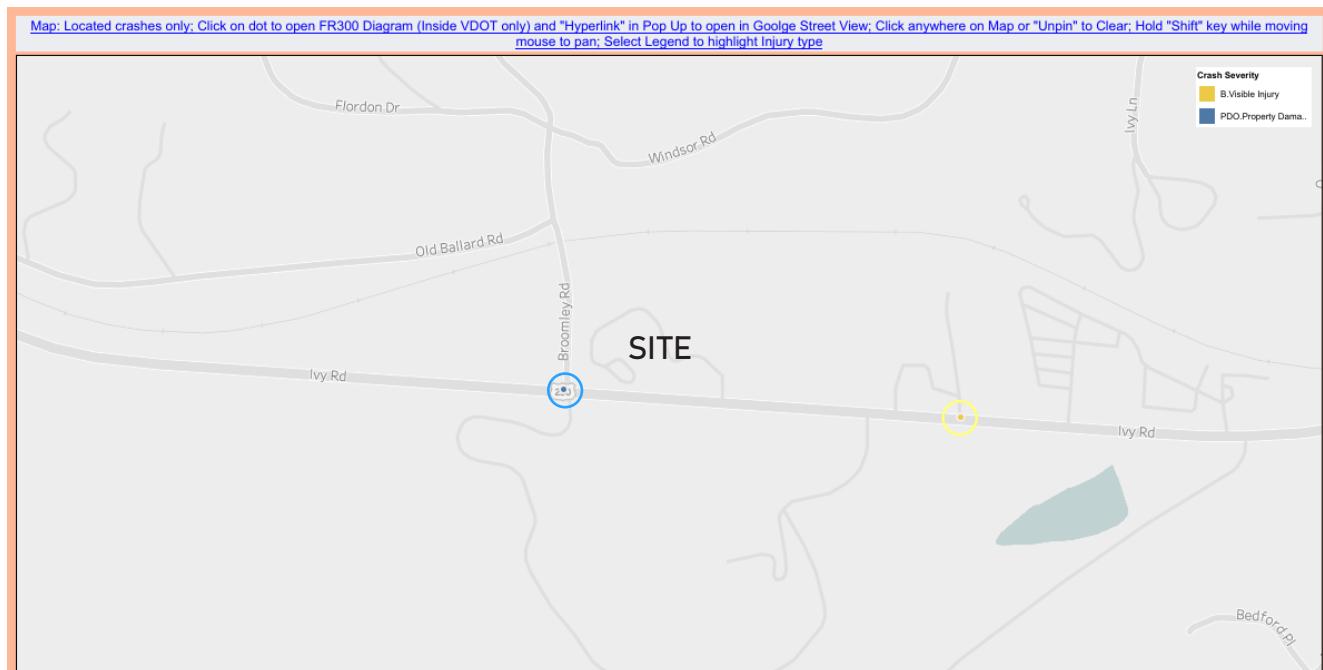
Collision Data for Angle Collisions:

There were two angle collisions along this .85 mile stretch of Route 250 since late 2014. Angle collisions are typical with collisions occurring from vehicles turning into or out of entrances.
