**Packet Guide**  
**City of Charlottesville**  
**Board of Architectural Review**  
**Regular Meeting**  
**February 18, 2026 5:30 p.m.**  
**Hybrid Meeting (In-person at Council Chamber and virtual via Zoom)**

2. **Certificate of Appropriateness Application**

BAR # HST26-0001

701-705 West Main Street; TMP 320157000

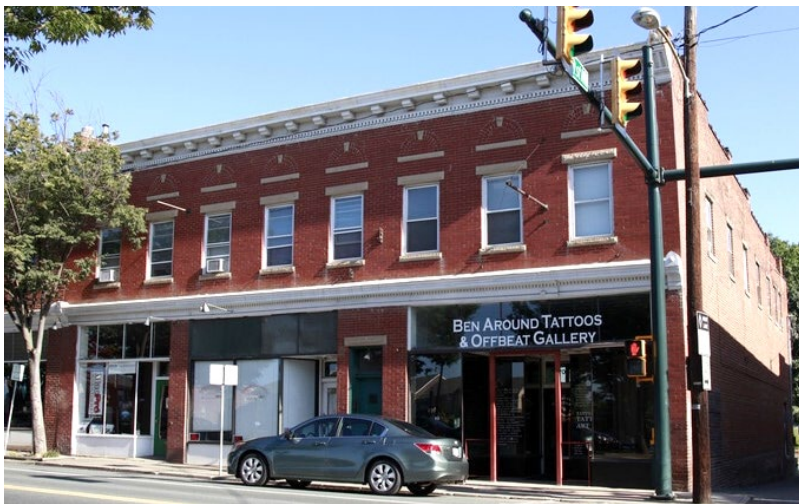
West Main Street façade, c. 2008

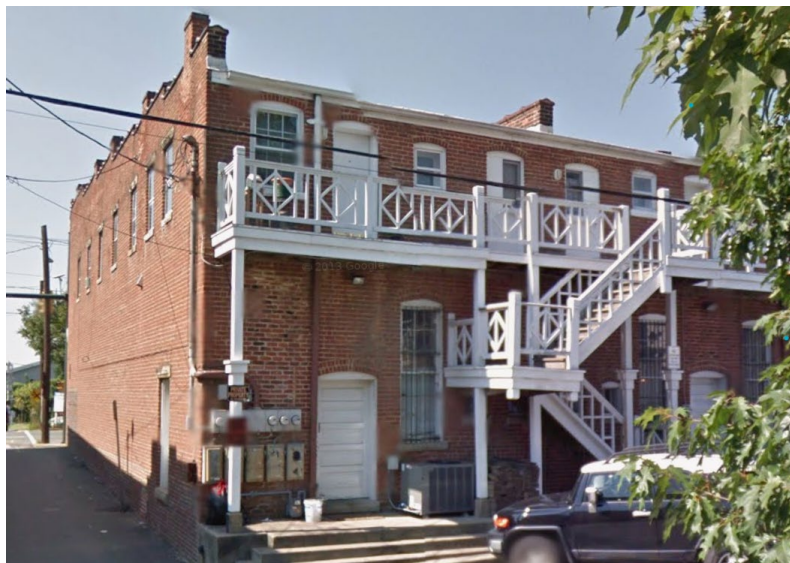
Rear elevation in 2012, prior to window and porch alterations.

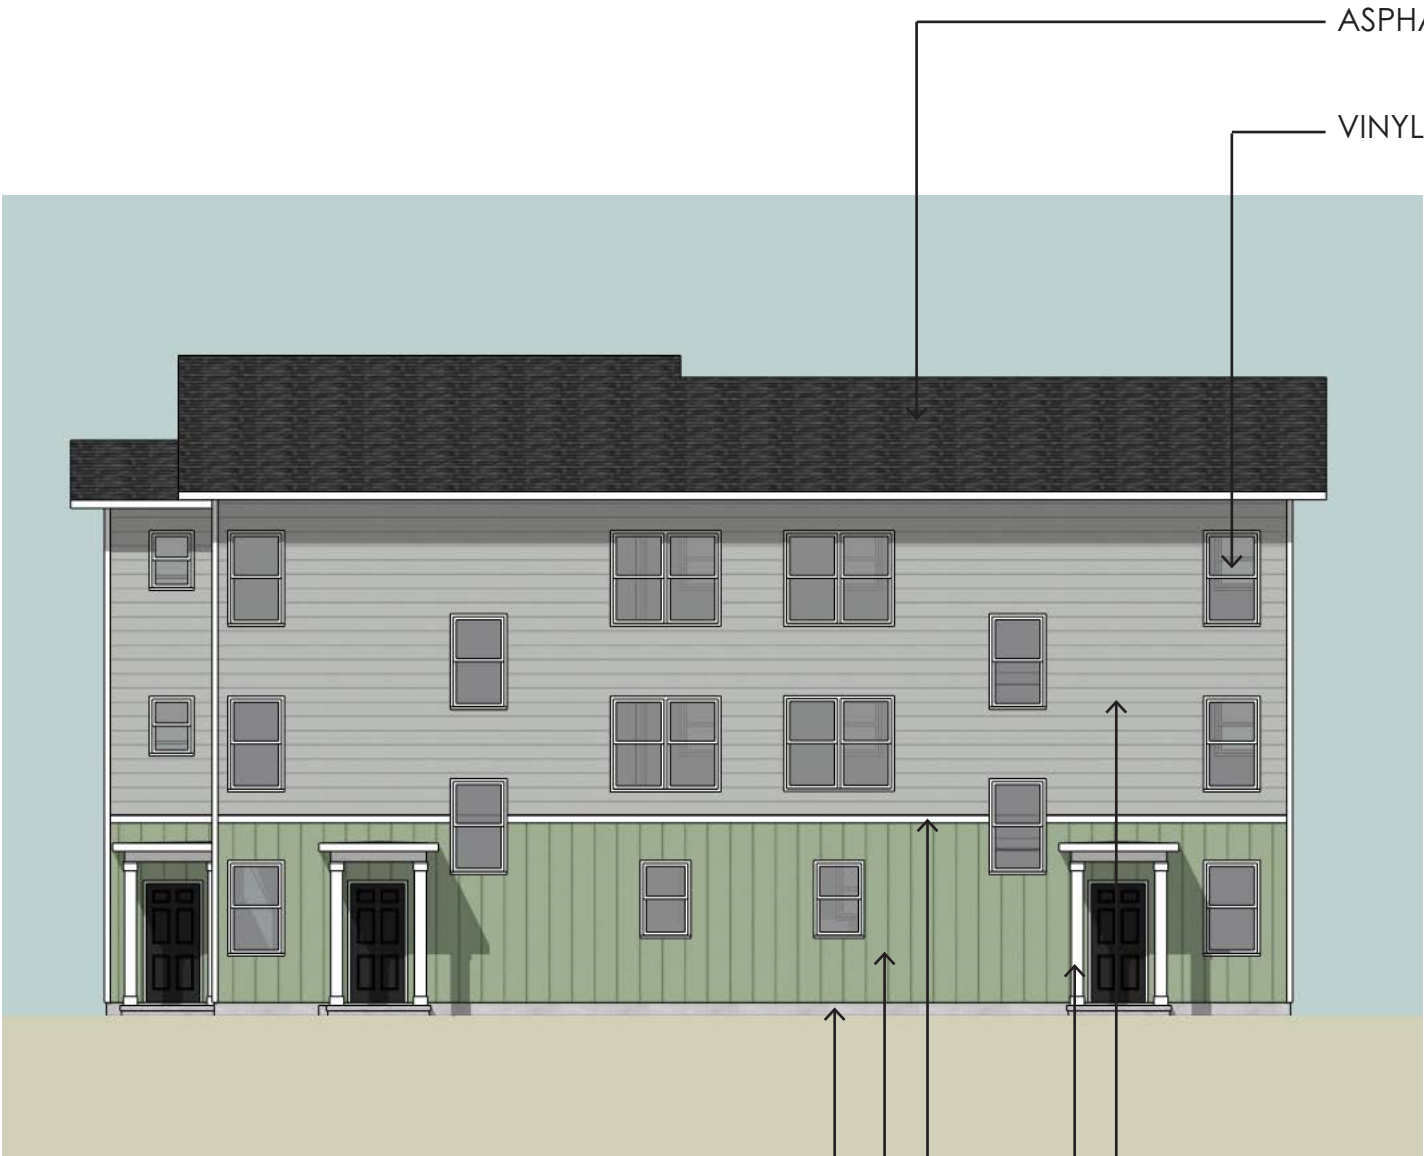
**BUILDING #1 ELEVATION**  
FRONT ELEVATION

ASPHALT SHINGLES

BOARD & BATTEN SIDING - GREEN

PARGED CONCRETE

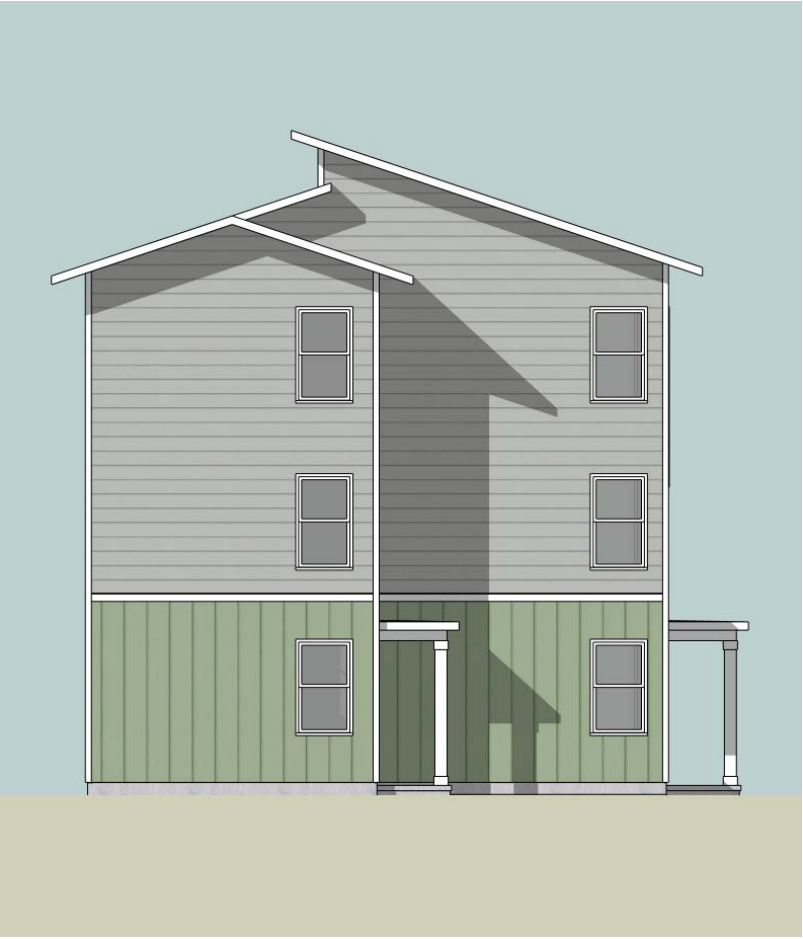
**BUILDING #1 ELEVATION**  
LEFT ELEVATION

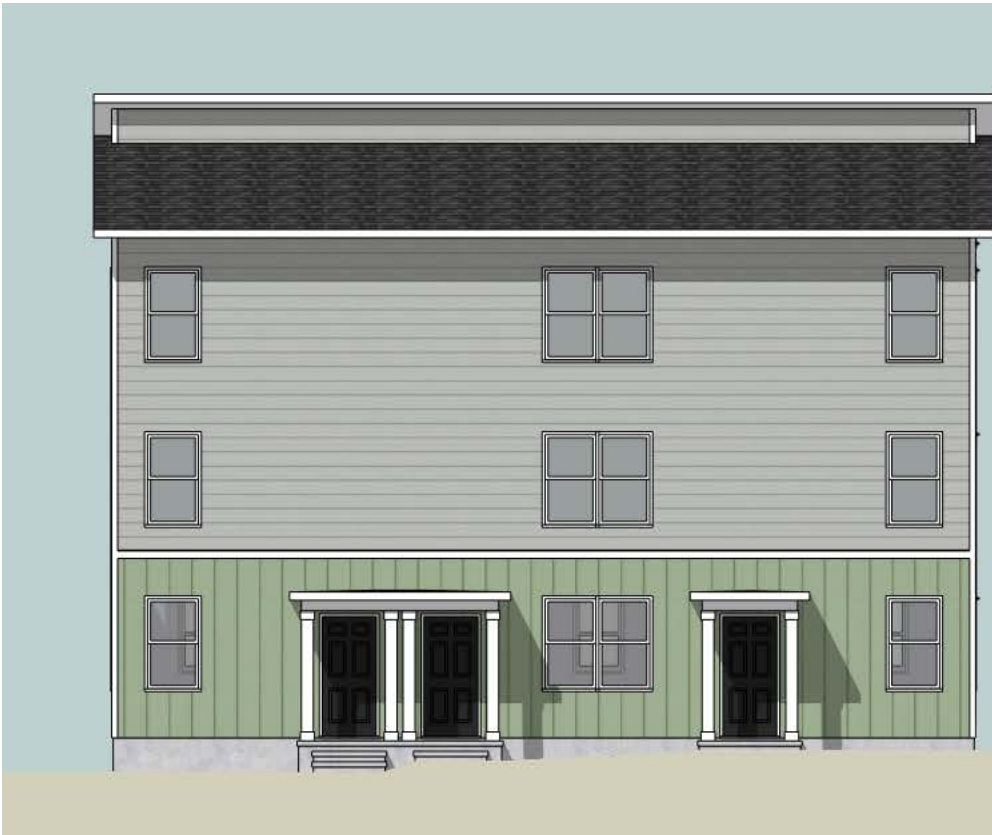
**BUILDING #2 & #3 ELEVATION**  
FRONT ELEVATION

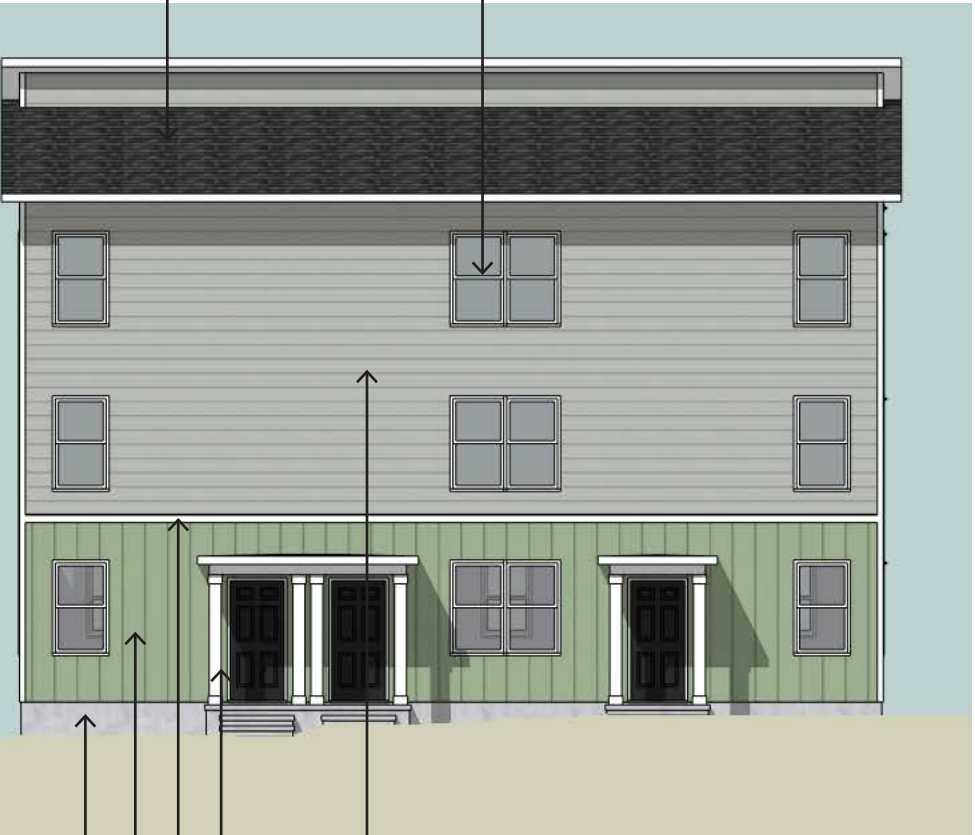
**BUILDING #2 & #3 ELEVATION**  
RIGHT ELEVATION

- ASPHALT SHINGLES
- VINYL D.H. WINDOW - WHITE
- LAP SIDING - GRAY
- SQUARE COLUMNS - WHITE
- TRIM - WHITE
- BOARD & BATTEN SIDING - GREEN
- PARGED CONCRETE

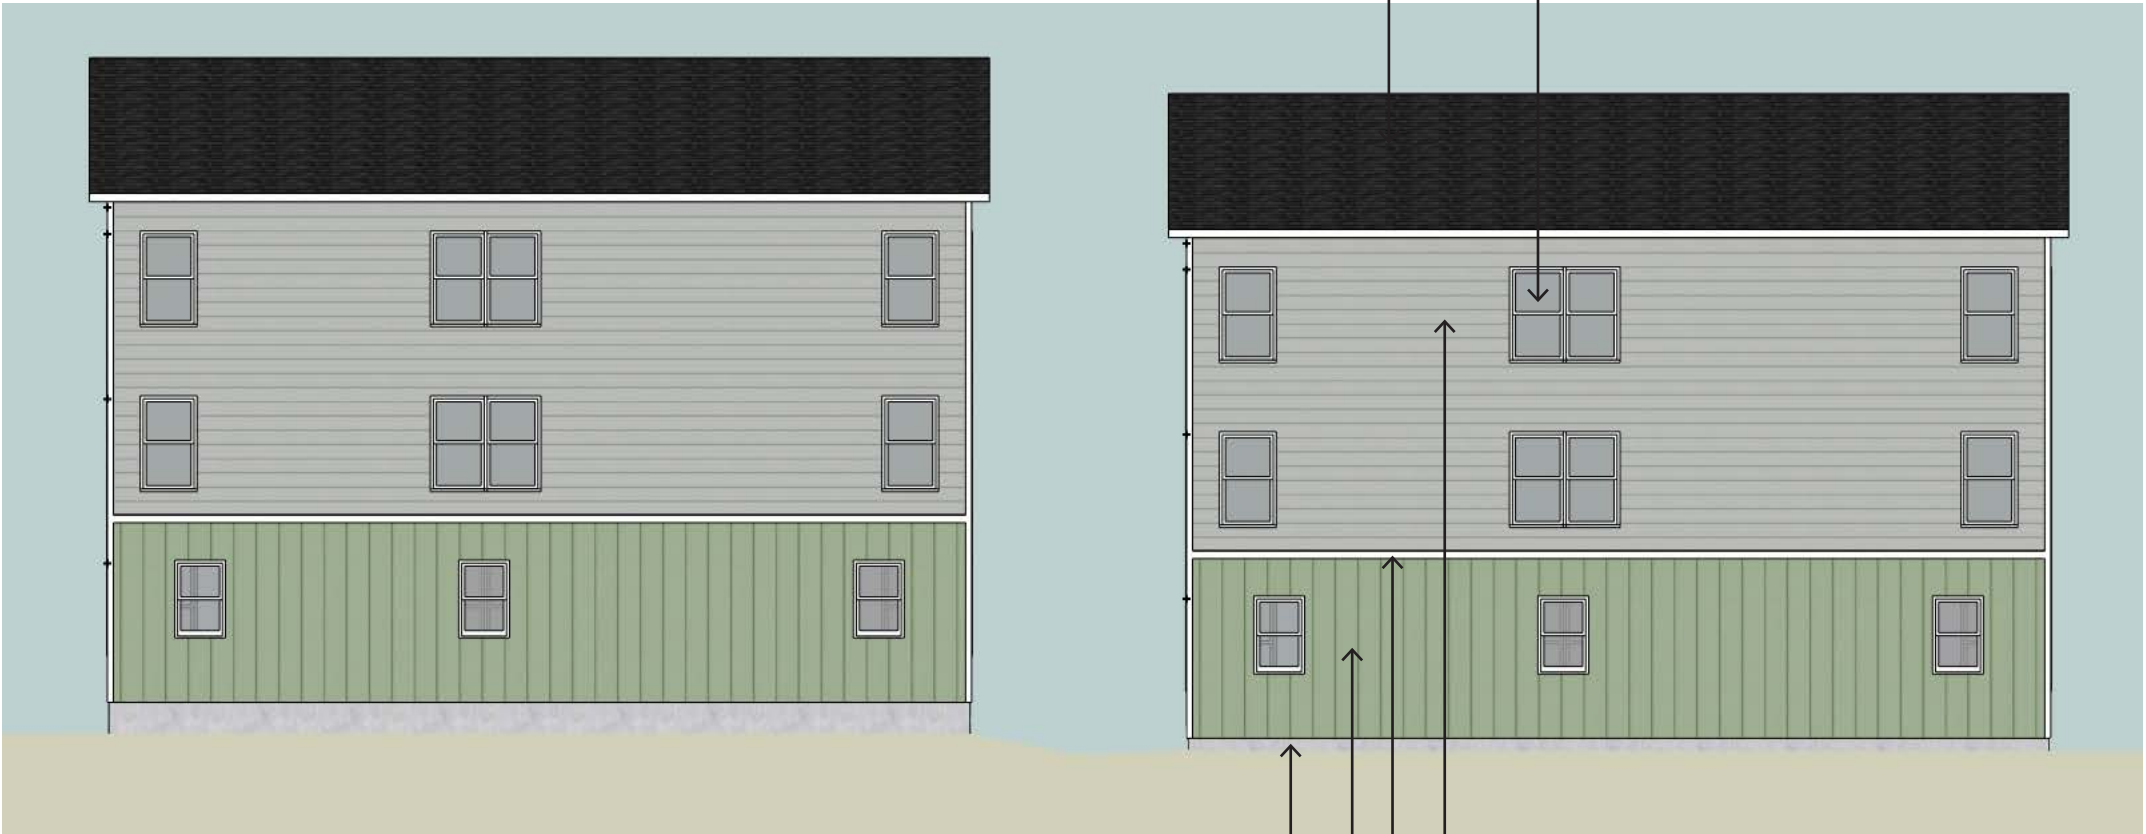
**BUILDING #2 & #3 ELEVATION**  
REAR ELEVATION

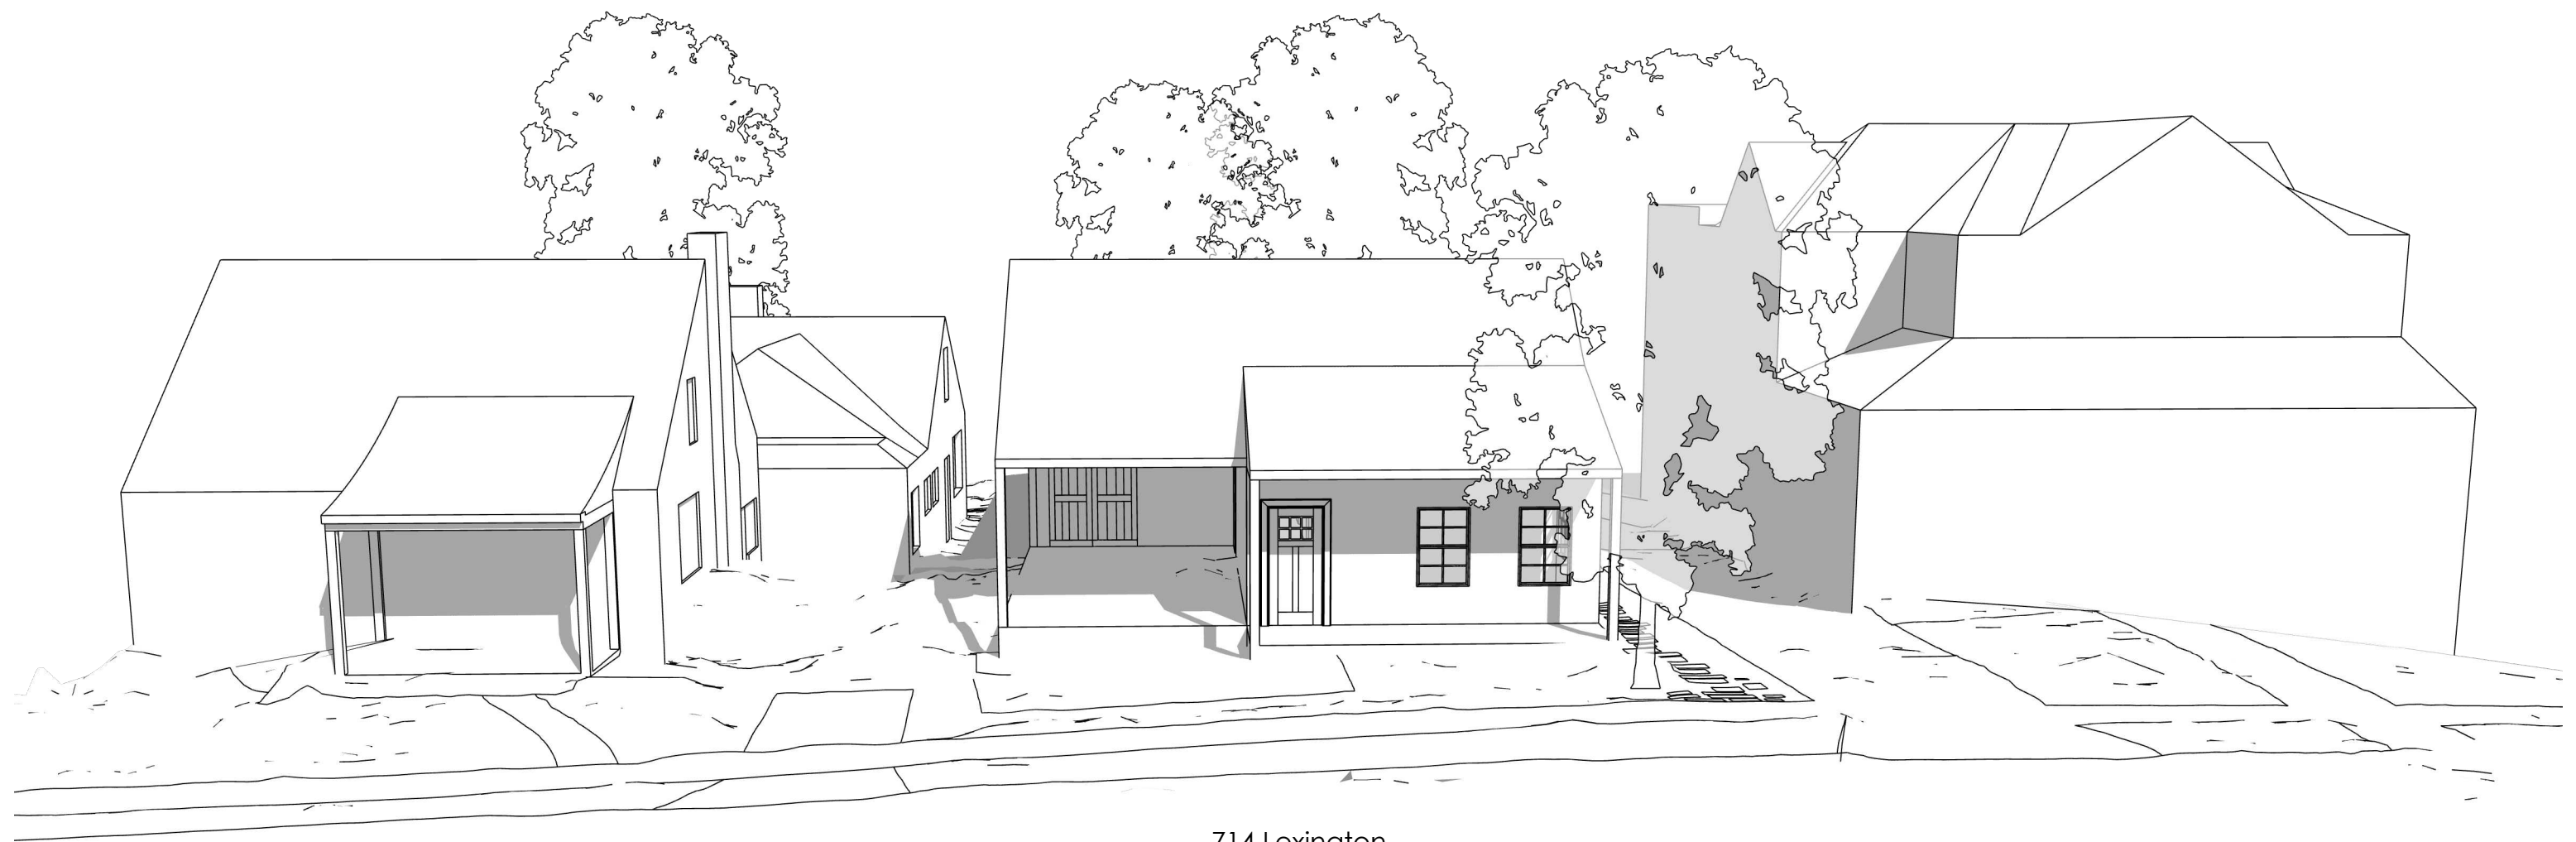
1 West Elevation  
Scale: NTS

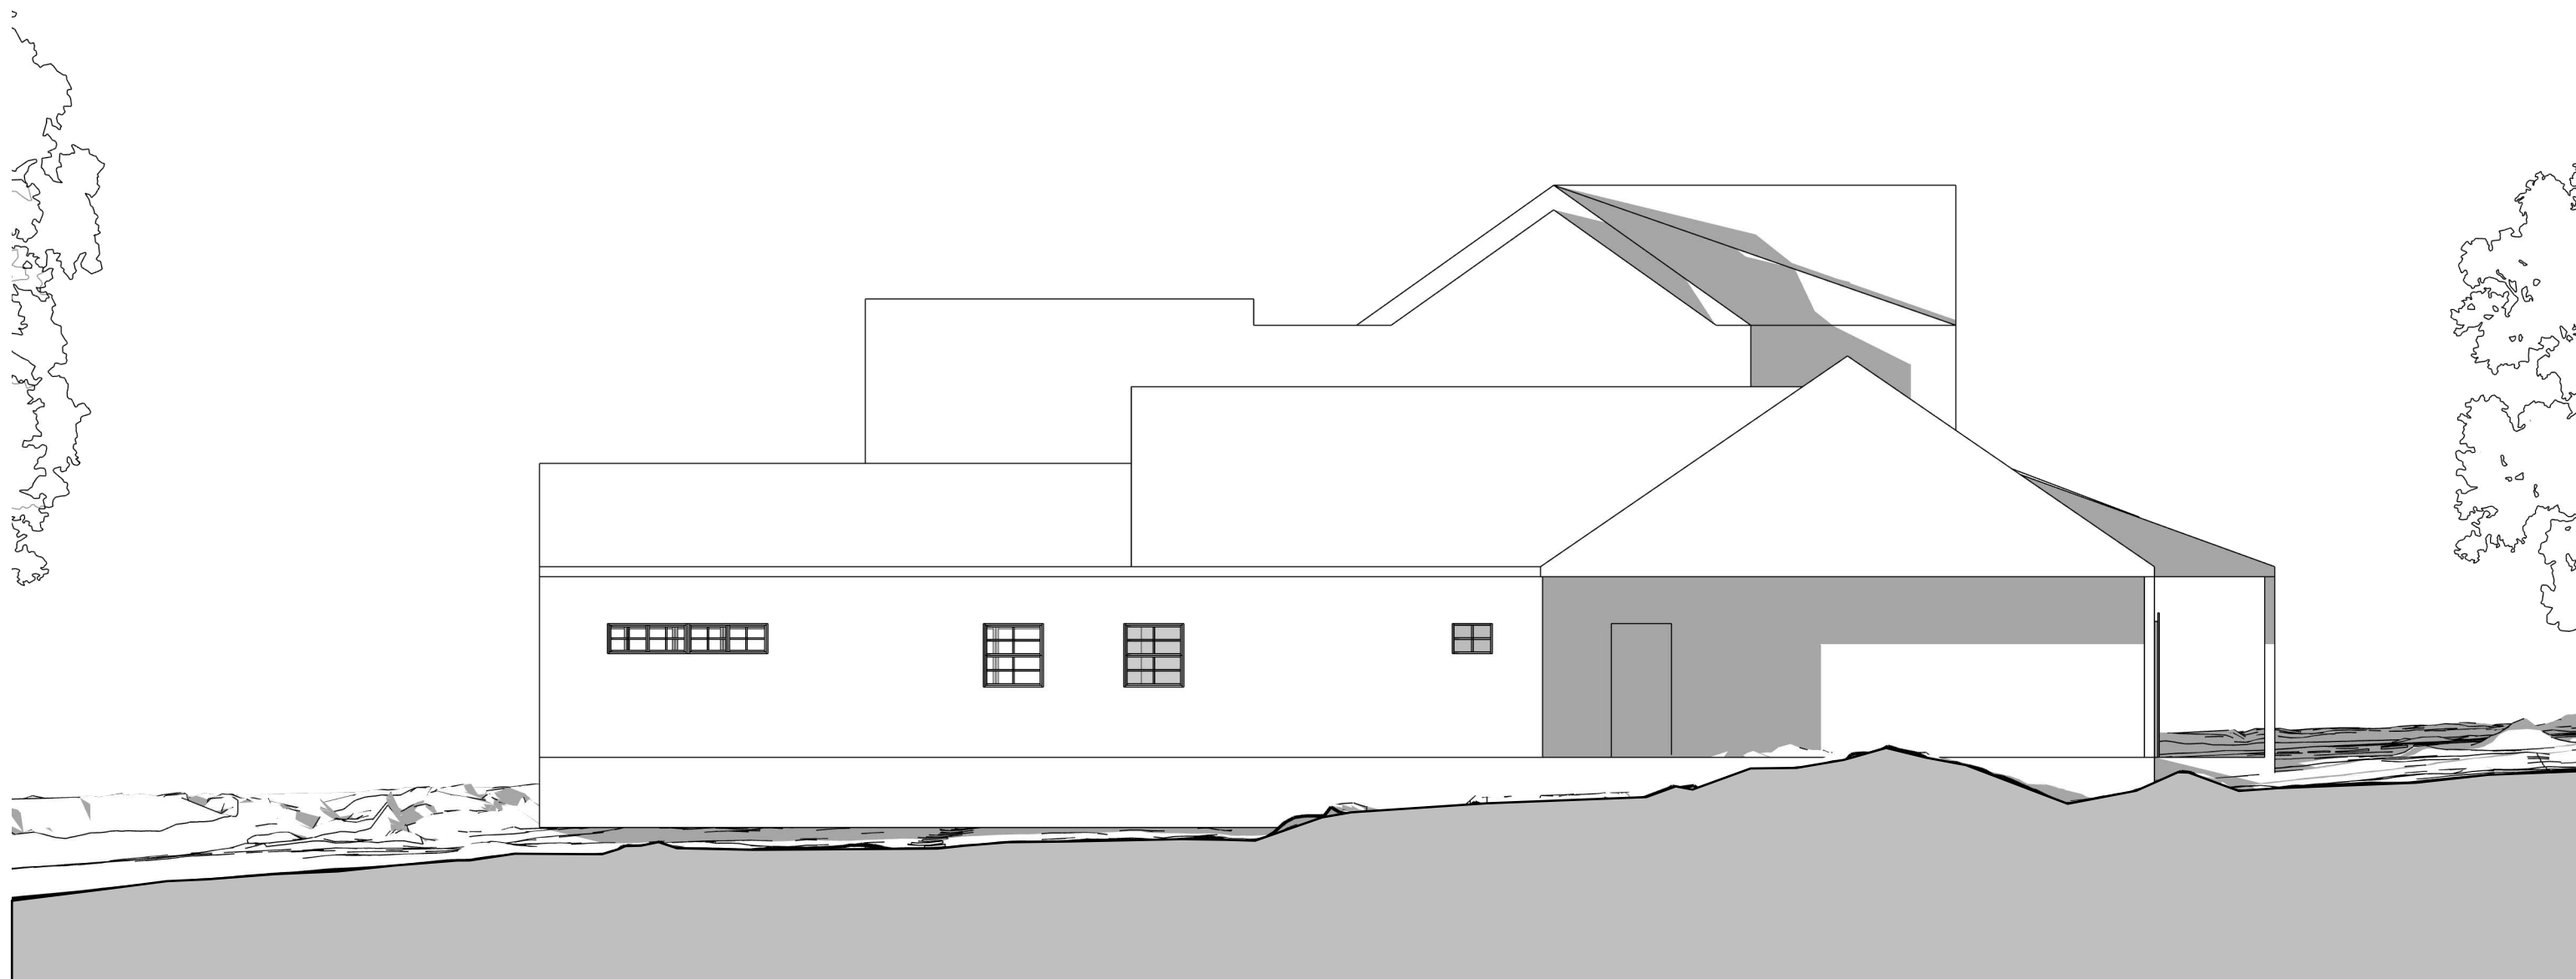
## A1.3 North Elevation

1 North Elevation  
Scale: 1/8" = 1'-0"

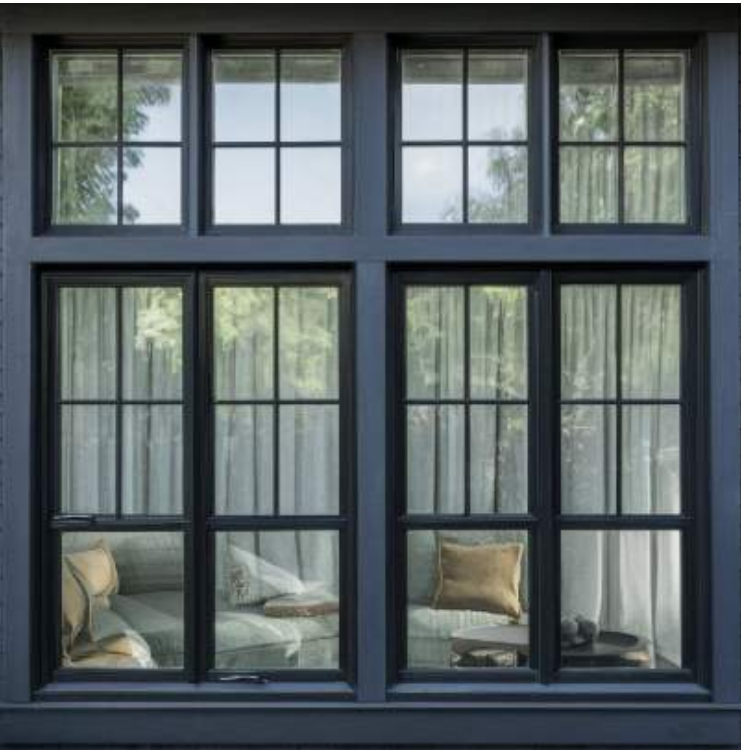
**Windows: Pella Lifestyle Series**  
**Aluminum-clad wood double-hung windows**

Half Colonial  
(shown on Casement)
