STRATEGICALLY TARGETED AND  
AFFORDABLE ROADWAY SOLUTIONS

# MPO Policy Board Meeting

1. US 29 Corridor: Hydraulic Rd to Woodbrook Rd
2. US 29/250 Bypass Interchange with Emmet St

*August 27, 2025*

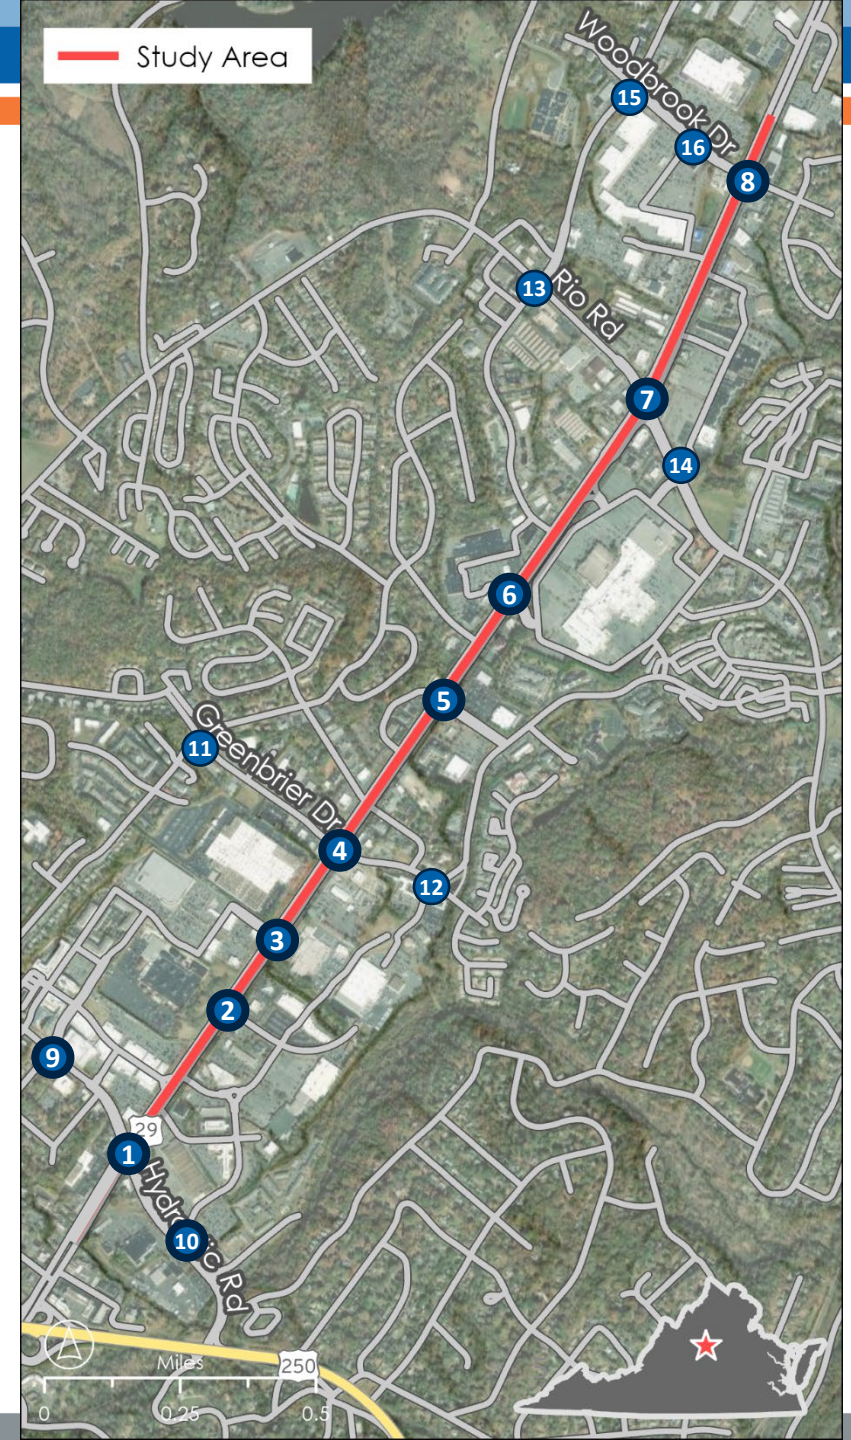
### ① Data Collection (TMCs) on US 29:

1. Hydraulic Road
2. Seminole Court
3. Lenox Avenue
4. Greenbrier Drive
5. Branchlands Boulevard
6. Fashion Square Drive
7. Rio Road
8. Woodbrook Drive
9. Hydraulic Rd and District Ave/Cedar Hill Rd
10. Hydraulic Rd and Hillsdale Dr

### ⑪ Supporting Data Collection (TMCs) :

11. Greenbrier Dr and Commonwealth Dr
12. Greenbrier Dr and Hillsdale Dr
13. Rio Rd and Berkmar Dr
14. Rio Rd and Fashion Square Dr
15. Woodbrook Rd and Berkmar Dr
16. Woodbrook Rd and Rio Hill Center

48-hr tube counts were also be collected.

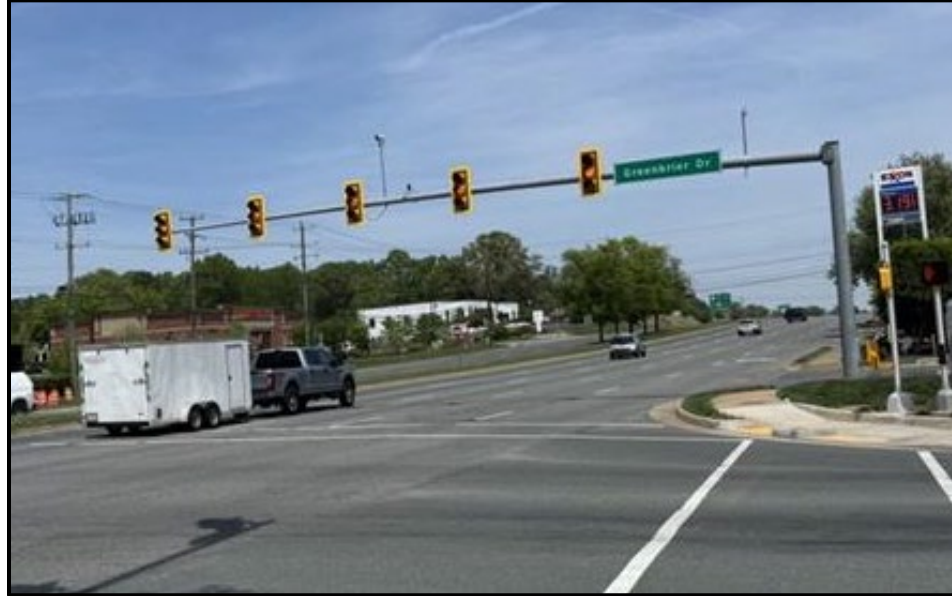
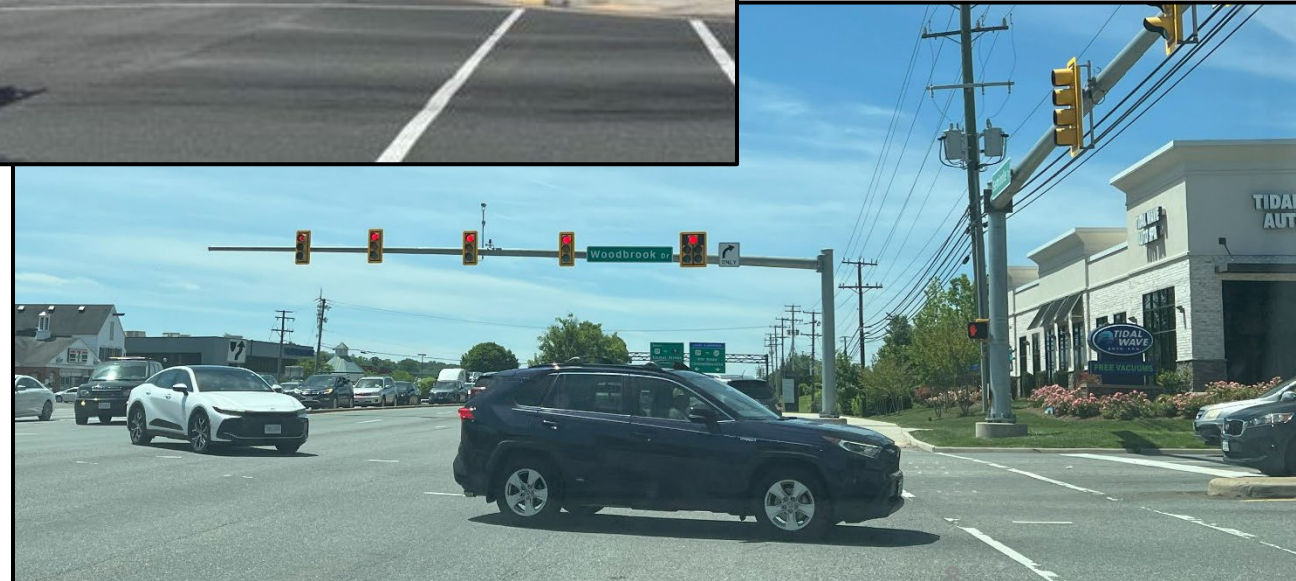
# OPERATIONS

## ■ Results Summary

- Overall congestion is Light-to-Moderate/Heavy
- Signal timings are sufficient along US 29 - Queue lengths along are long but vehicles typically clear intersection in one cycle
- Delays and queues are mostly associated with minor movements from side streets
- There are some turning on US 29 mainline with more delay and queues

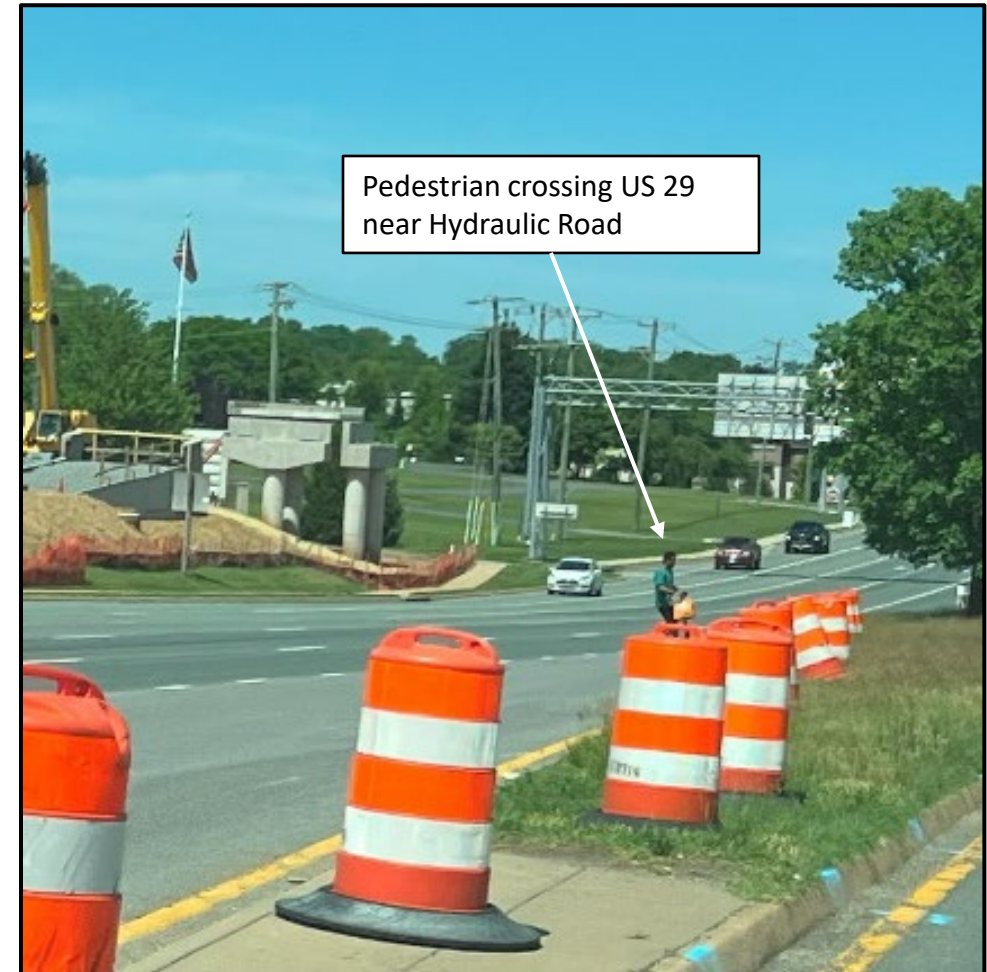
## ■ Identified PSI Intersections:

- Woodbrook Drive
- Greenbrier Drive
- Seminole Court
- Hydraulic Road

## ■ Identified Fatal & Injury Crash Factors:

- Speed differentials for rear-ends
- High density of access points
- Congestion throughout the day
- Rear-ends more concentrated along northbound direction
- More angle crashes involving southbound movements

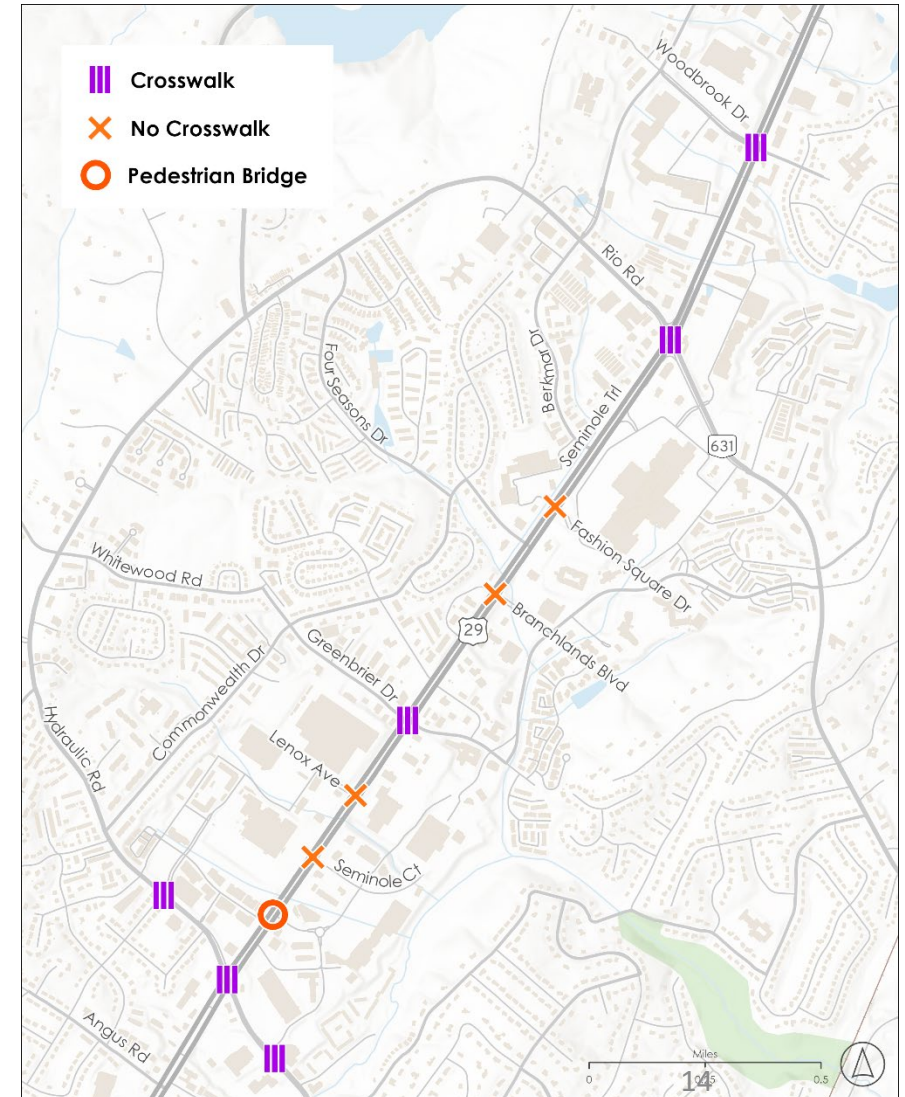
## Intersections with marked crosswalks across US 29:

- Hydraulic Road (NB approach only)
- Greenbrier Drive (SB approach only)
- Rio Road (NB approach only)
- Woodbrook (SB approach only)

**Pedestrian Bridge near Zan Road currently in construction**

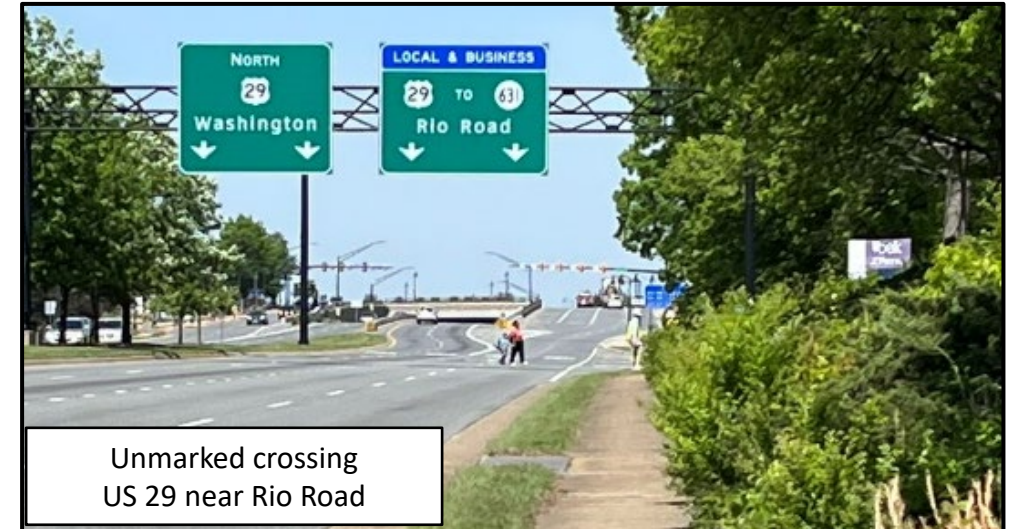
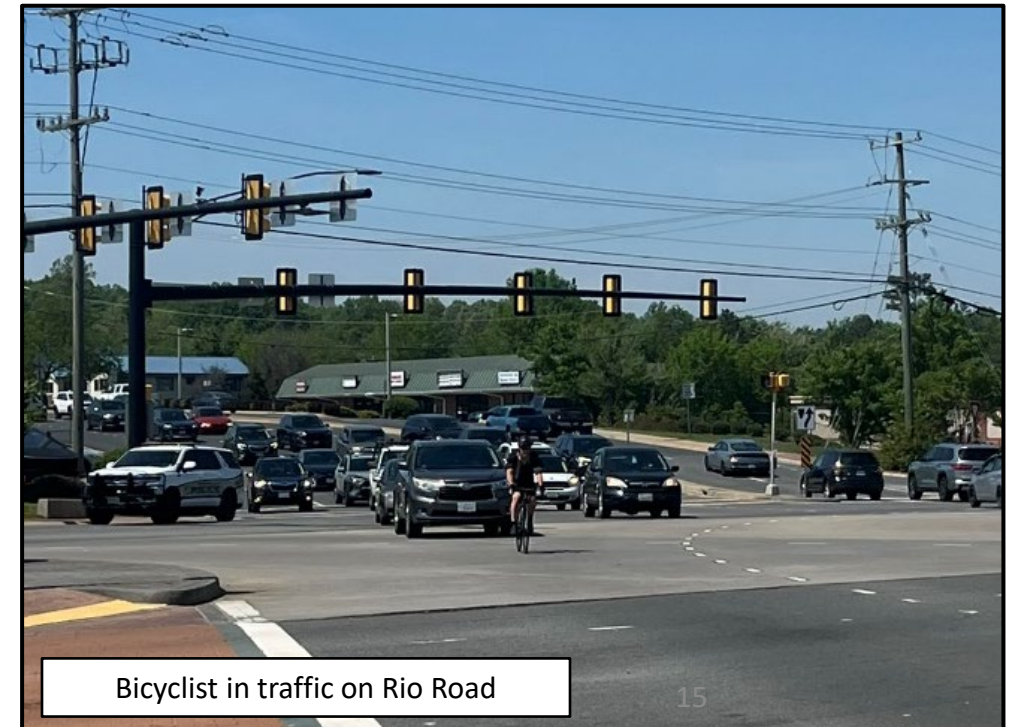
# BICYCLE AND PEDESTRIAN SUMMARY

- **Sidewalk network throughout corridor, no missing segments**
- **Few crosswalks across US 29 throughout corridor; only present at following intersections:**
  - Angus Road
  - Greenbrier Road
  - Rio Road
  - Woodbrook
  - Funded pedestrian bridge in vicinity of Zan Road
- **Observed pedestrians crossing US 29 at unmarked locations**
- **No shared-use path north of Angus Road; bicyclists use travel lanes**
- **Nine pedestrian crashes during analysis period (2019-2023)**
  - Four occurred at mid-block locations
  - Two fatal crashes occurred between Fashion Square Drive, Rio Road

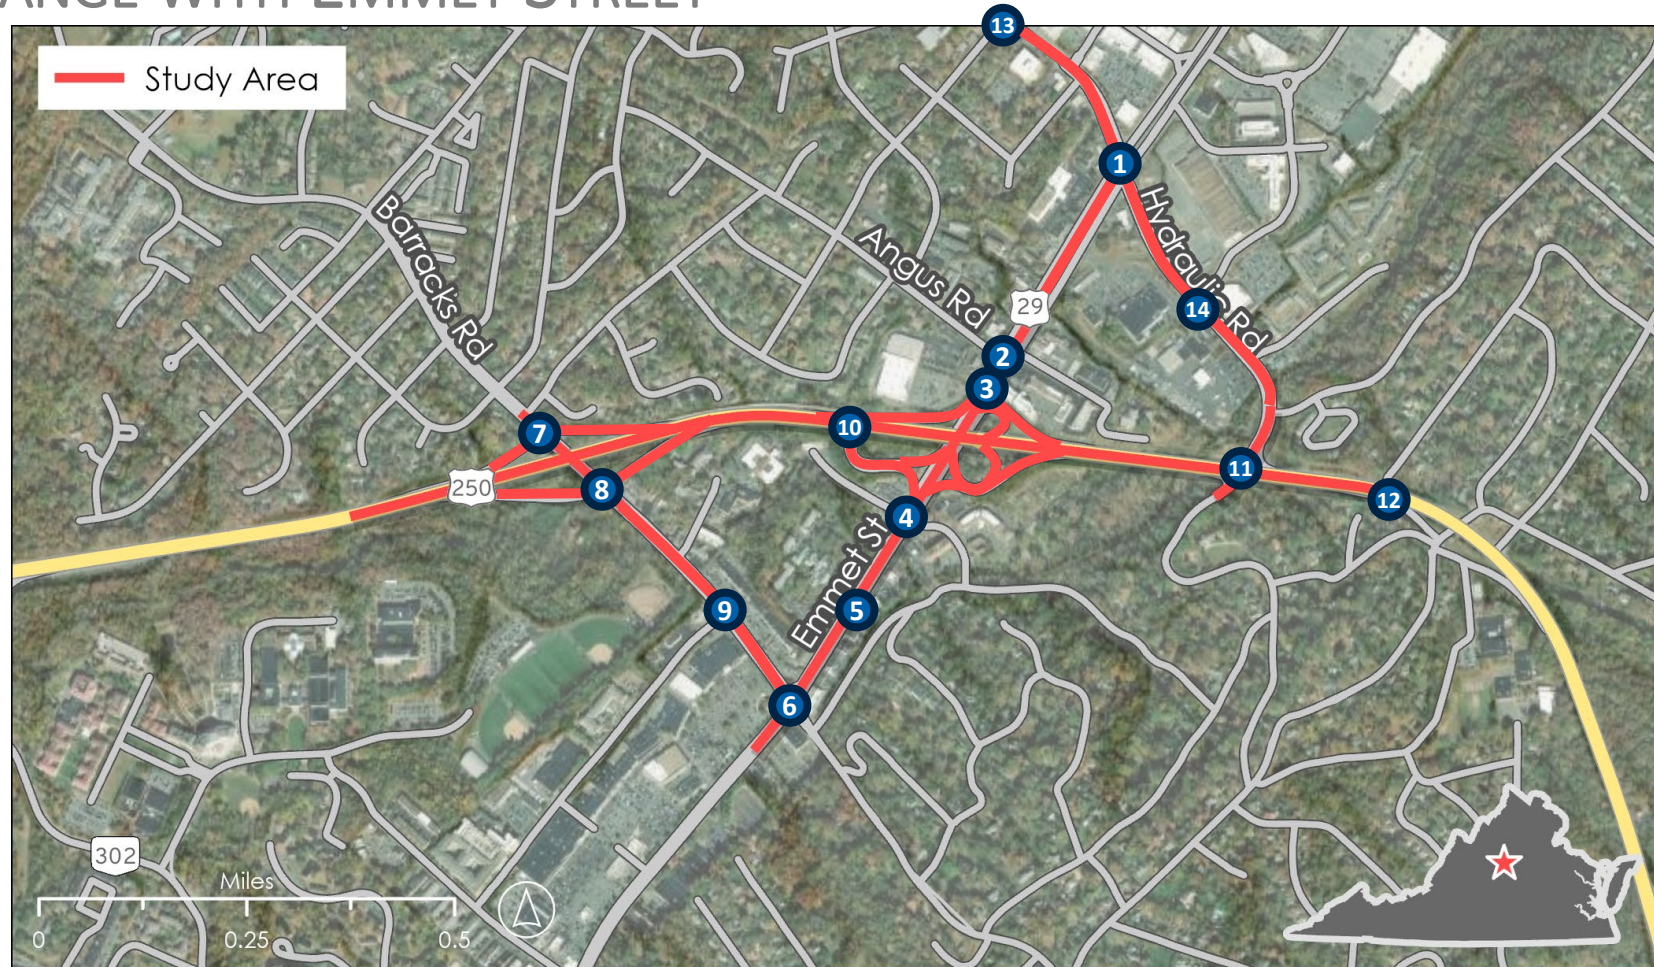
#### Data TMCs Collection:

1. US 29 and Hydraulic Road
2. US 29 and Angus Road
3. US 29 and US29/250 Bypass WB ramps
4. Emmet St and Earhart St/Morton Dr
5. Emmet St and Entrance to Fed Exec Institute
6. Emmet St and Barracks Rd
7. Barracks Rd and US29/250 Bypass WB ramps
8. Barracks Rd and US29/250 Bypass EB ramps
9. Barracks Rd and Millmont St
10. US29/250 Bypass and Ramp to SB Emmet St
11. Hydraulic Road and US29/250 Bypass
12. US29/250 Bypass and Ramp to Dairy Rd
13. Hydraulic Road and District Ave
14. Hydraulic Road and Hillsdale Dr

48-hr tube counts will also be collected.

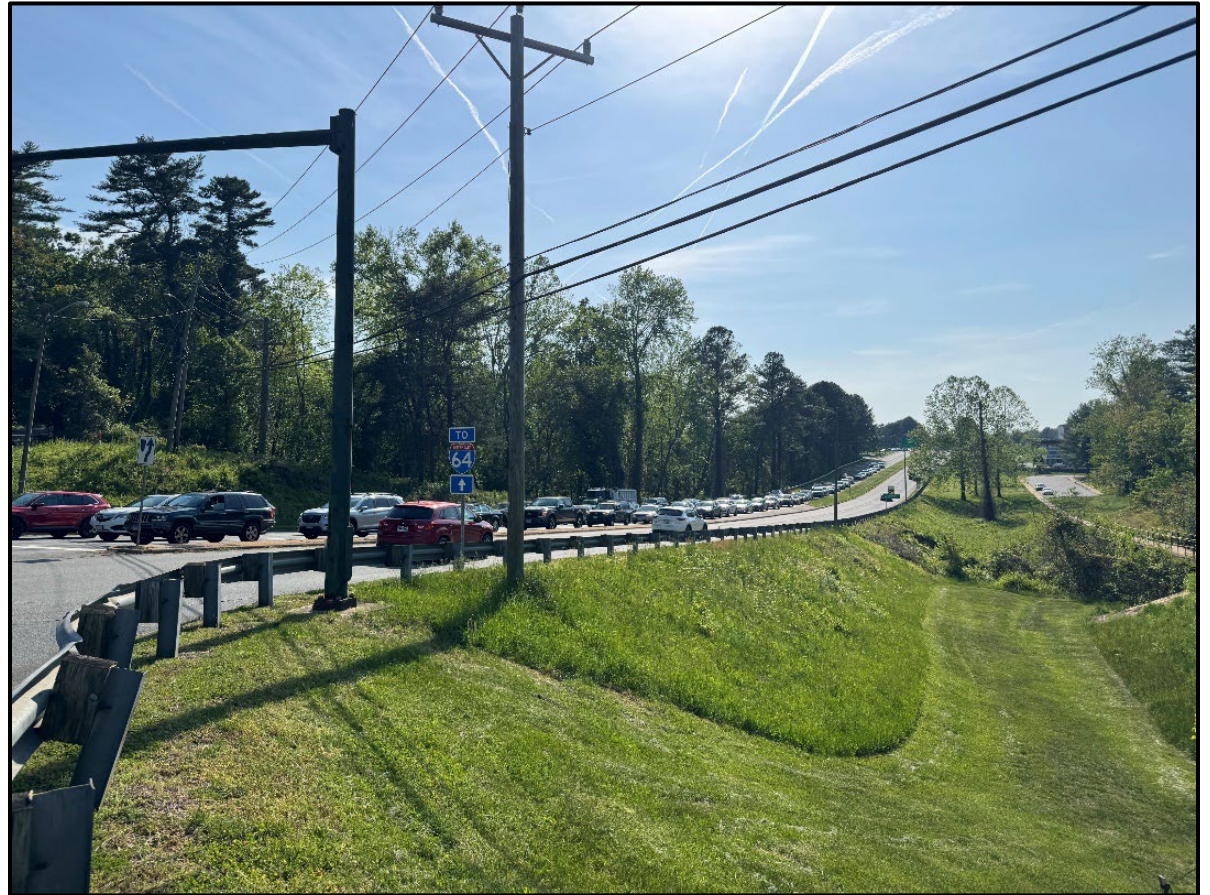
# OPERATIONS

## ■ Results Summary

- Overall congestion is Light-to-Moderate/Heavy
- Queue lengths are long but vehicles typically clear intersection in one cycle along US 29 within interchange area
- Delay along Barracks Rd and at intersection of Emmet St/Barracks is worse than other locations

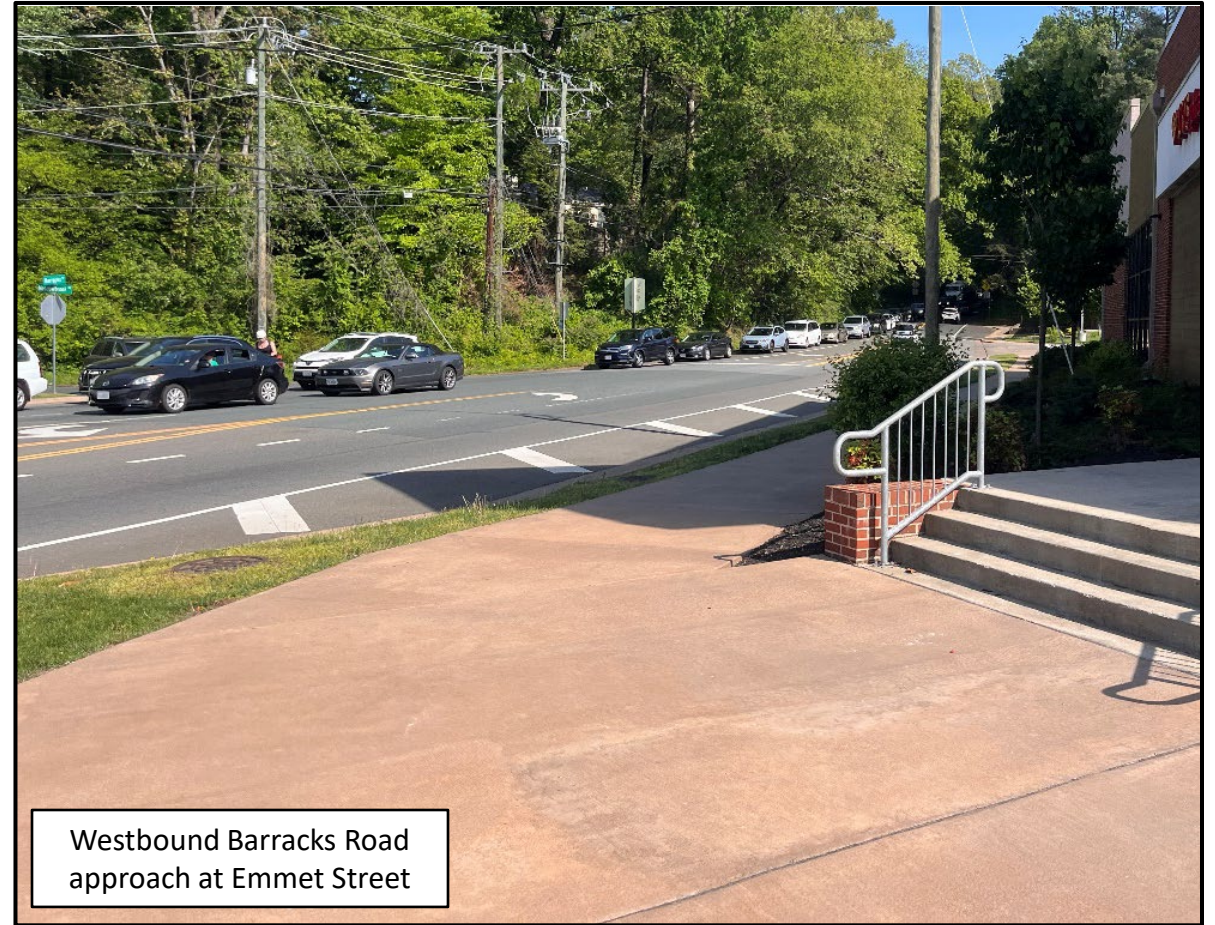
## ■ PSI Intersections:

- US 29 at Hydraulic Road
- US 29/US 250 SB Ramp at Barracks Road

## ■ Identified PSI Segments:

- Segment between Hydraulic Road and US 29/US 250 Interchange
- Segment between Morton Drive and Barracks Road
- Hydraulic Road segment between Hillsdale Drive and US 250 Bypass

## ■ Identified Fatal & Injury Crash Factors:

- Congestion throughout the day
- Interchange ramp geometry
- Off-road/Lane-Departures

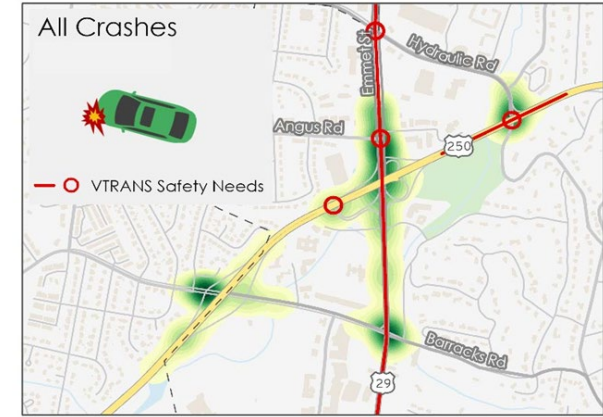
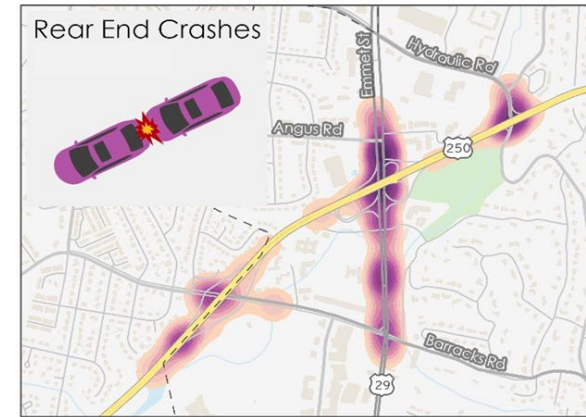
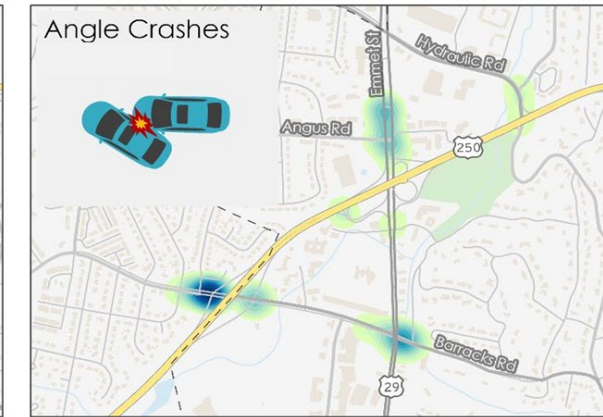
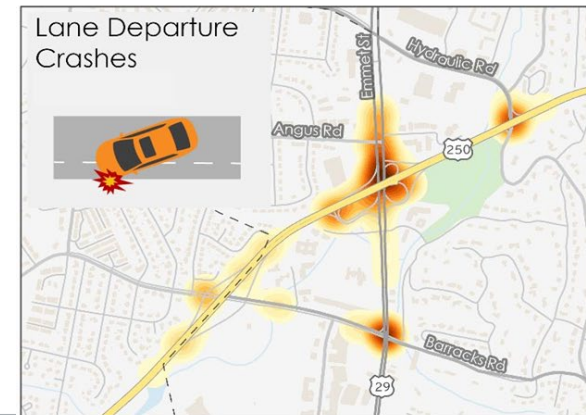
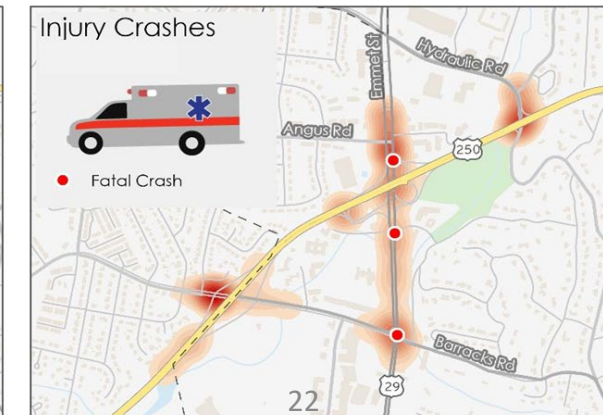
# CRASH SUMMARY (2019-2023)

## ■ Study Intersection Crash Hotspots

- Hydraulic Road/Emmett St – 212 crashes
- Angus Road/Emmett St – 53 crashes

## ■ Overall Crash Patterns

- Access management
  - Southbound between Kroger Way and Holiday Drive
  - Earhart/Morton Drive and 250 off-ramp
- Sideswipes
  - Approach of Hydraulic Road and 250 Bypass
- Interchange conflicts
  - Sideswipes
  - Fixed Object & Rear Ends

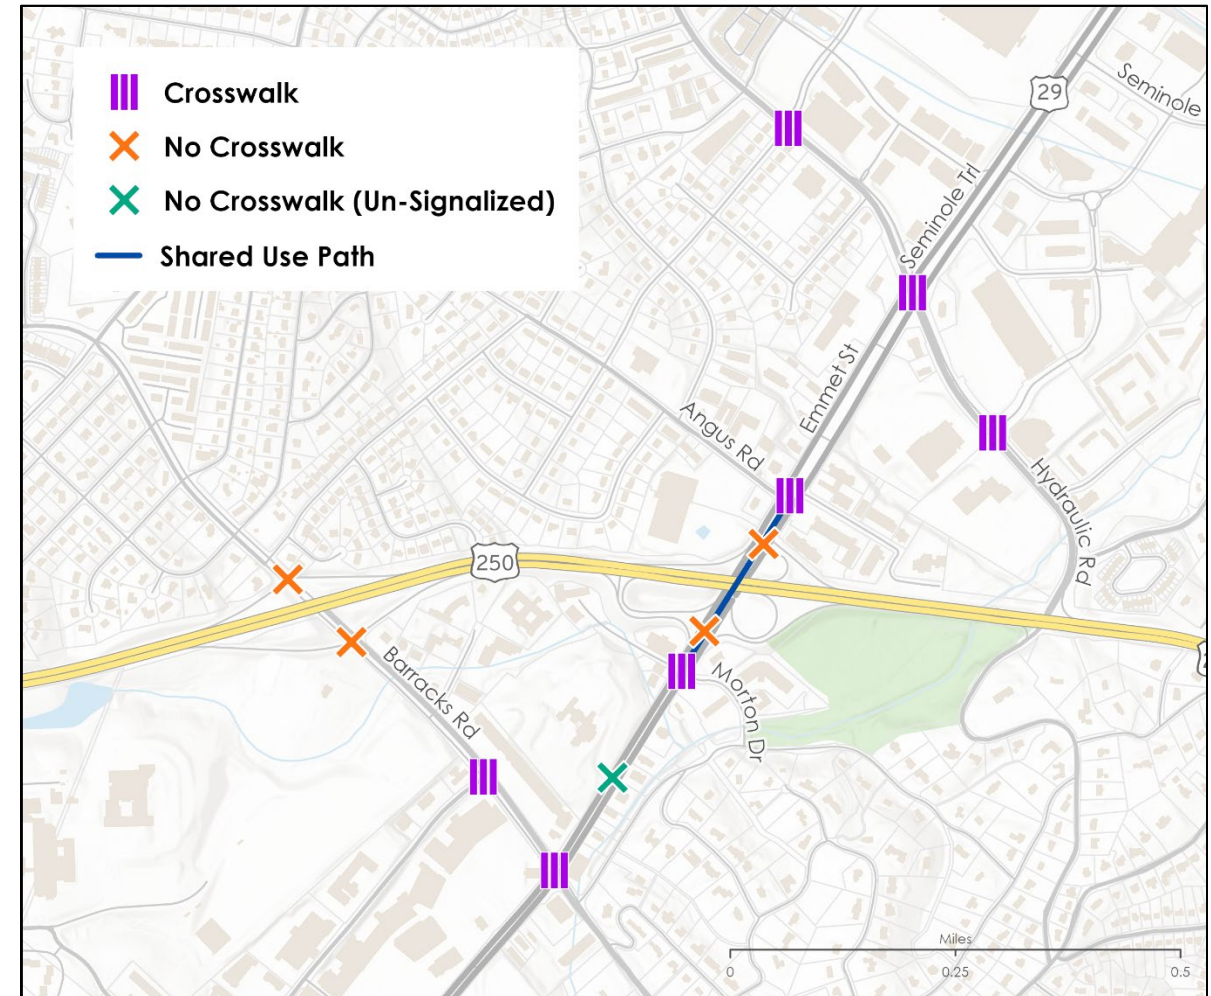
## Intersections with marked crosswalks across Emmet Street:

- Angus Road (NB approach only)
- Morton Drive
- Barracks Road

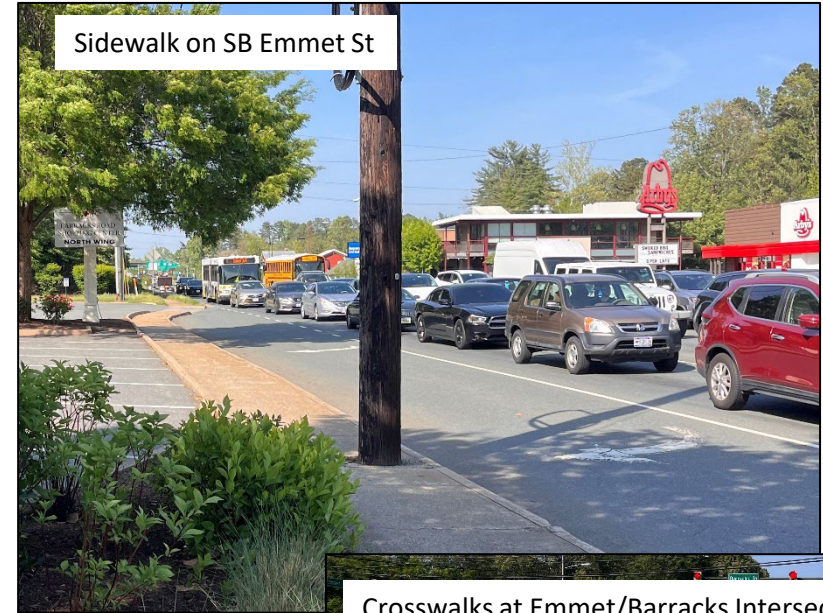
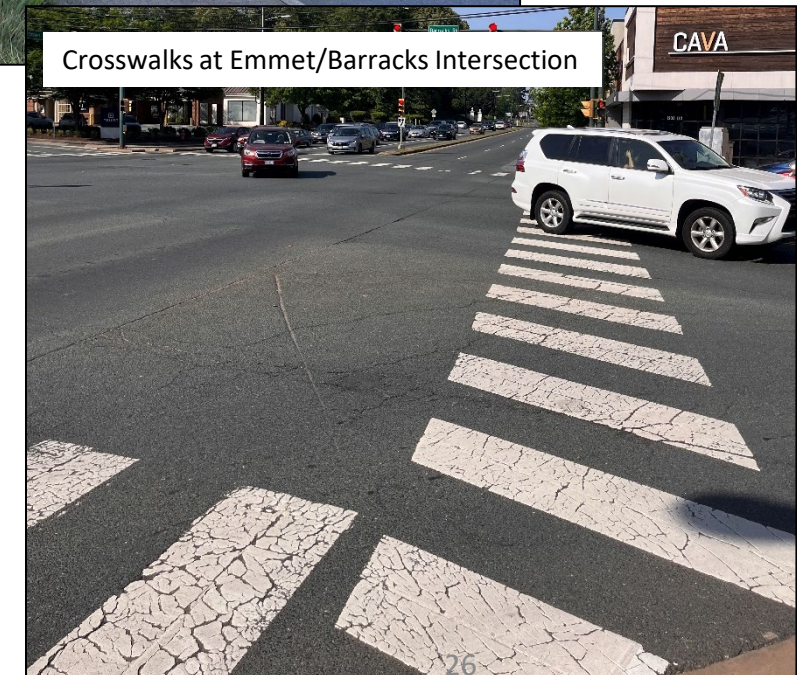
# BICYCLE AND PEDESTRIAN SUMMARY

- Sidewalk network throughout corridor, no missing segments
- Crosswalks present at all signalized intersections along Emmet Street
- Shared-use path within median from Morton Drive to Angus Road
- Three pedestrian crashes during analysis period (2019-2023), including one fatal
  - Two occurred near Angus Road
  - Fatal crash occurred at Morton Drive; police report noted pedestrian may have been intoxicated.

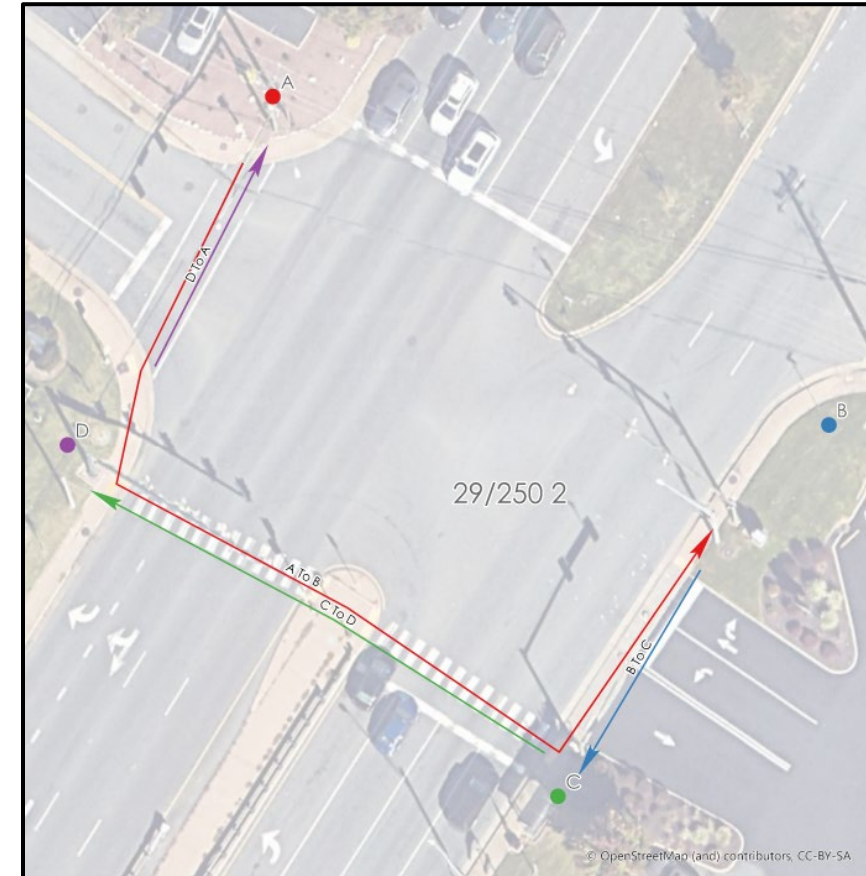
Flag #1: SB right turns in conflict with pedestrians  
Flag #7: Multilane Crossings  
Flag #10: Motor Vehicle Left-Turns across pedestrian path

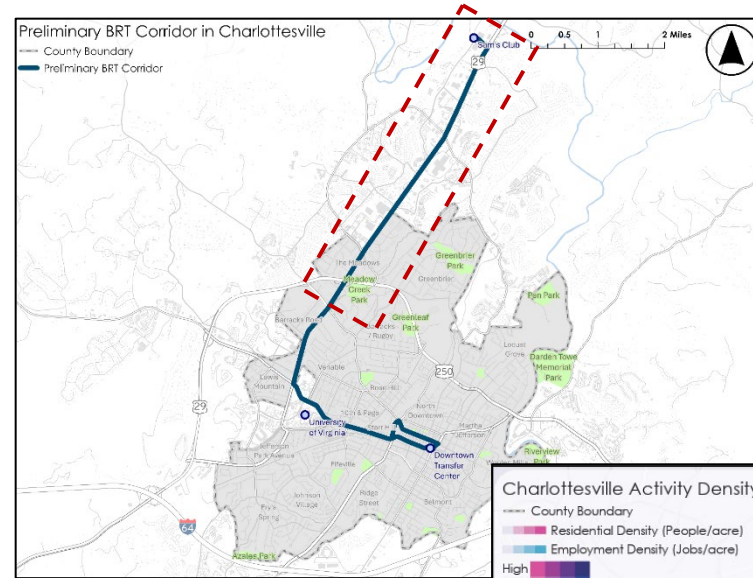
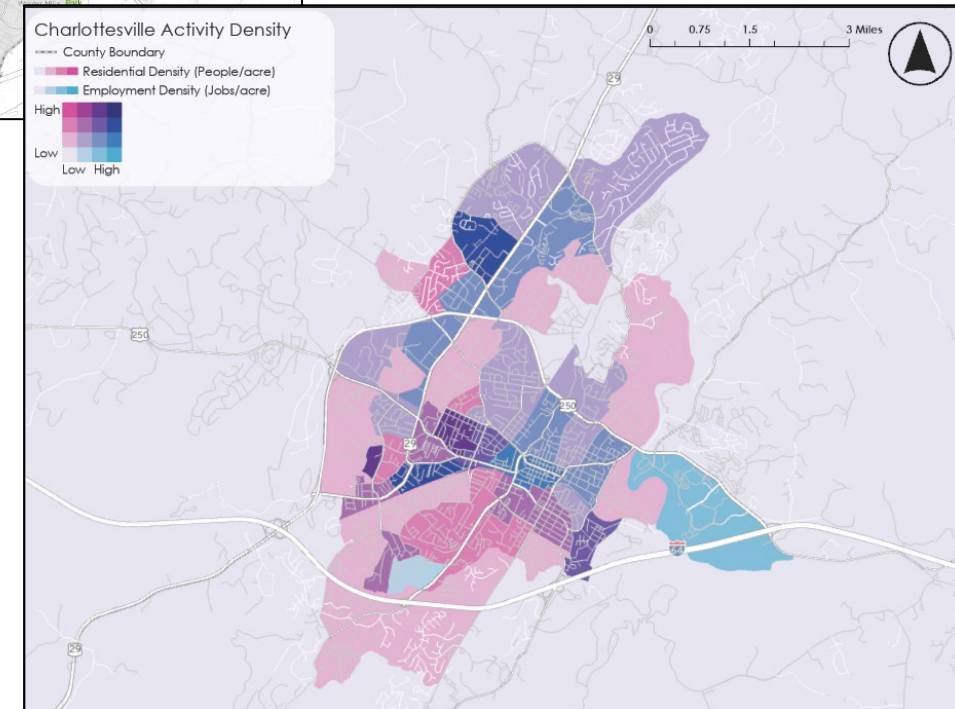
## ■ Analysis Objectives:

- Identify potential high-frequency transit alternatives in US 29 corridor between Downtown and US 29 North
- Ensure no other recommendations preclude high-capacity transit in future.

## ■ Analysis Steps:

- Determine potential alignment and station locations based on activity density, redevelopment potential, and operational feasibility
  - Residential and employment density
  - Redevelopment potential (ownership patterns, parcelization, future land use, etc.)
  - Multimodal accessibility

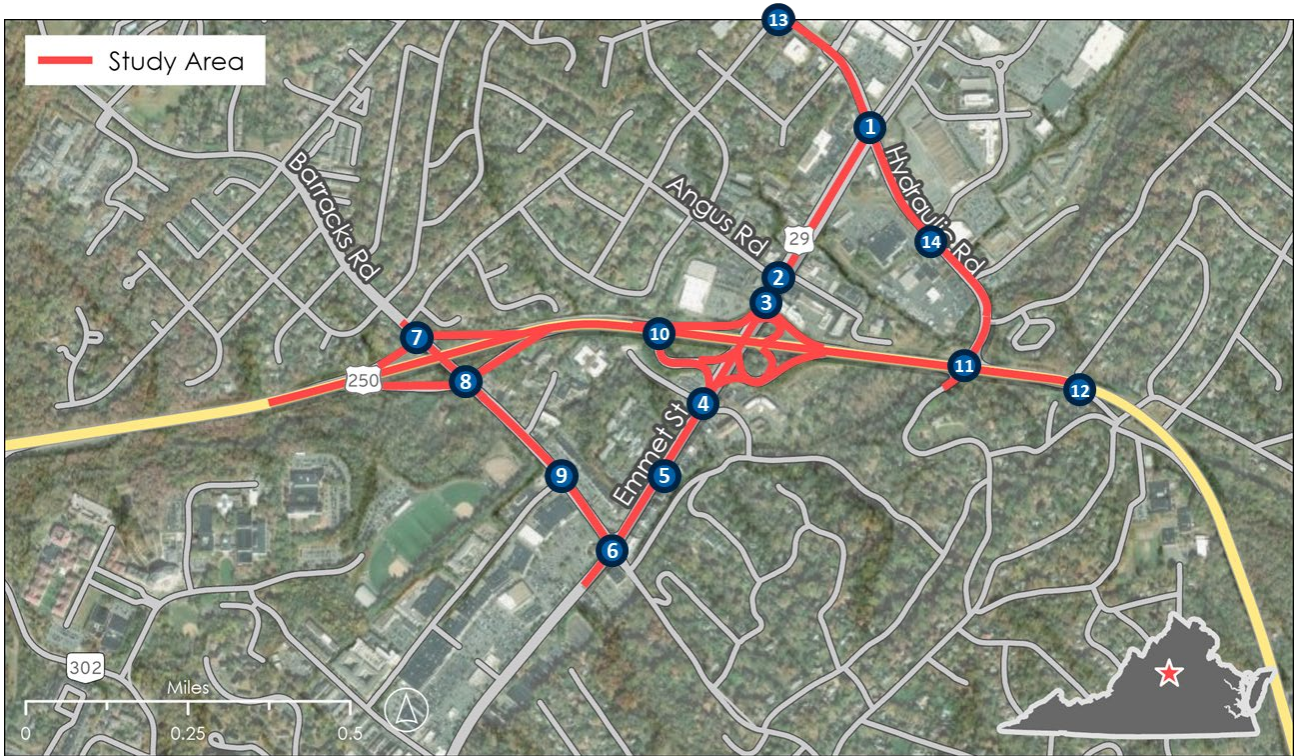
**Toolbox of solutions:**

- Interchange Modification
  - Innovative interchange solutions
- Traditional Improvements
  - Ramp improvements
- Bike/Ped Improvements
  - Shared-use paths, pedestrian bridge, transit service upgrades, etc.
- Low-Cost Improvements
  - Signal timing optimization, turn lanes, hard separation barriers to prevent weaving, etc.
