# PROJECT PIPELINE CULPEPER DISTRICT

Charles Proctor/Sandy Shackelford – POC/Culpeper District  
Albemarle County Studies

# Culpeper District Projects

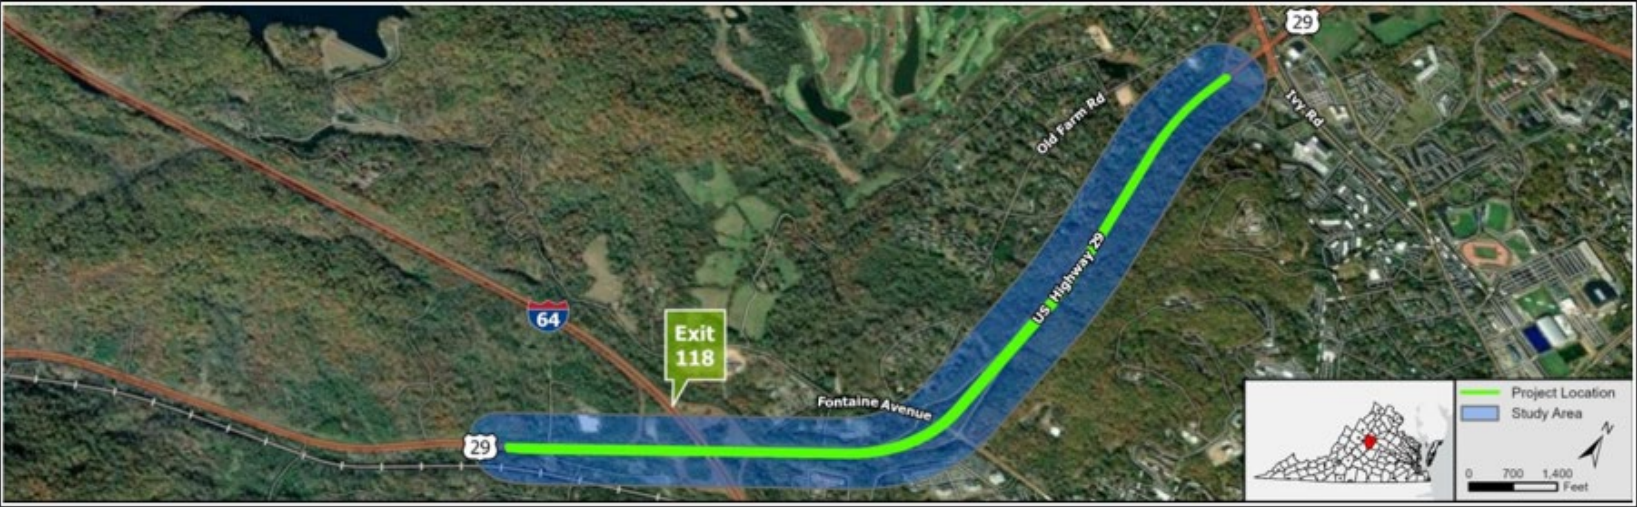
# CU-25-01: US 29 & I-64

To resolve the traffic backup of the dual left-turn lane from US Route 29 southbound to get onto I-64 eastbound. There are significant safety concerns here due to the short turn lane length. The study also aims to improve the small park and ride lot located on Teel Lane, just south of the interchange on the east side of US Route 29 southbound.

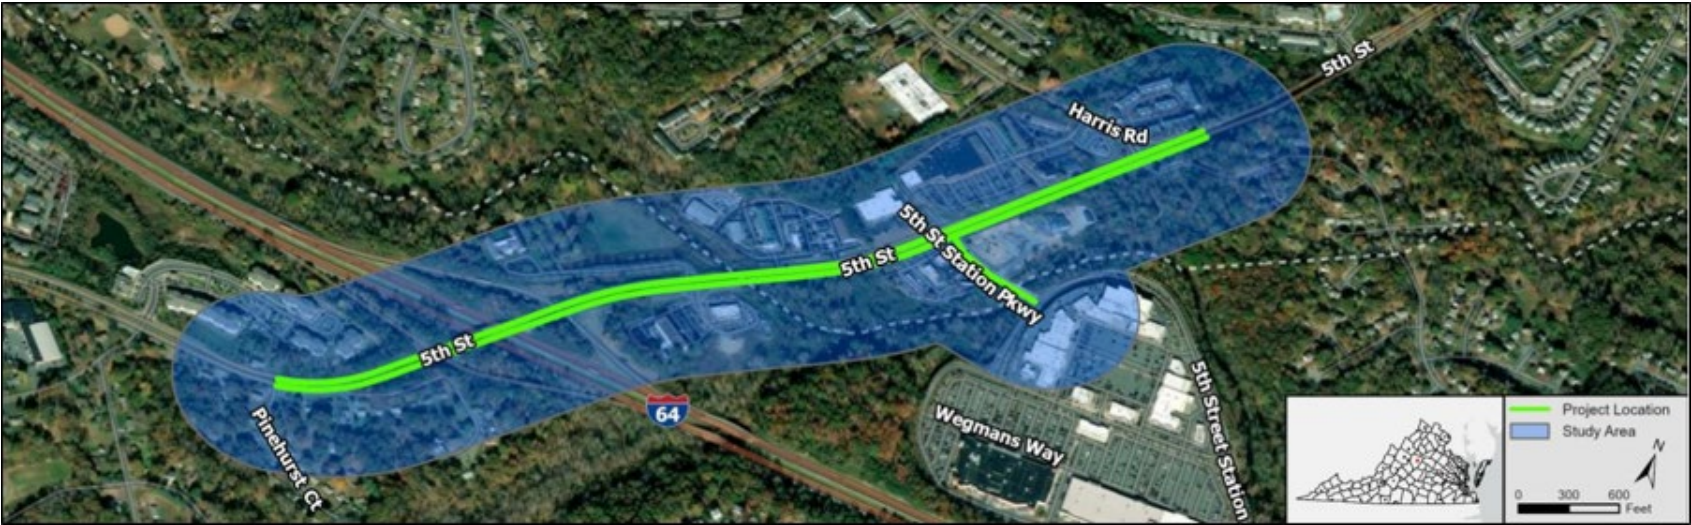
# CU-25-03: 5<sup>th</sup> Street

To re-evaluate previous studies and SMART SCALE applications along the corridor to refine and value-engineer solutions with improved benefit-to-cost potential. The study will result in updated concepts for consideration in the upcoming Round 7 of SMART SCALE.
